# **ADDENDUM NO. B**

**West Lothian Roof Replacement**

**PROJECT NO. 956399**

Roof Asset Management Program

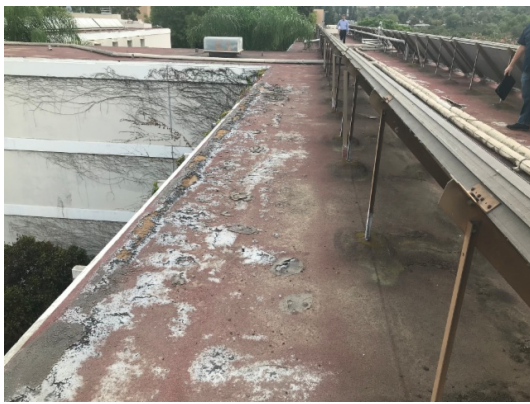
**Photo 1**

<b>Rating</b>	Failed		
<b>Condition</b>	<p><b>Splits:</b> Membrane splits are usually caused by building movement, ridges, and expansion and contraction. Such movement can be caused by lack of attachment of one or more of the component parts of the roof system, or where the building itself generates movement. Weak or inflexible membranes reach a point where they cannot accommodate further movement. At this time the roof splits open. The open split allows water to enter the roofing system, saturating the insulation, and causes leaks into the building. The foam around the perimeter has been unable to withstand the expansion and contraction of the metal edge. Each overlap of the metal is causing too much stress on the foam which then splits. Each of these failures can cause severe leakage inside the building.</p>

The foam membrane around the perimeter has failed.

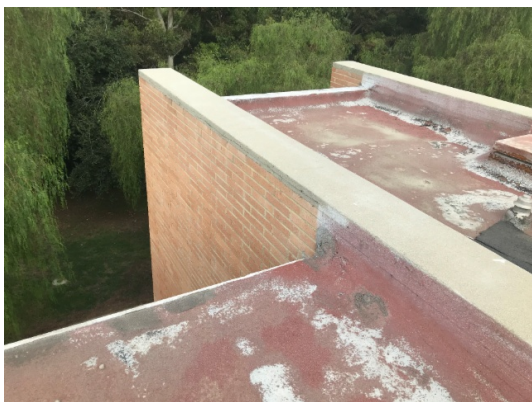
**Photo 6**

Perimeter wall to metal edge detail.

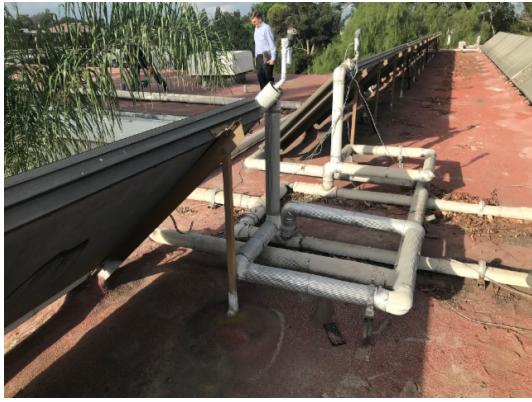
**Photo 7**

Heavy conduit section from solar panels.

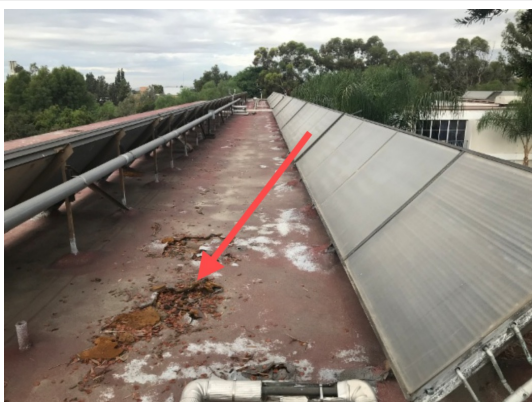
**Photo 10**

Severe damage to foam membrane.

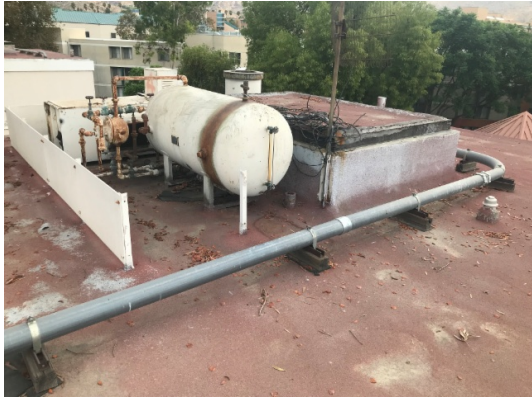
**Photo 12**

Mechanical equipment near elevator shaft.

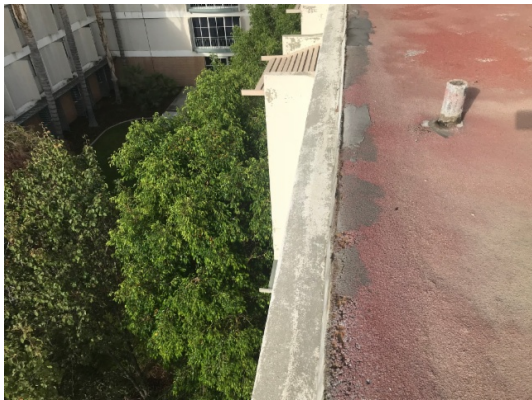
**Photo 13**

Metal edge to concrete perimeter detail.

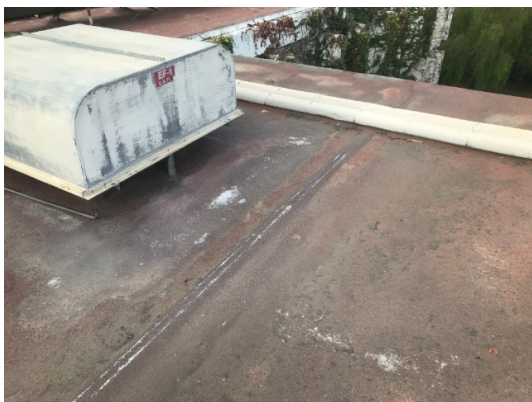
**Photo 14**

The expansion joint was buried beneath the foam membrane.

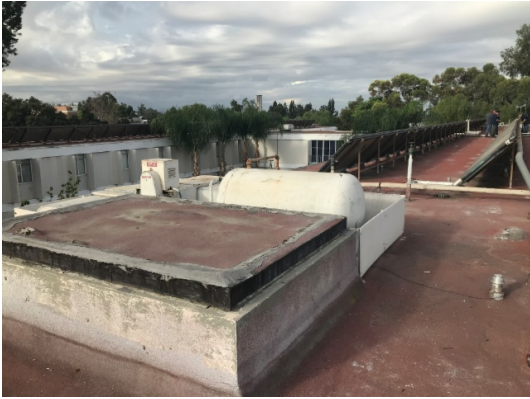
**Photo 20**

Elevator shaft.
