***University of California, Riverside
Building Demolitions – Veitch, Boyden and Stored Products
Insecticide
Project Numbers: 958138 and 958144***

**Addendum No. 4 to the Program Environmental Impact Report for the
University of California, Riverside 2021 Long Range Development Plan**

**PLANNING, DESIGN & CONSTRUCTION
University of California, Riverside
900 University Avenue
Riverside, California 92521**

JANUARY 2026

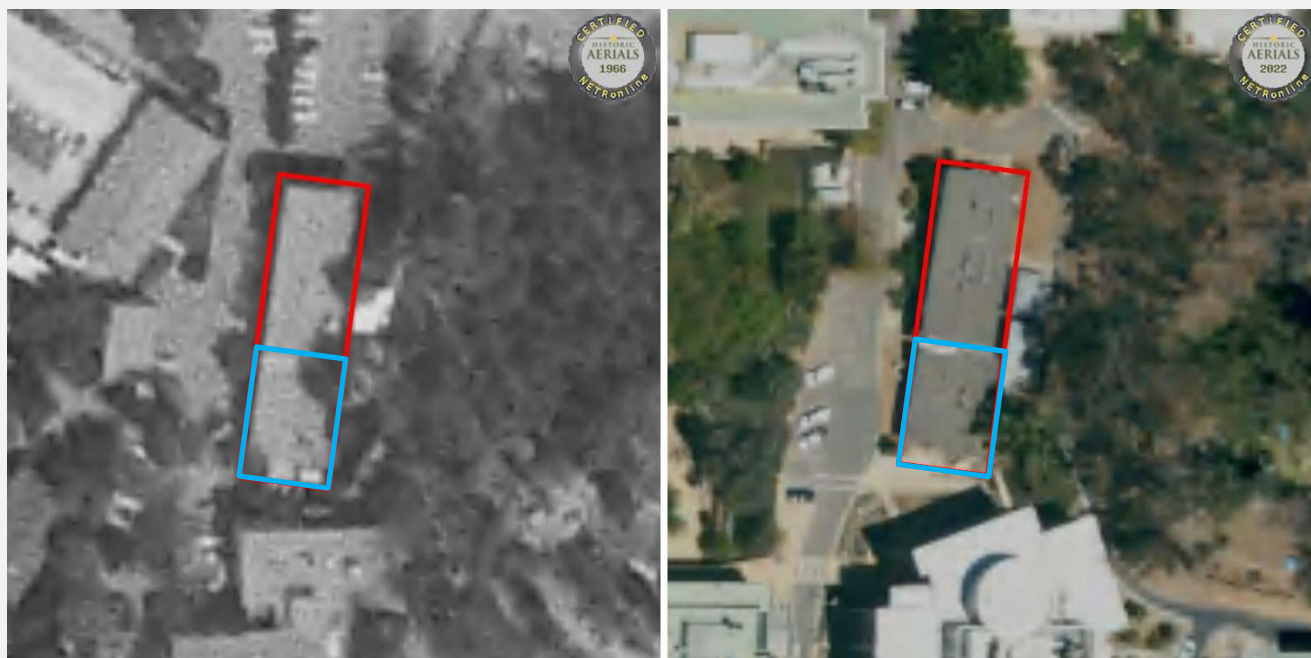
Exhibit 1. The Boyden Laboratory (red outline) and SPI Building (blue outline) in 1966 (left), and in 2022 (right)

The following section provides an overview of the construction history for Boyden Laboratory and the SPI Building and information on architect Graham Latta. As noted previously, the subject properties consist of two adjacent buildings constructed for UCR's Department of Entomology. Historic aerial photographs offer an overview of the building's setting and footprint over time (Exhibit 1) (NETR 2024).

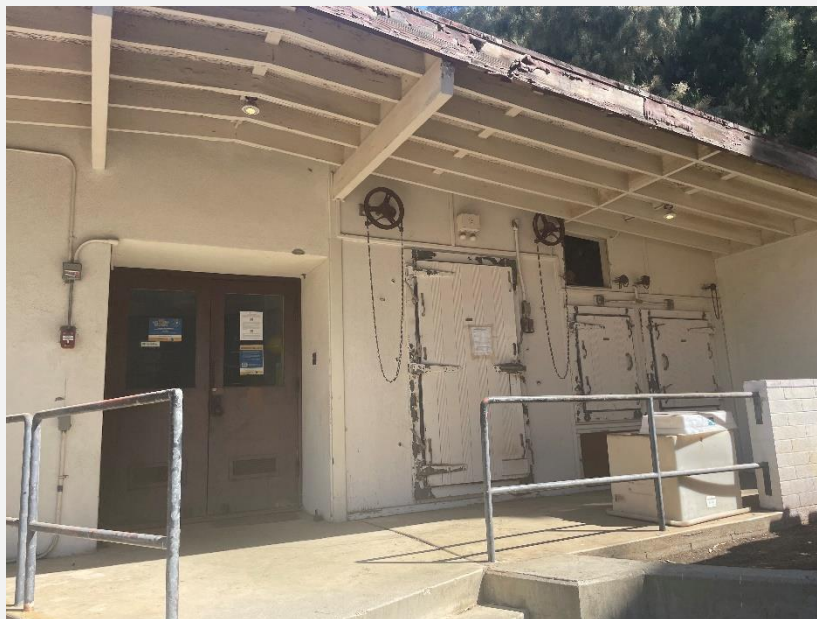
Exhibit 4. Primary entrance and refrigerator doors on the primary (north) elevation of the SPI Building, view looking northeast. Photograph taken September 18, 2024.

Alterations observed during the property survey include the replacement of the primary entrance door on the primary (south) elevation, the replacement of three windows on the primary (south) elevation with an air conditioning unit and fitted wood panel, and the replacement of two windows on the rear (north) elevation with an air conditioning unit and fitted wood panel (Exhibits 4, 5, and 8). The building includes some minor elements of the Mid-Century Modern style, including an overall horizontal design composition; one-story height; simple geometric volumes; stucco cladding; simply treated materials; and a lack of applied historicist ornamentation.

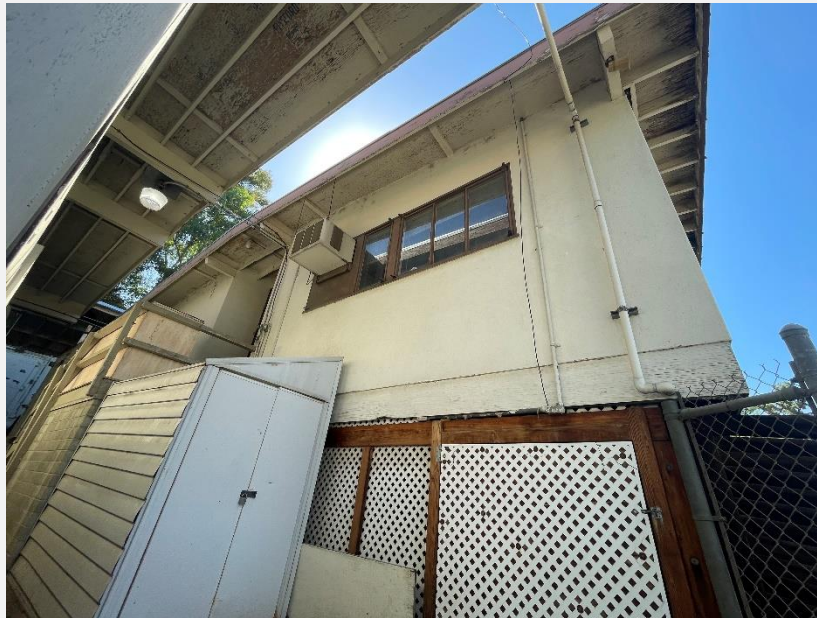
Exhibit 5. Secondary entrance and window replacements with an air conditioning unit on the rear (north) elevation of the SPI Building, view looking southeast. Photograph taken September 18, 2024.

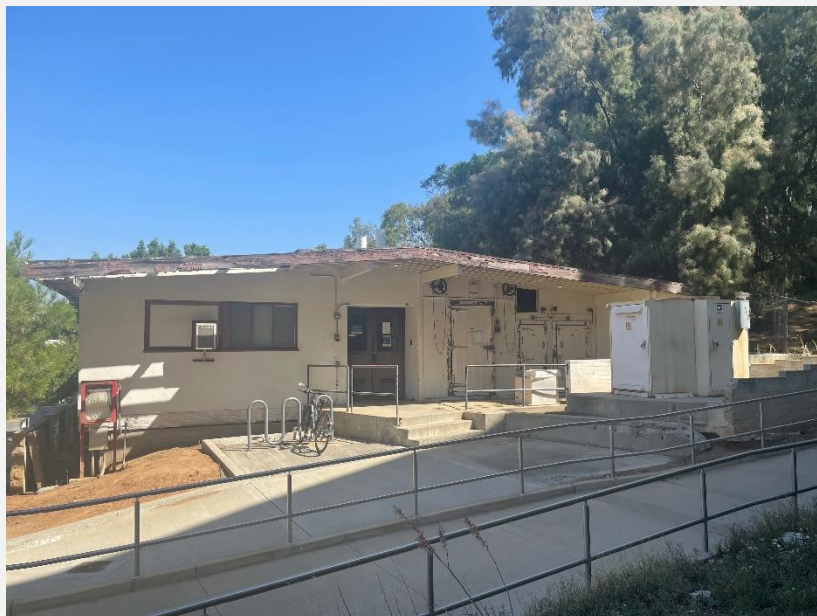
Exhibit 8. Window replacements with an air conditioning unit on the primary (south) elevation of the SPI Building, view looking northeast. Photograph taken September 18, 2024.

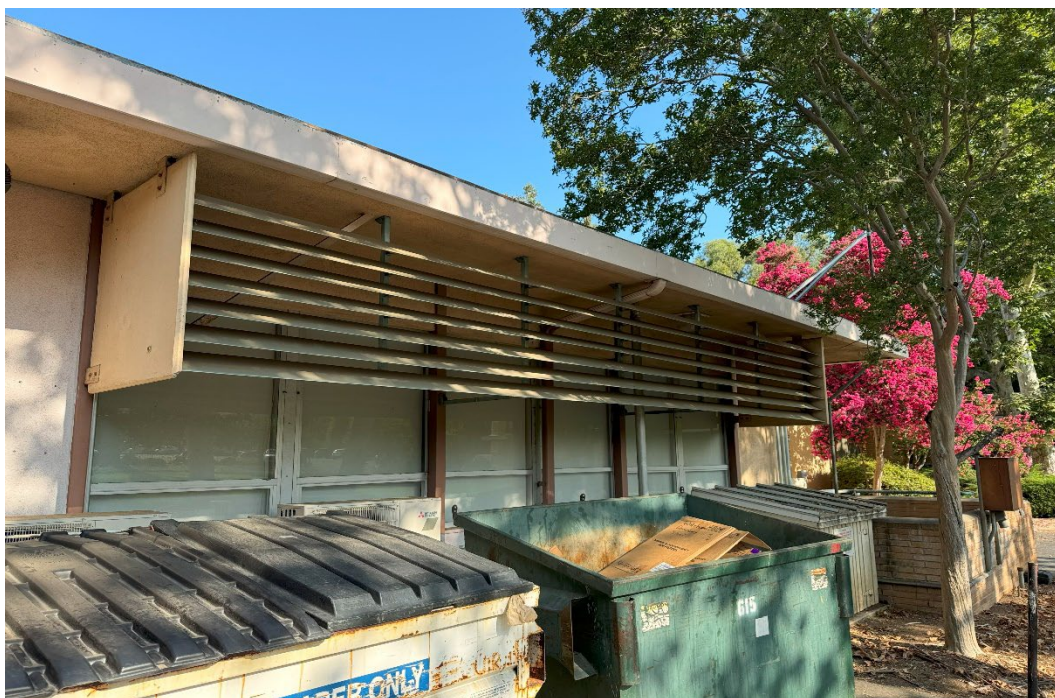
Photograph 1: Metal wall posts-paint negative for lead, stucco ACCM by Point Count.

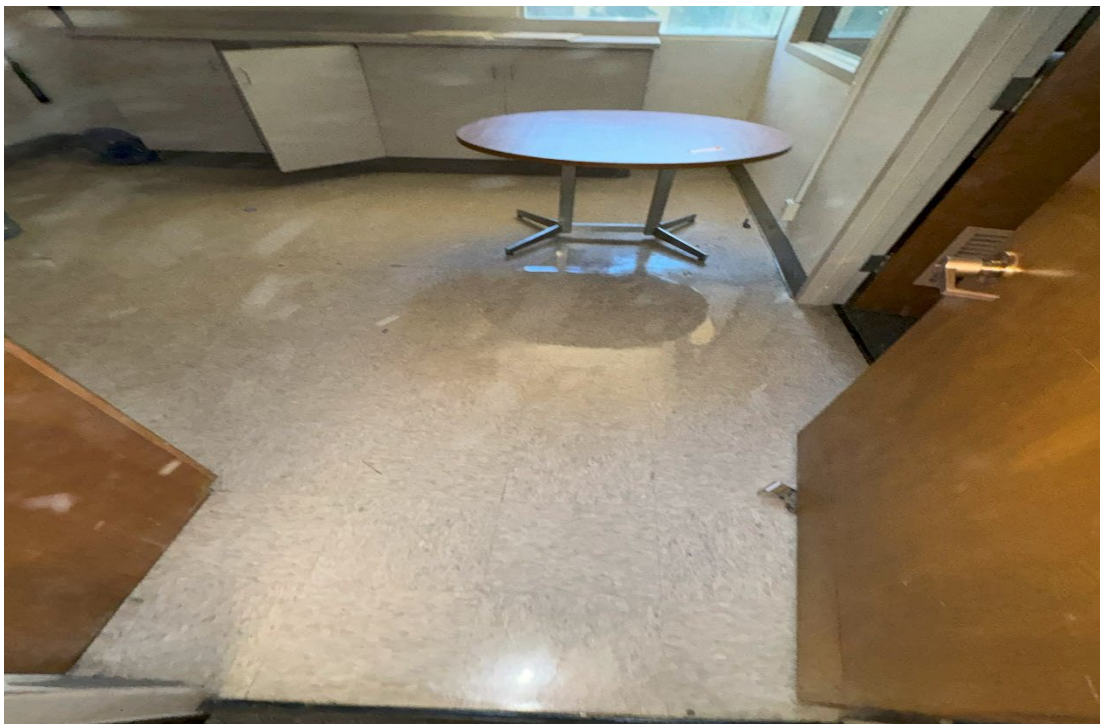
Photograph 13: 12" VFT-non asbestos in room 399 and restroom 397.

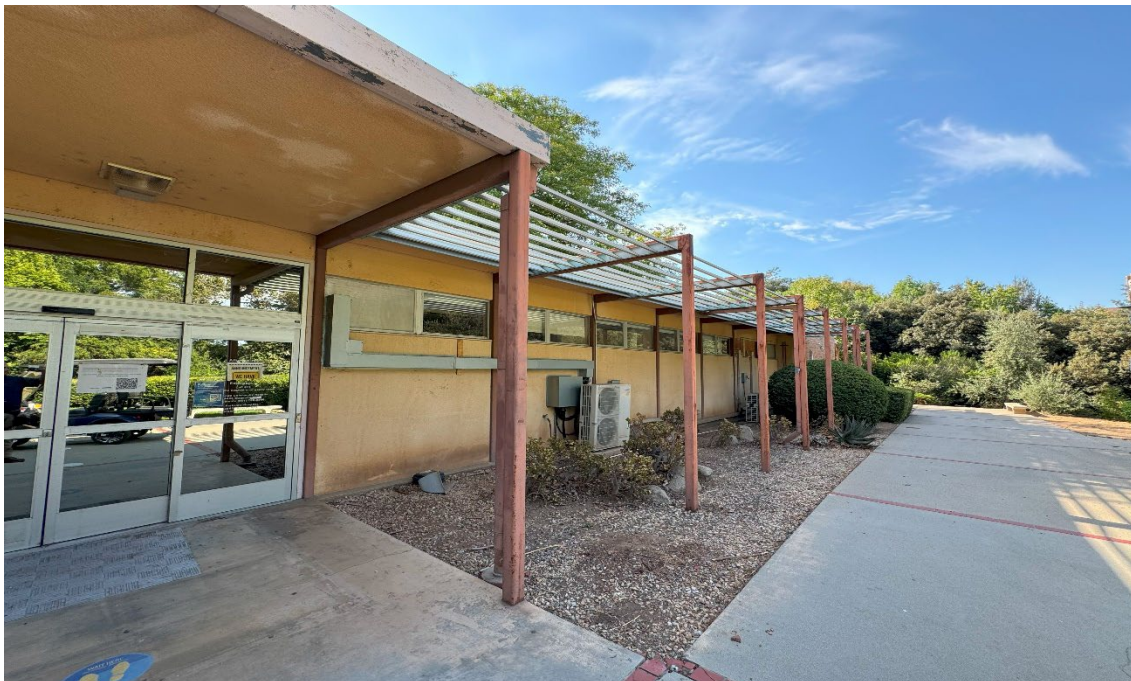
Photograph 19: Brown sunshade support posts with lead base paint-exterior southwest-SW entry.
