Addendum #1 to Final Environmental Impact Report for the
Glen Mor 2 Student Apartments Project
(SCH# 2010081020)

Project Title: Glen Mor 2 Student Apartments
Project Number: 956334
Project Location: The project is located on the University of California, Riverside (UCR) campus, generally northwest of Big Springs Road and Valencia Hill Drive. The site is south of the existing Glen Mor 1 and Pentland Hills residential complexes and east of Lothian residence hall.
City: Riverside
County: Riverside

Addendum #1 for Glen Mor 2 Student Apartments
Modified Arroyo Improvements
September 25, 2012

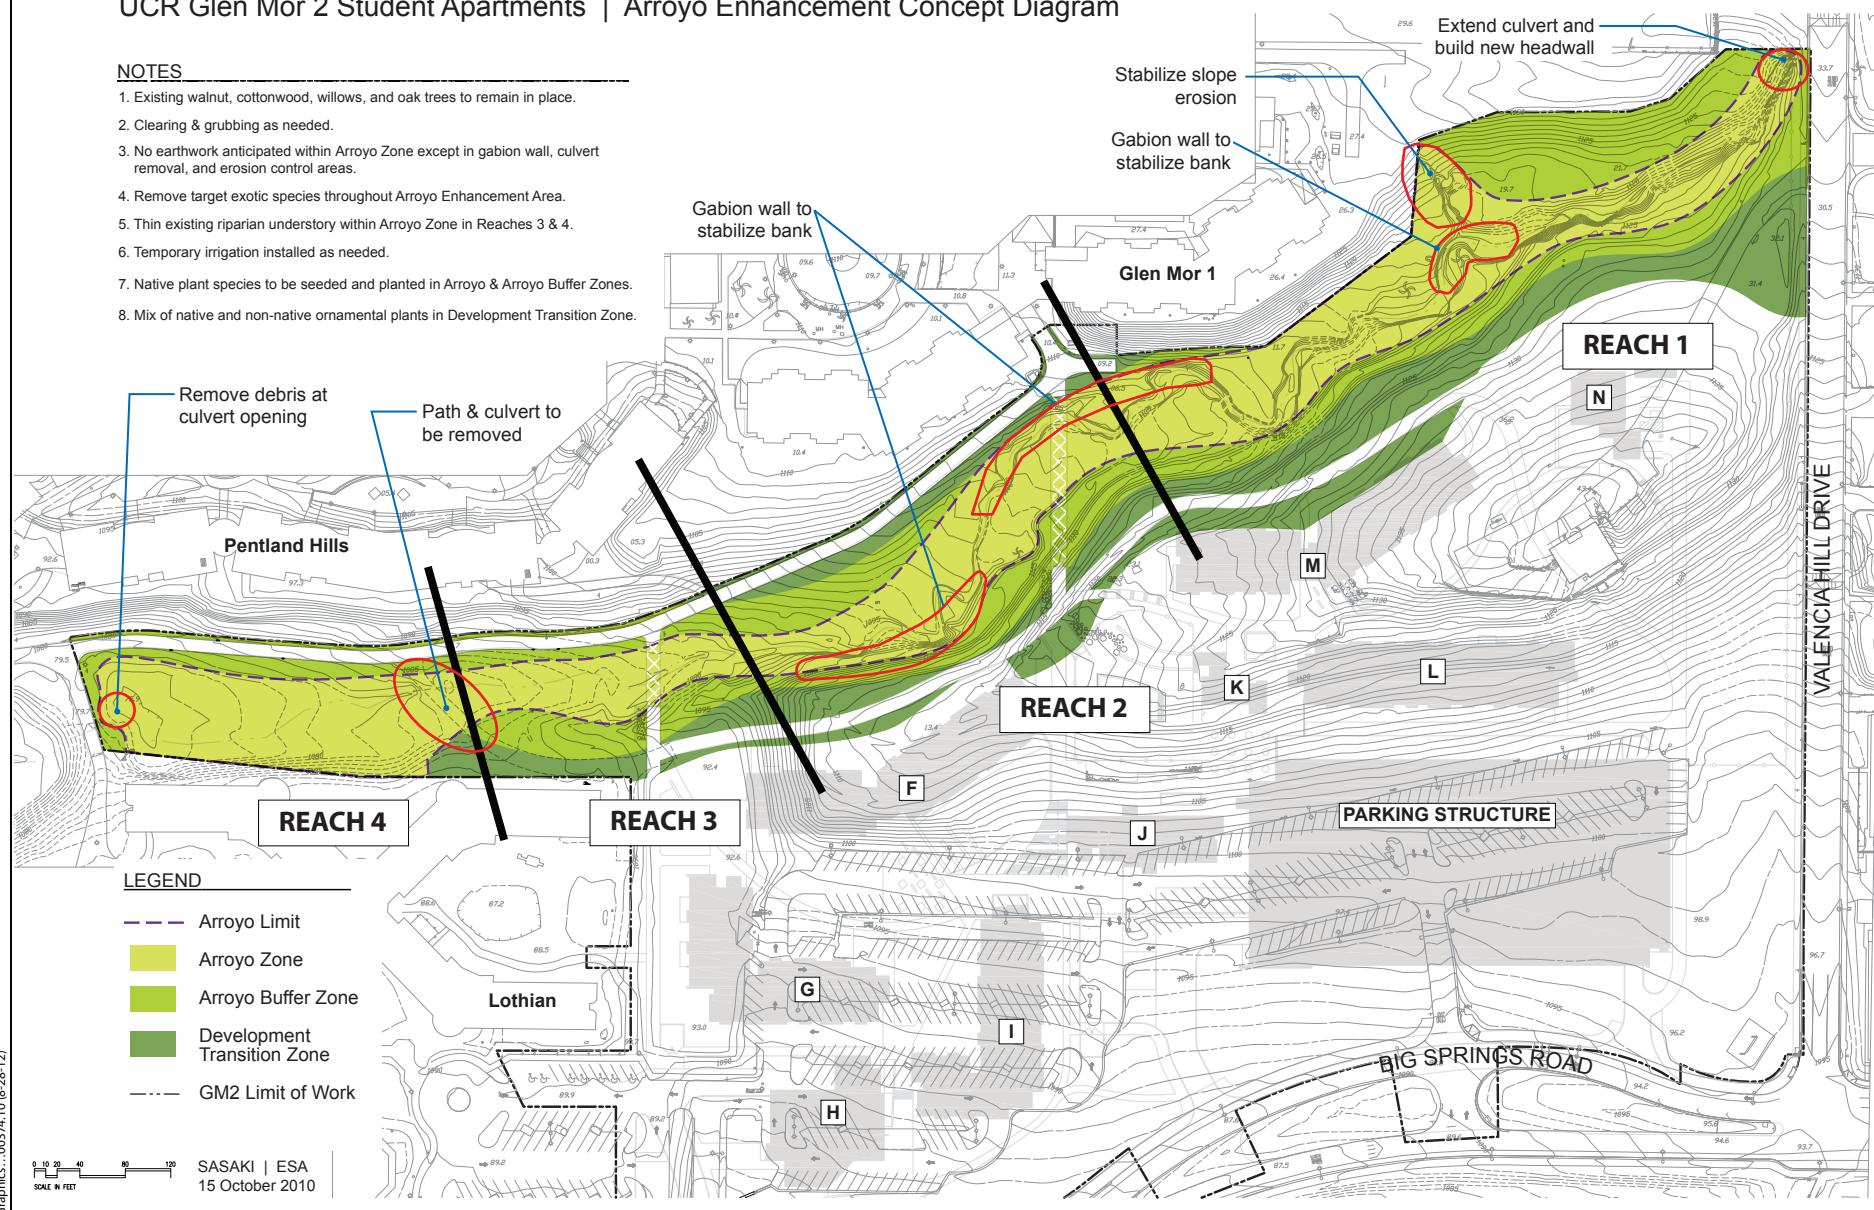
1. Existing walnut, cottonwood, willows, and oak trees to remain in place.
2. Clearing & grubbing as needed.
3. No earthwork anticipated within Arroyo Zone except in gabion wall, culvert removal, and erosion control areas.
4. Remove target exotic species throughout Arroyo Enhancement Area.
5. Thin existing riparian understory within Arroyo Zone in Reaches 3 & 4.
6. Temporary irrigation installed as needed.
7. Native plant species to be seeded and planted in Arroyo & Arroyo Buffer Zones.
8. Mix of native and non-native ornamental plants in Development Transition Zone.

Figure 2-5
Proposed Arroyo Improvements
Glen Mor 2 Student Apartments
Revised September 2012 for Arroyo Improvements Addendum

- a. Added References
- b. Revised Figure 2-5
- c. September 12, 2012 ICF Memorandum
- d. Revised Mitigation Measures BIO 3 and BIO 4
- e. Revised Figure 2-7

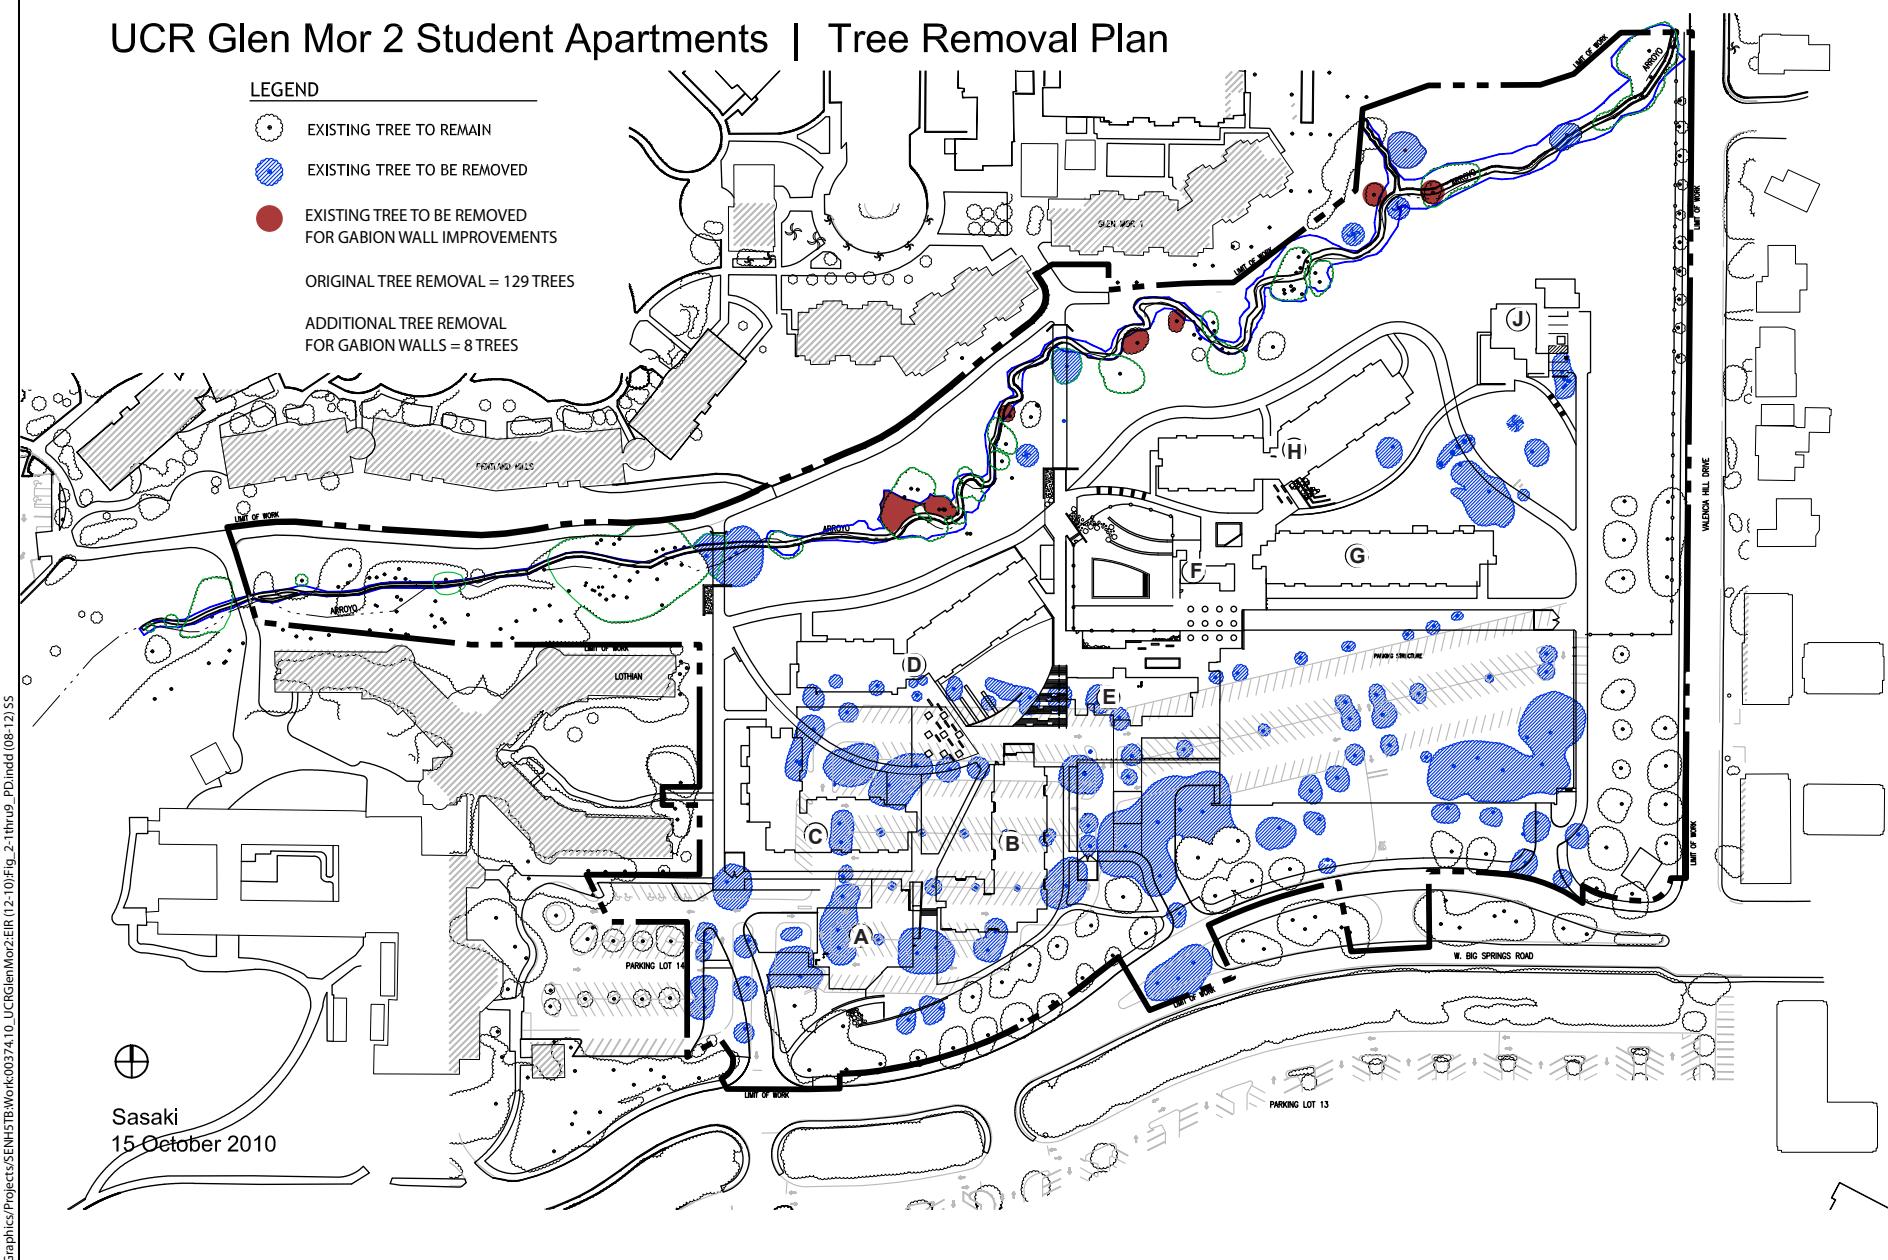
UCR Glen Mor 2 Student Apartments | Tree Removal Plan

Figure 2-7
Tree Removal Plan
Glen Mor 2 Student Apartments
Revised September 2012 for Arroyo Improvements Addendum

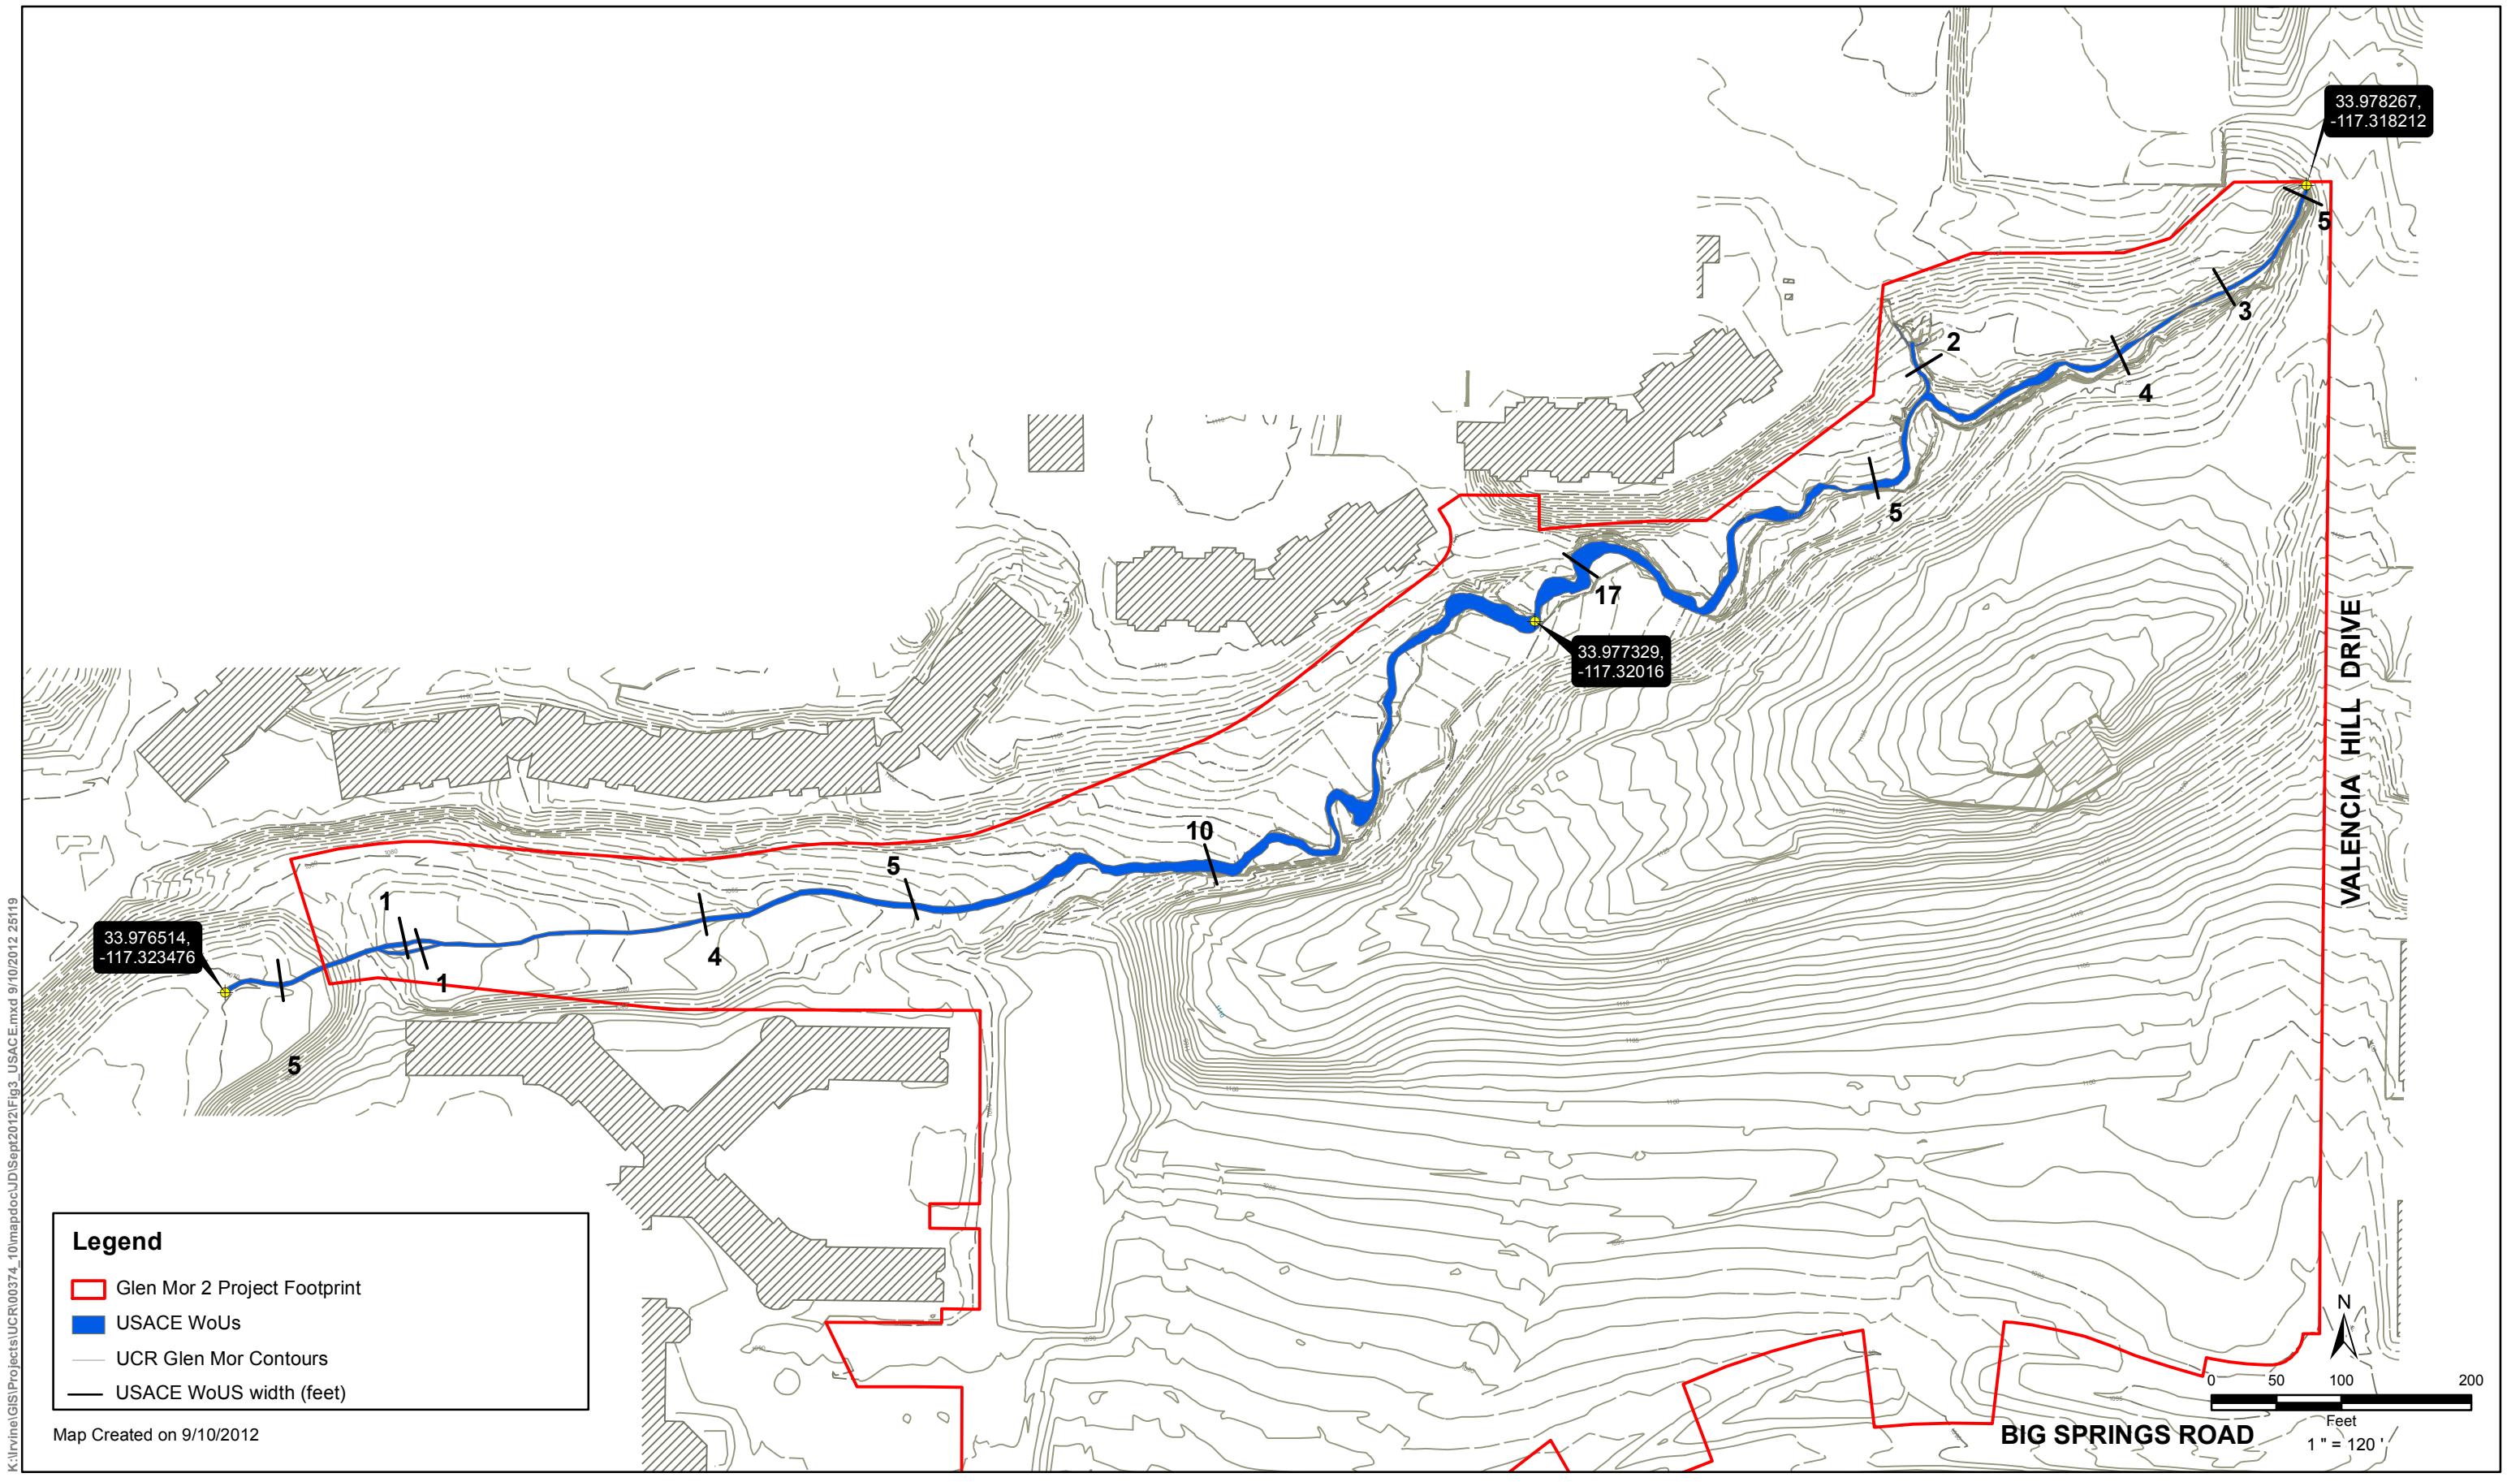
Figure 3
USACE Jurisdictional Delineation 2012 Update
Glen Mor 2 Student Apartments Project

One ephemeral drainage totaling 0.27 acre and 2,204 linear feet of non-wetland waters of the United States (Figure 3) is located within the arroyo, and is potentially subject to USACE jurisdiction. The drainage enters the study area on the northeastern corner of the Project area and meanders westerly for approximately 2,204 linear feet until evidence of an OHWM dissipates temporarily in the ruderal field located west of the Lothian residence hall. The drainage connects via sheet flow over a distance of approximately 400 feet to a downstream feature known as the Junction Basin. The Junction Basin discharges via culvert to a surface channel along North Campus Drive, which opens into another basin feature known as the Glade Basin, a turf landscaped feature at the northeast corner of Aberdeen Drive and Campus Drive. Flows from the Glade Basin discharge into an underground storm drain which emerges approximately 1,300 feet downstream at the Gage Basin, a riparian zone at the northwest corner of Canyon Crest Drive and University Avenue that is the terminal feature of the stormwater management system for this portion of the campus. Water from the Gage Basin enters the city storm drain system, which discharges to the Santa Ana River, a tributary of the Pacific Ocean.

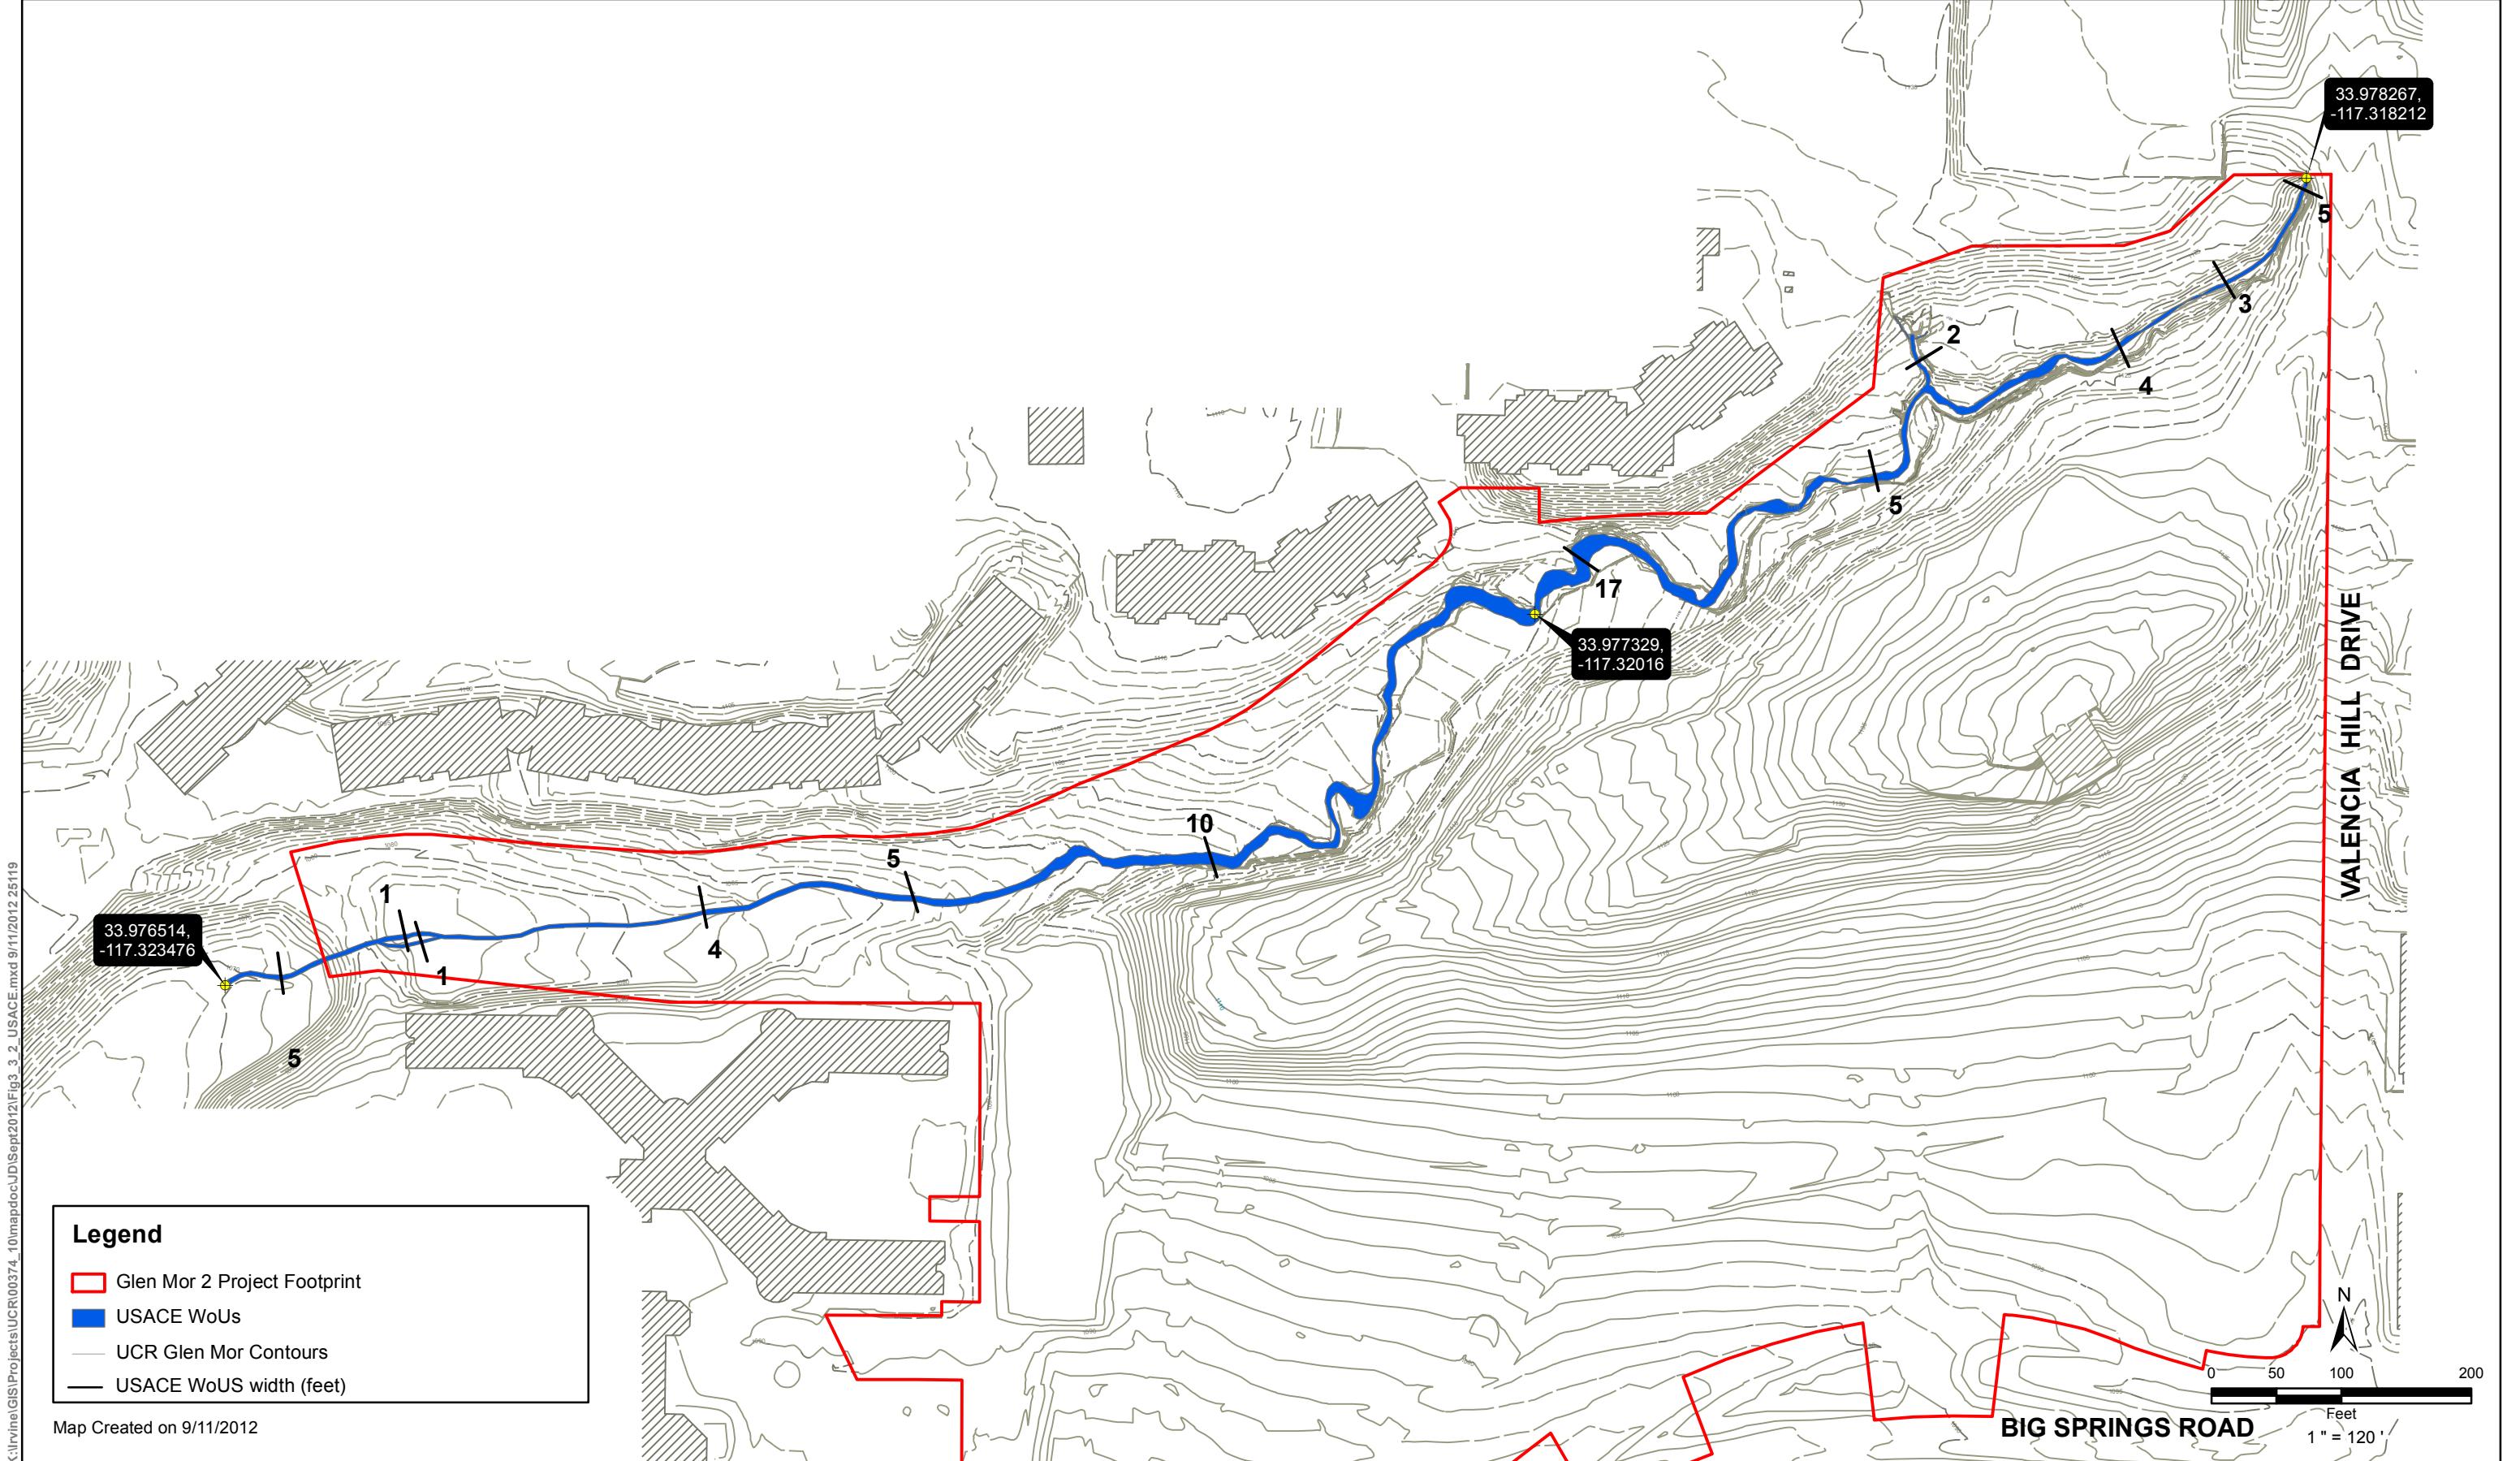
Attachment g
Revised Figure 3.3-2

Figure 3.3-2
USACE Jurisdictional Delineation
Glen Mor 2 Student Apartments Project
Revised September 2012 for Arroyo Improvements Addendum

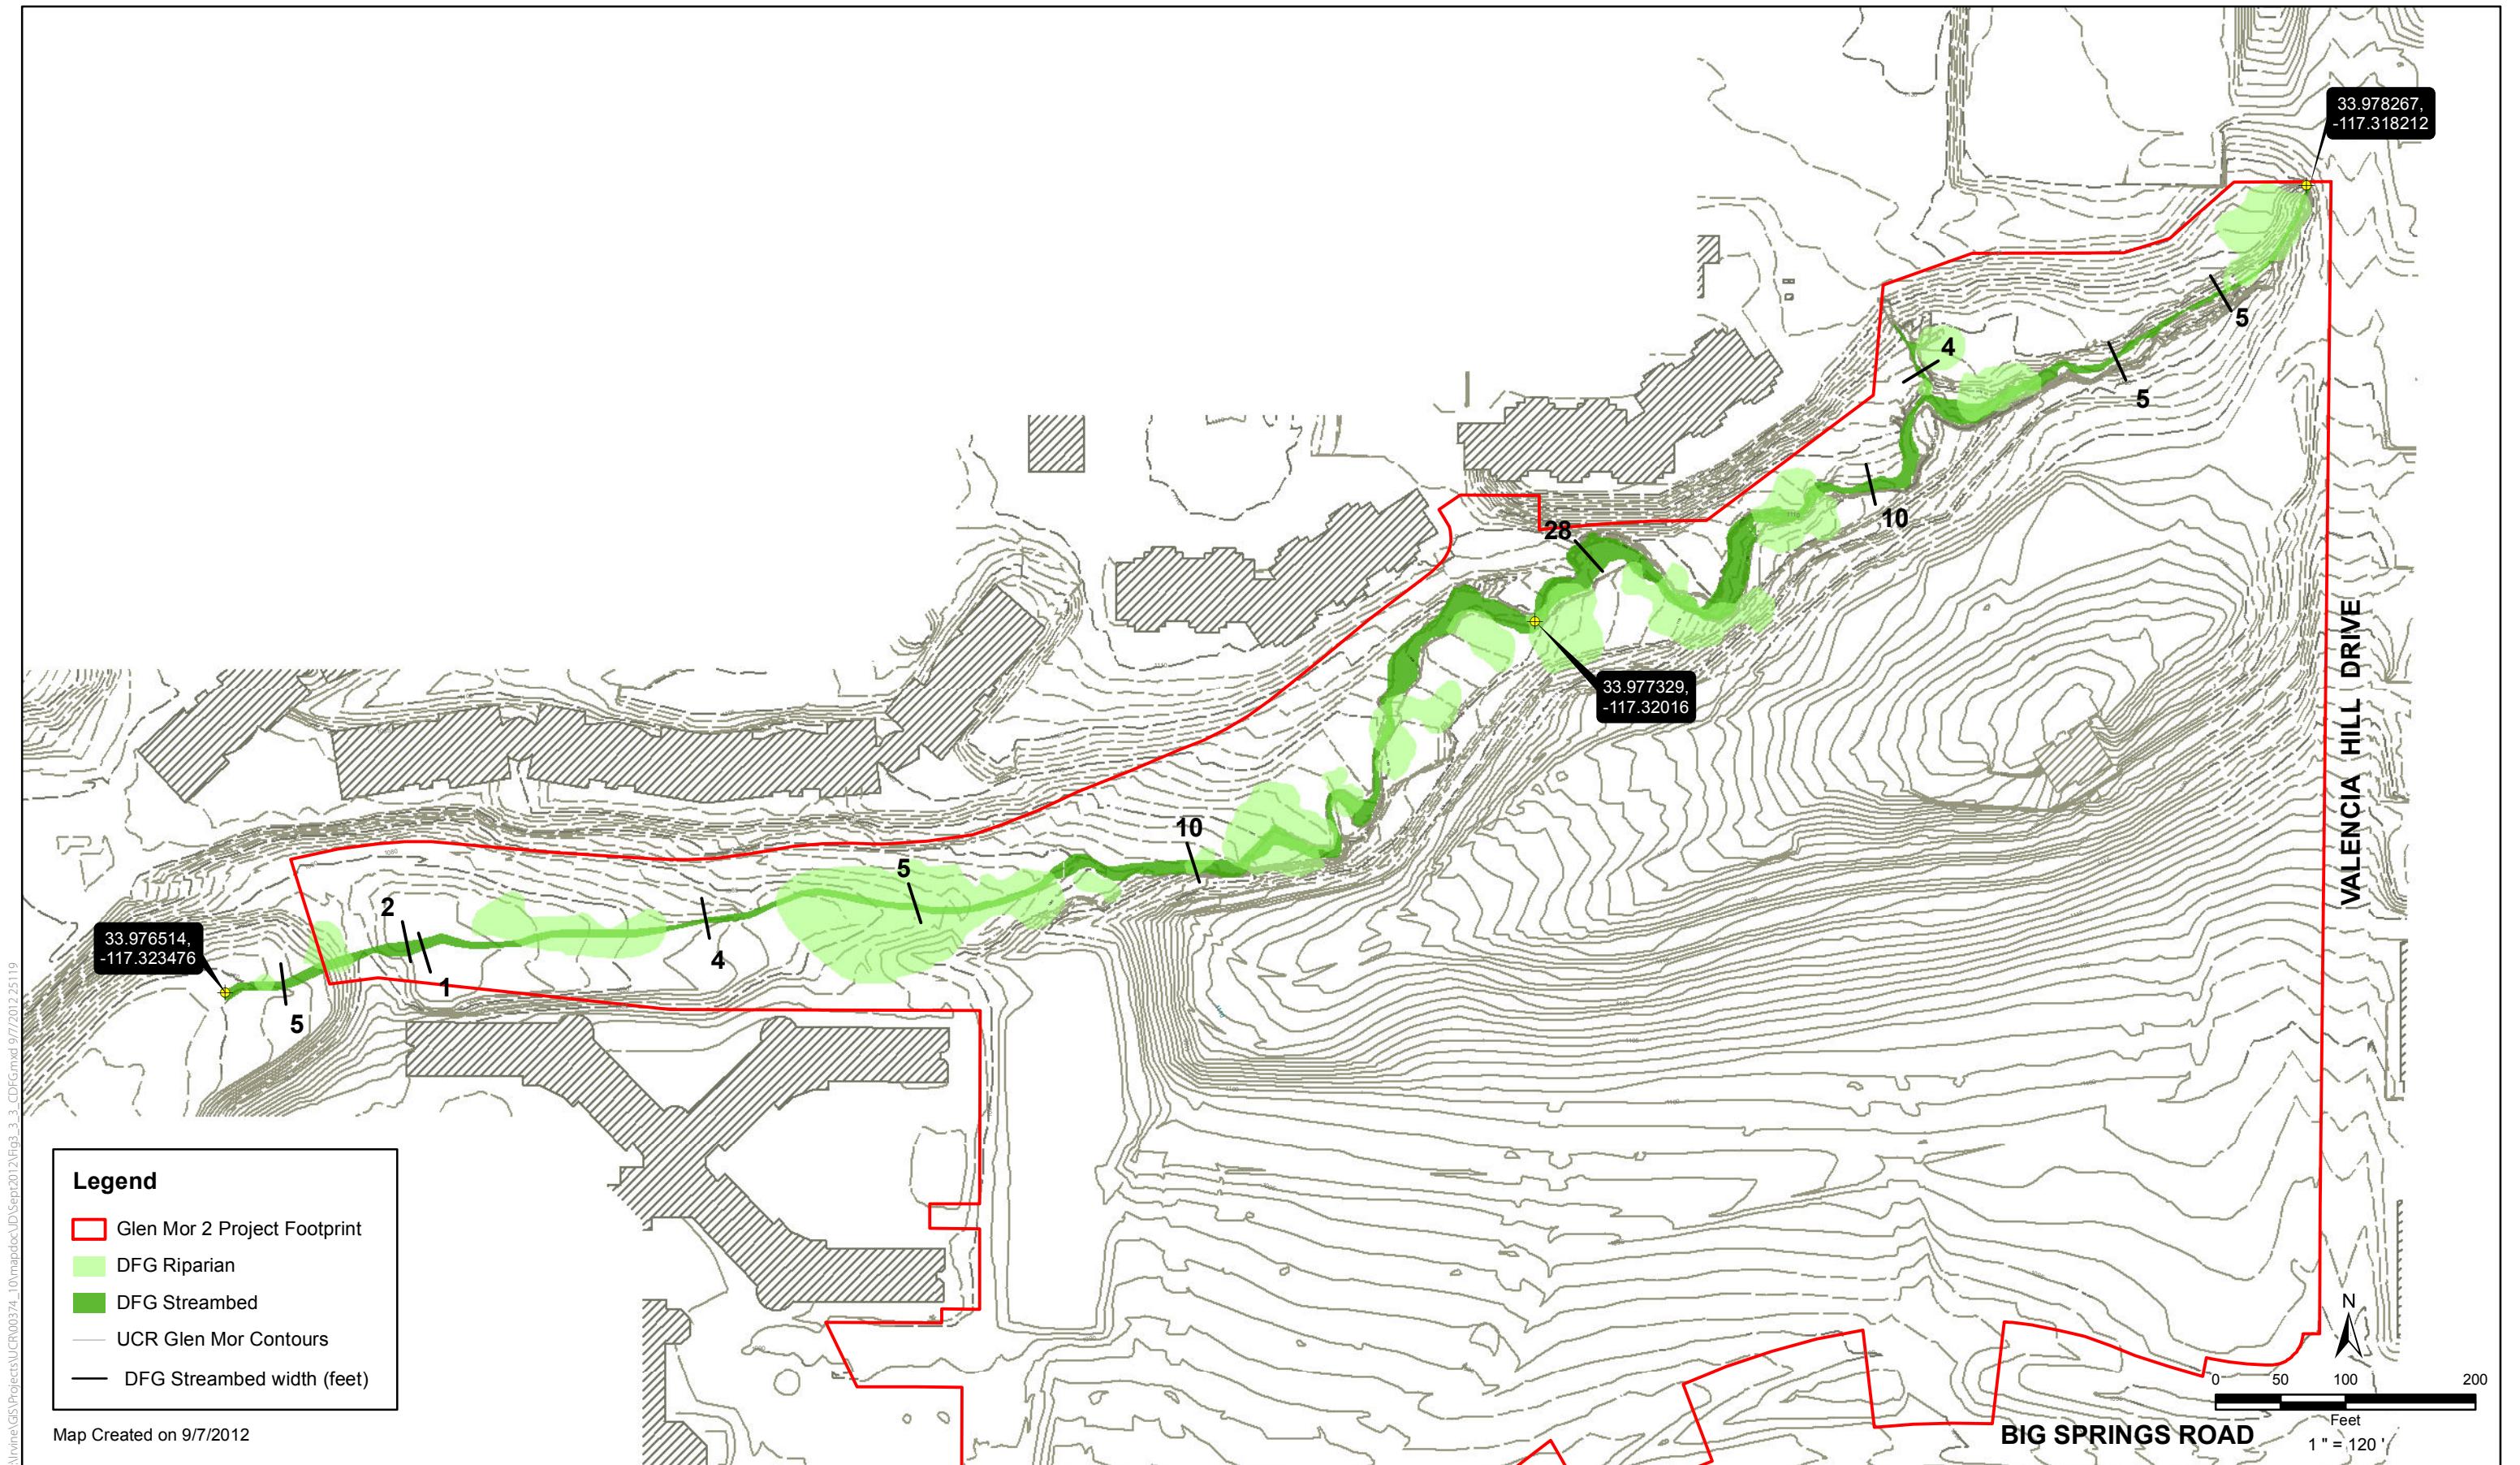
Attachment h
Revised Figure 3.3-3

Figure 3.3-3
DFG Jurisdictional Delineation
Glen Mor 2 Student Apartments Project
Revised September 2012 for Arroyo Improvements Addendum

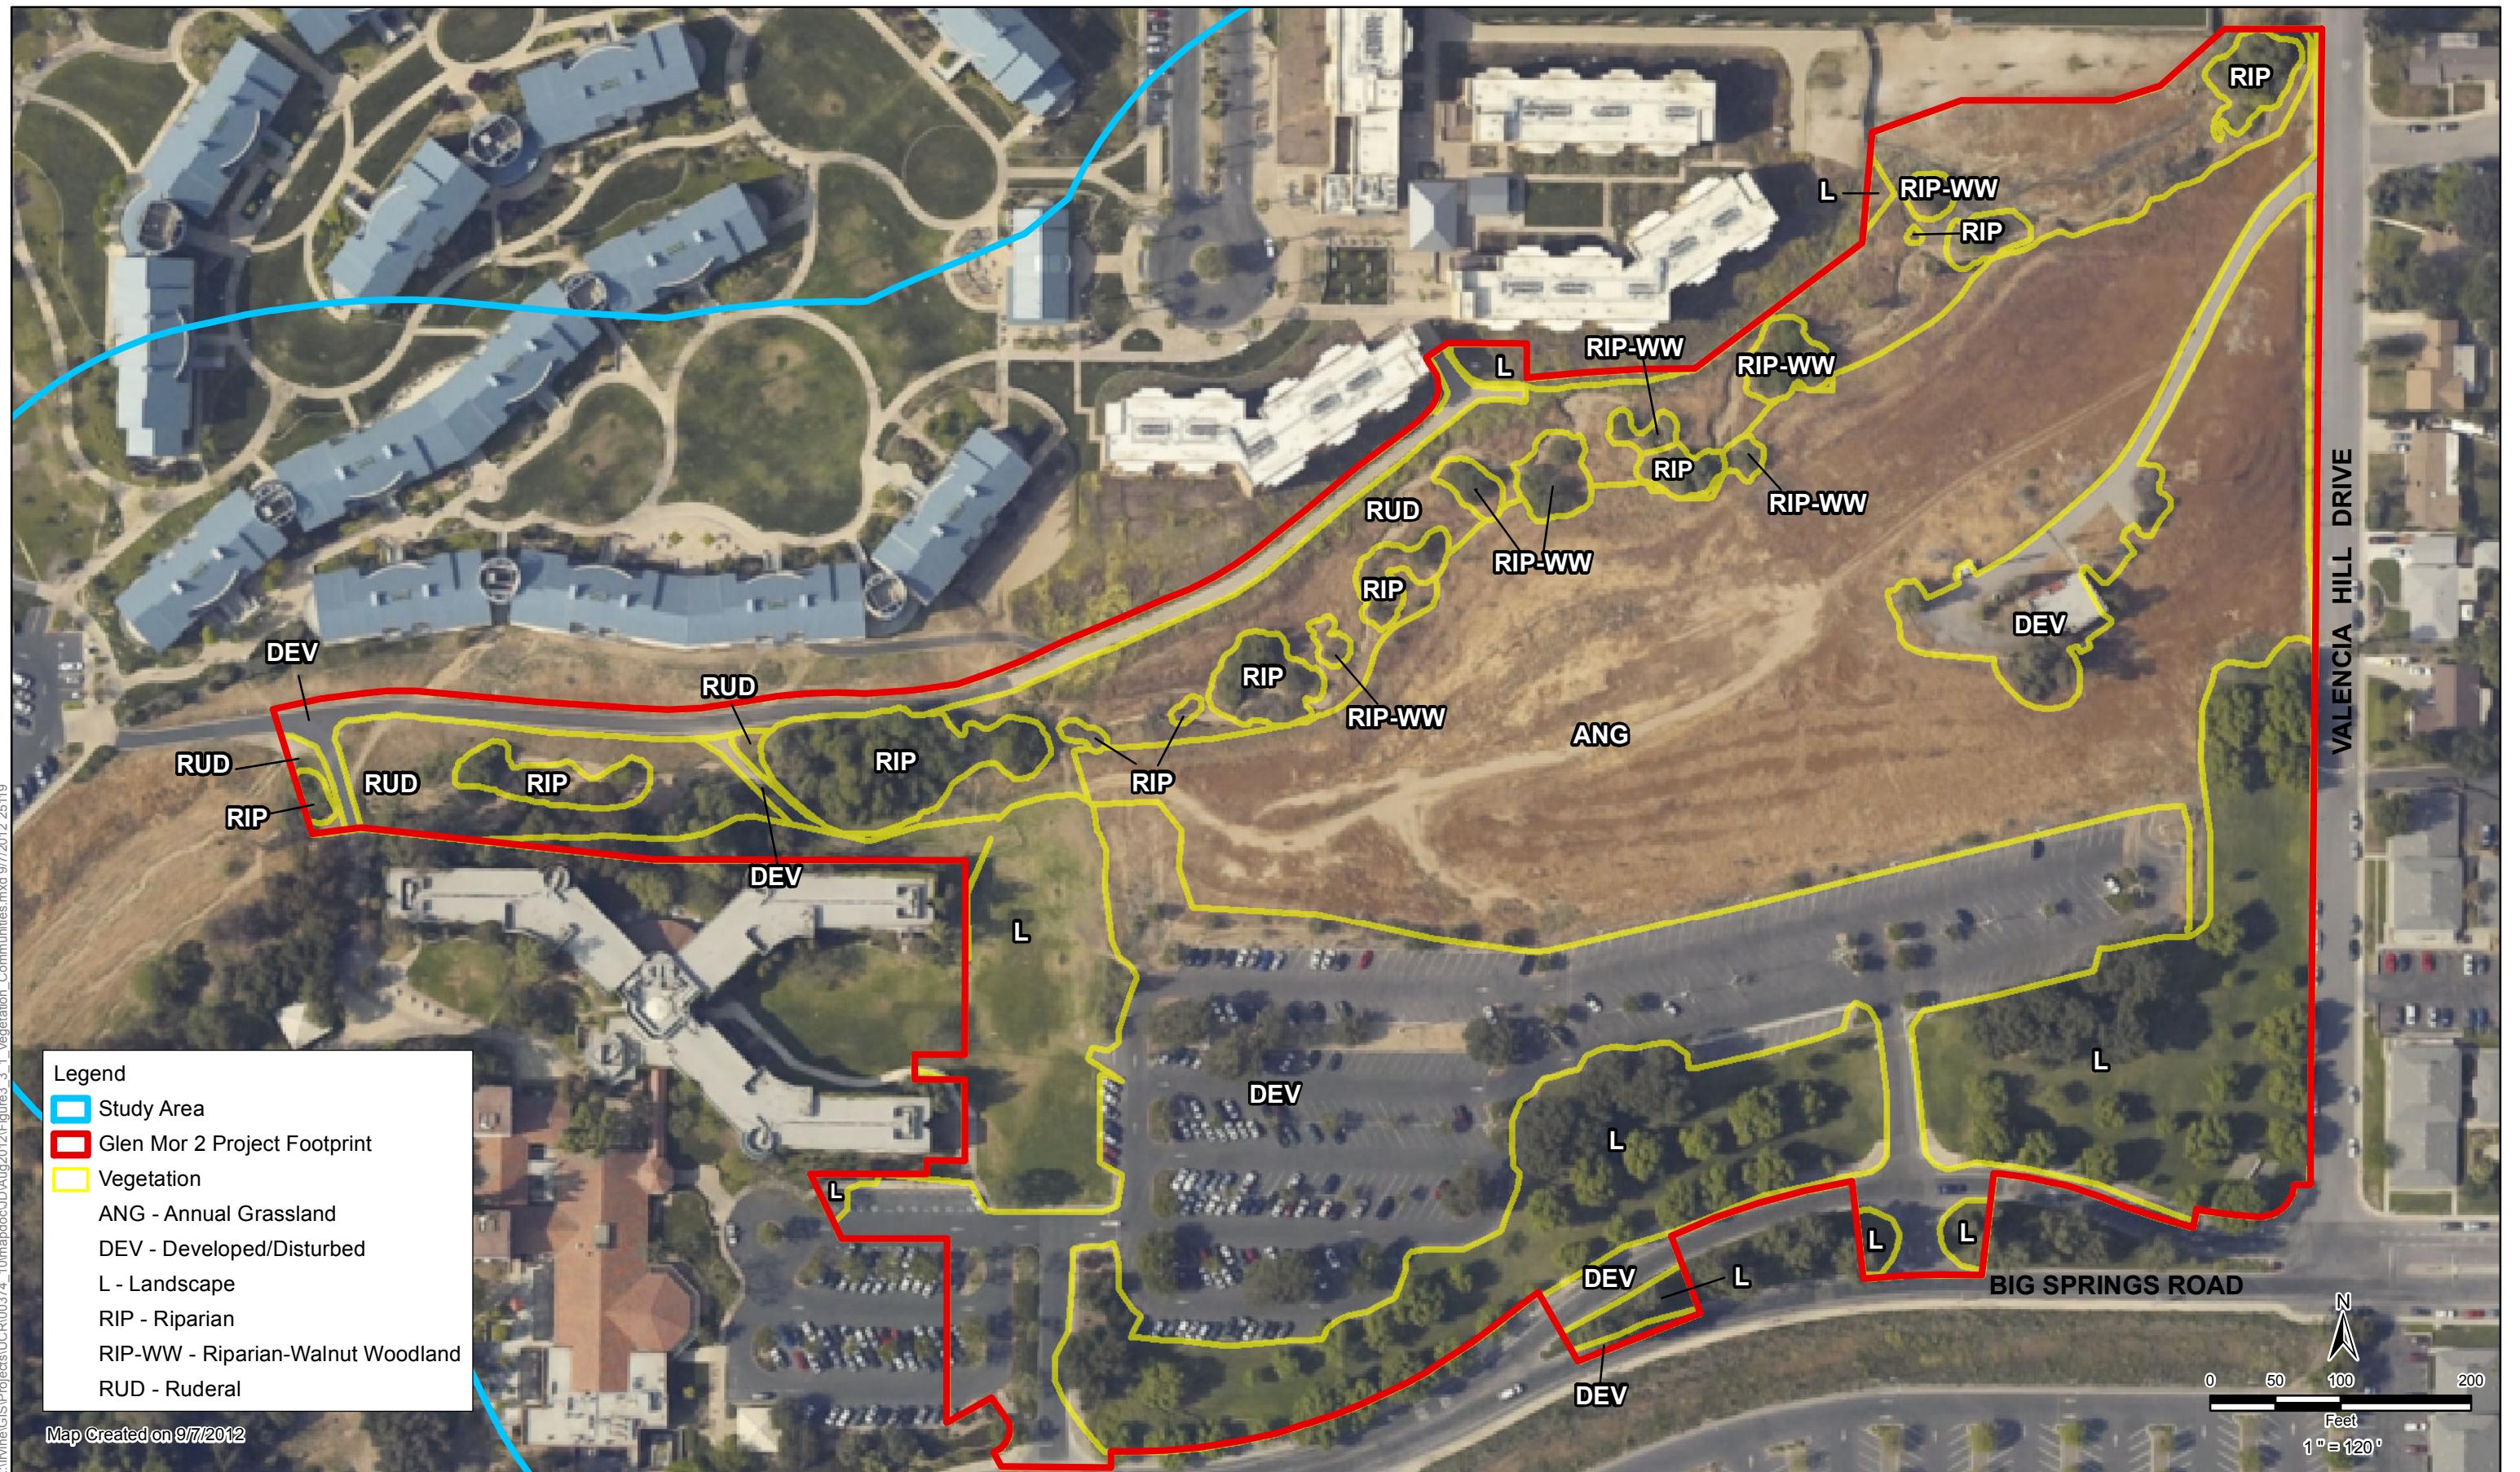
Attachment i
Revised Figure 3.3-1

Figure 3.3-1
Vegetation Communities
Glen Mor 2 Student Apartments
Revised September 2012 for Arroyo Improvements Addendum
