Addendum #1 to Final Environmental Impact Report for the
Glen Mor 2 Student Apartments Project
(SCH# 2010081020)

Project Title: Glen Mor 2 Student Apartments
Project Number: 956334
Project Location: The project is located on the University of California, Riverside (UCR) campus, generally northwest of Big Springs Road and Valencia Hill Drive. The site is south of the existing Glen Mor 1 and Pentland Hills residential complexes and east of Lothian residence hall.
City: Riverside
County: Riverside

Addendum #1 for Glen Mor 2 Student Apartments
Modified Arroyo Improvements
September 25, 2012

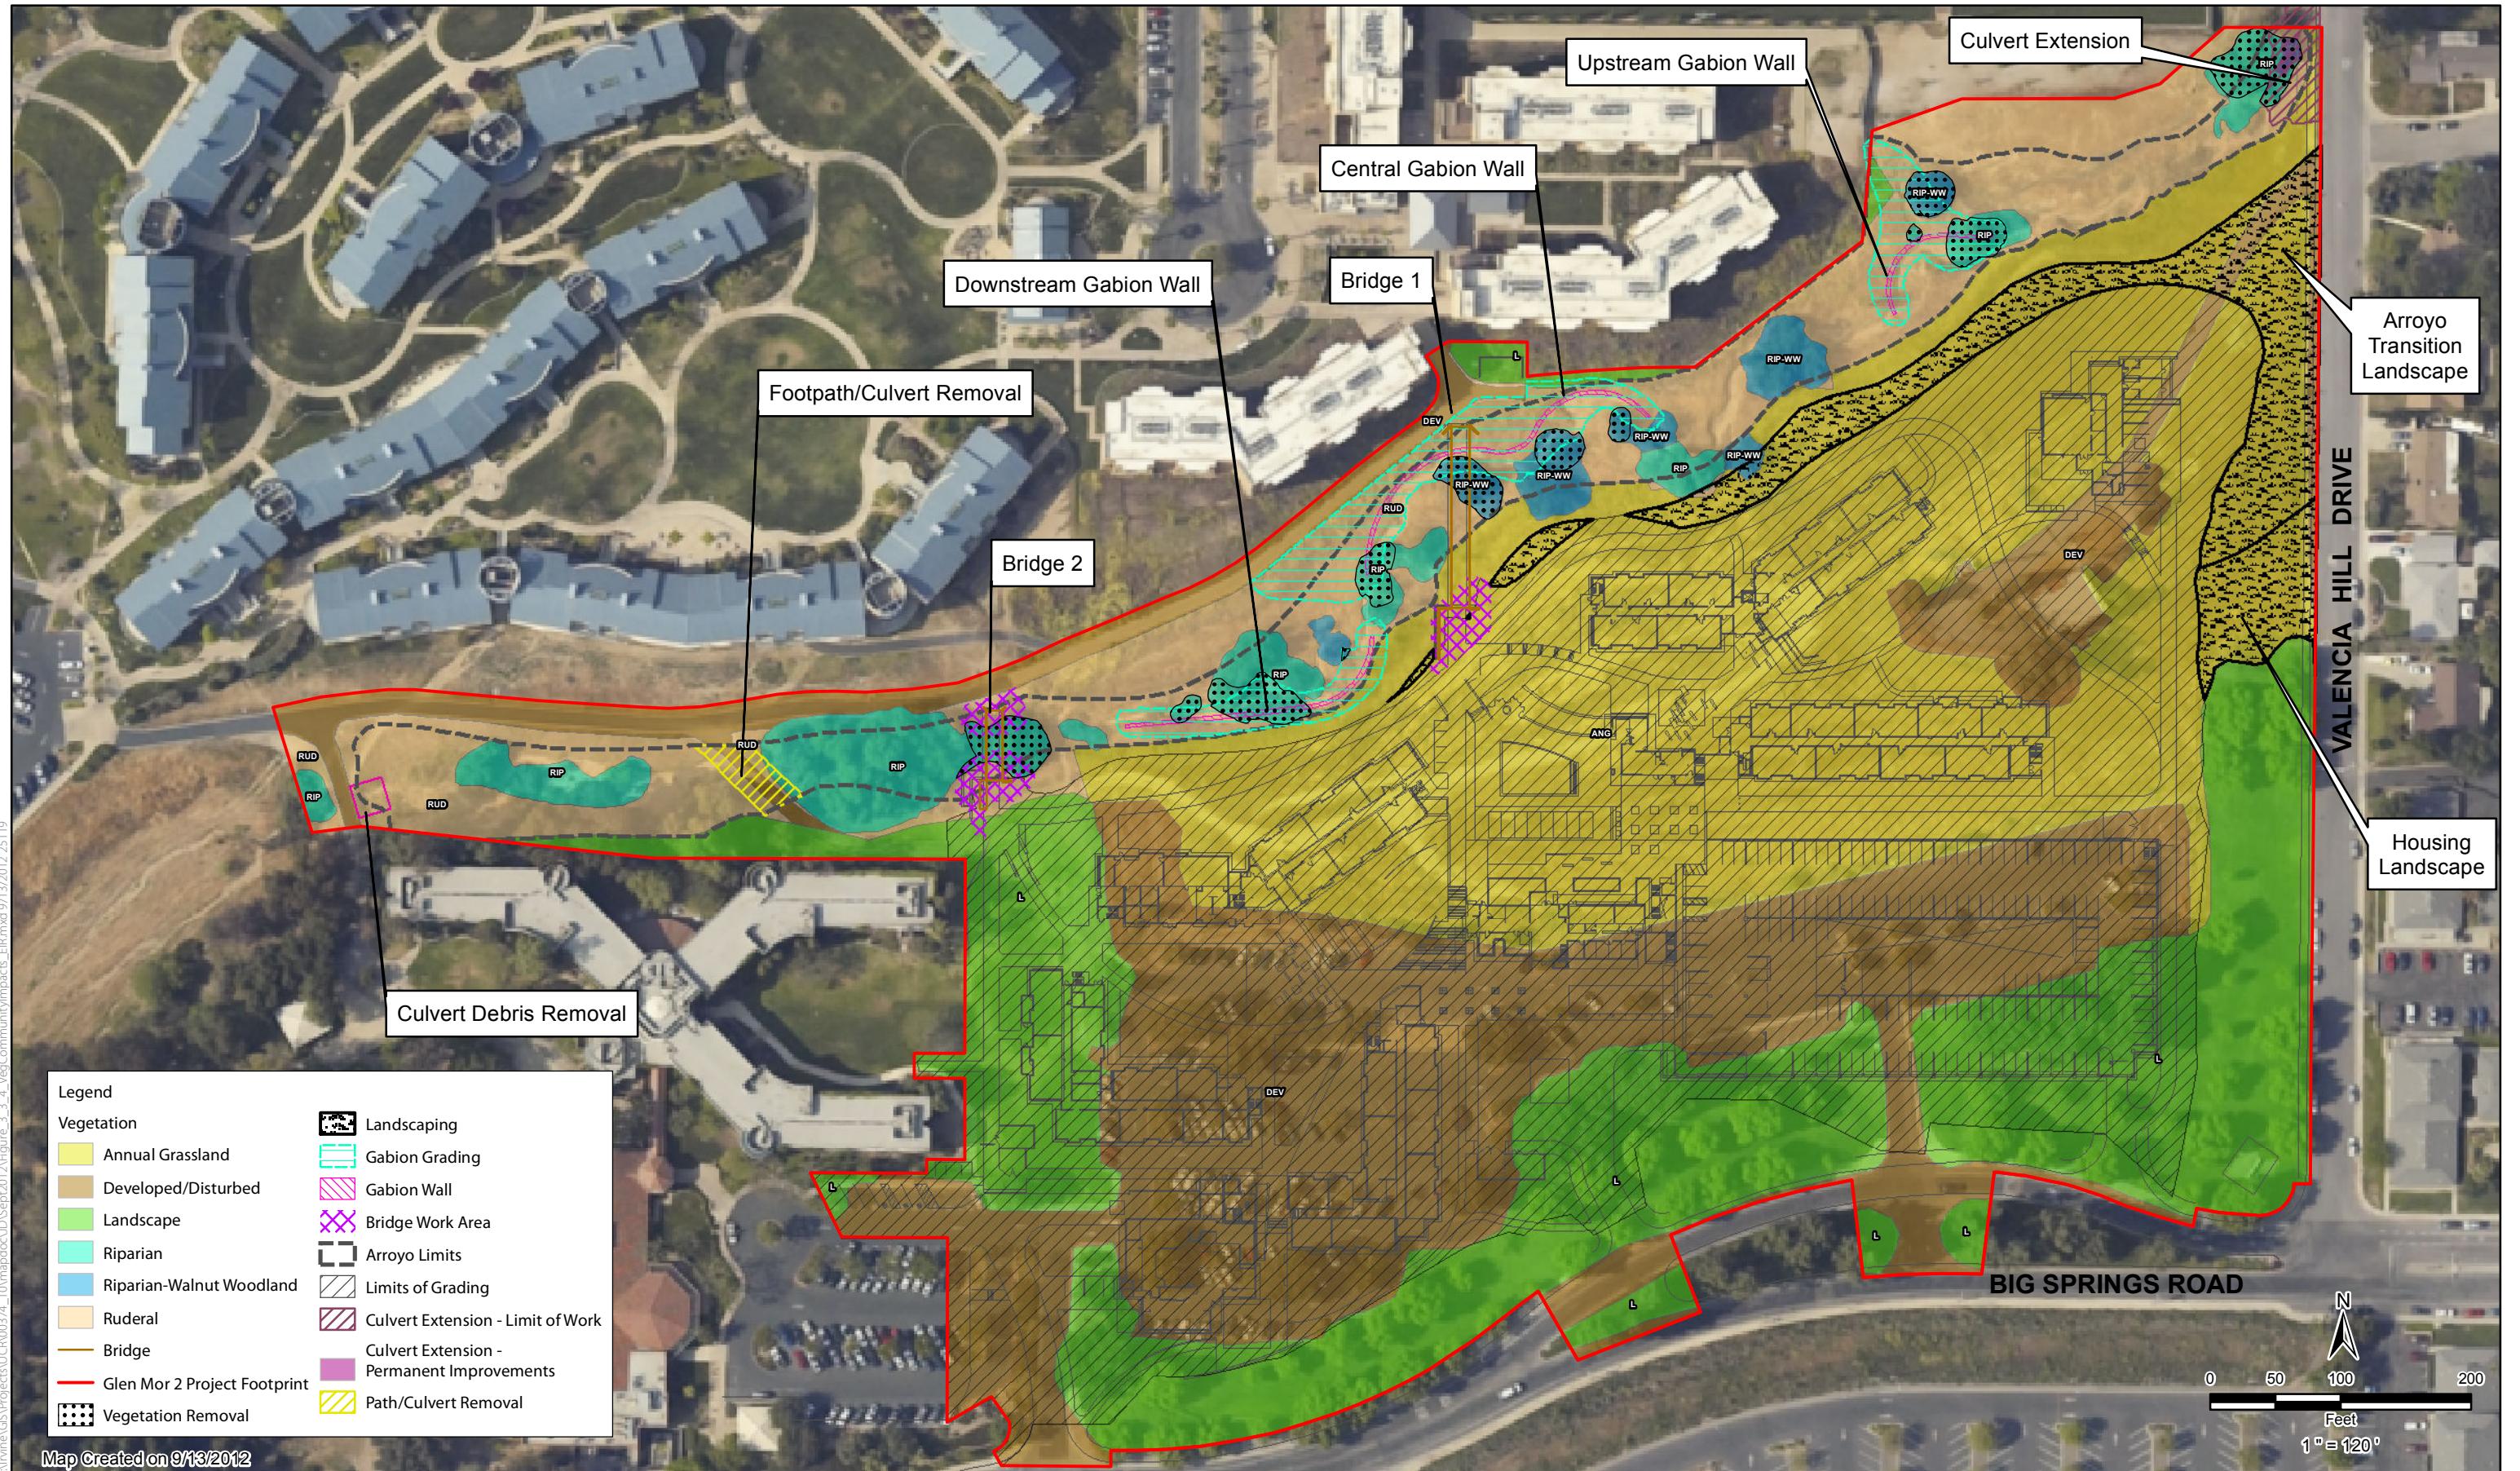
Attachment I
Revised Figure 3.3-4

Note: Vegetation Removal limits at the Culvert Extension adjacent to Valencia Hill Drive reflect the possibility that the large cottonwood tree at this location may be lost due to work within the tree's root zone. Monitoring activities during and after construction will be directed at preserving this tree in accordance with MM BIO 3. However, in the event the tree fails despite all reasonable measures, replacement plantings will be implemented in accordance with MM BIO 4.

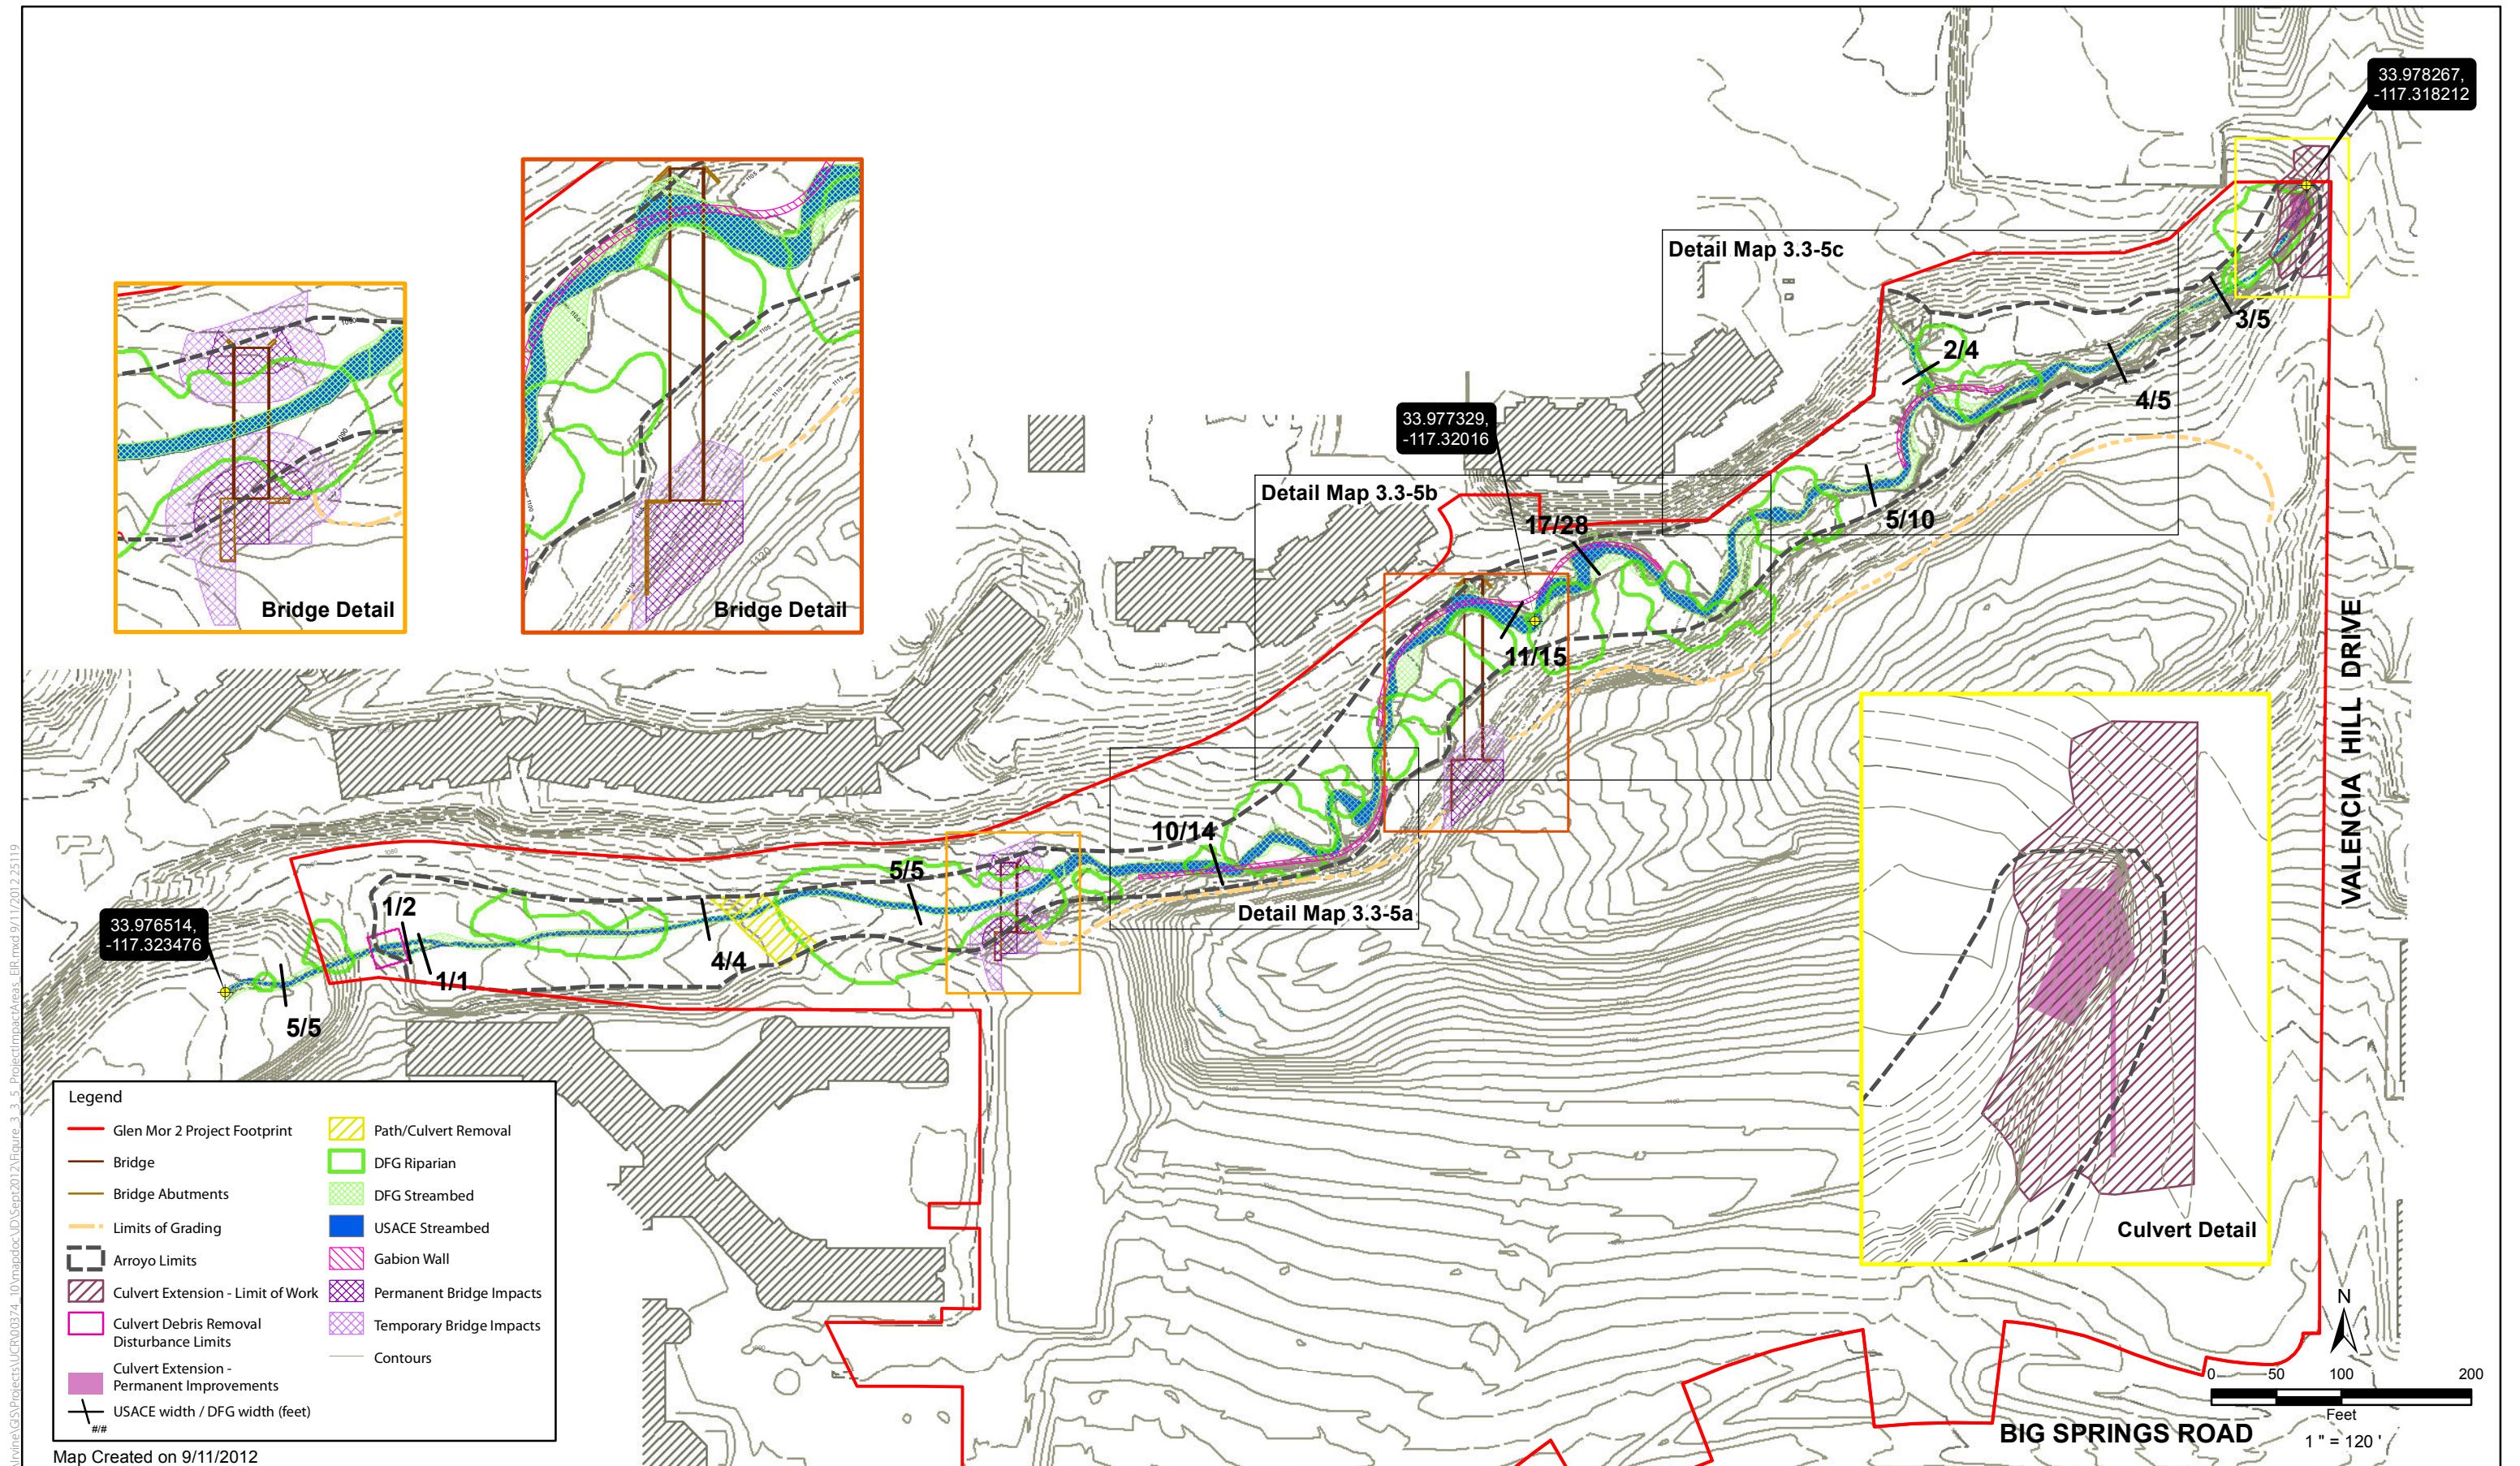
Figure 3.3-5
Arroyo and Jurisdictional Water Impacts
Glen Mor 2 Student Apartments
Revised September 2012 for Arroyo Improvements Addendum

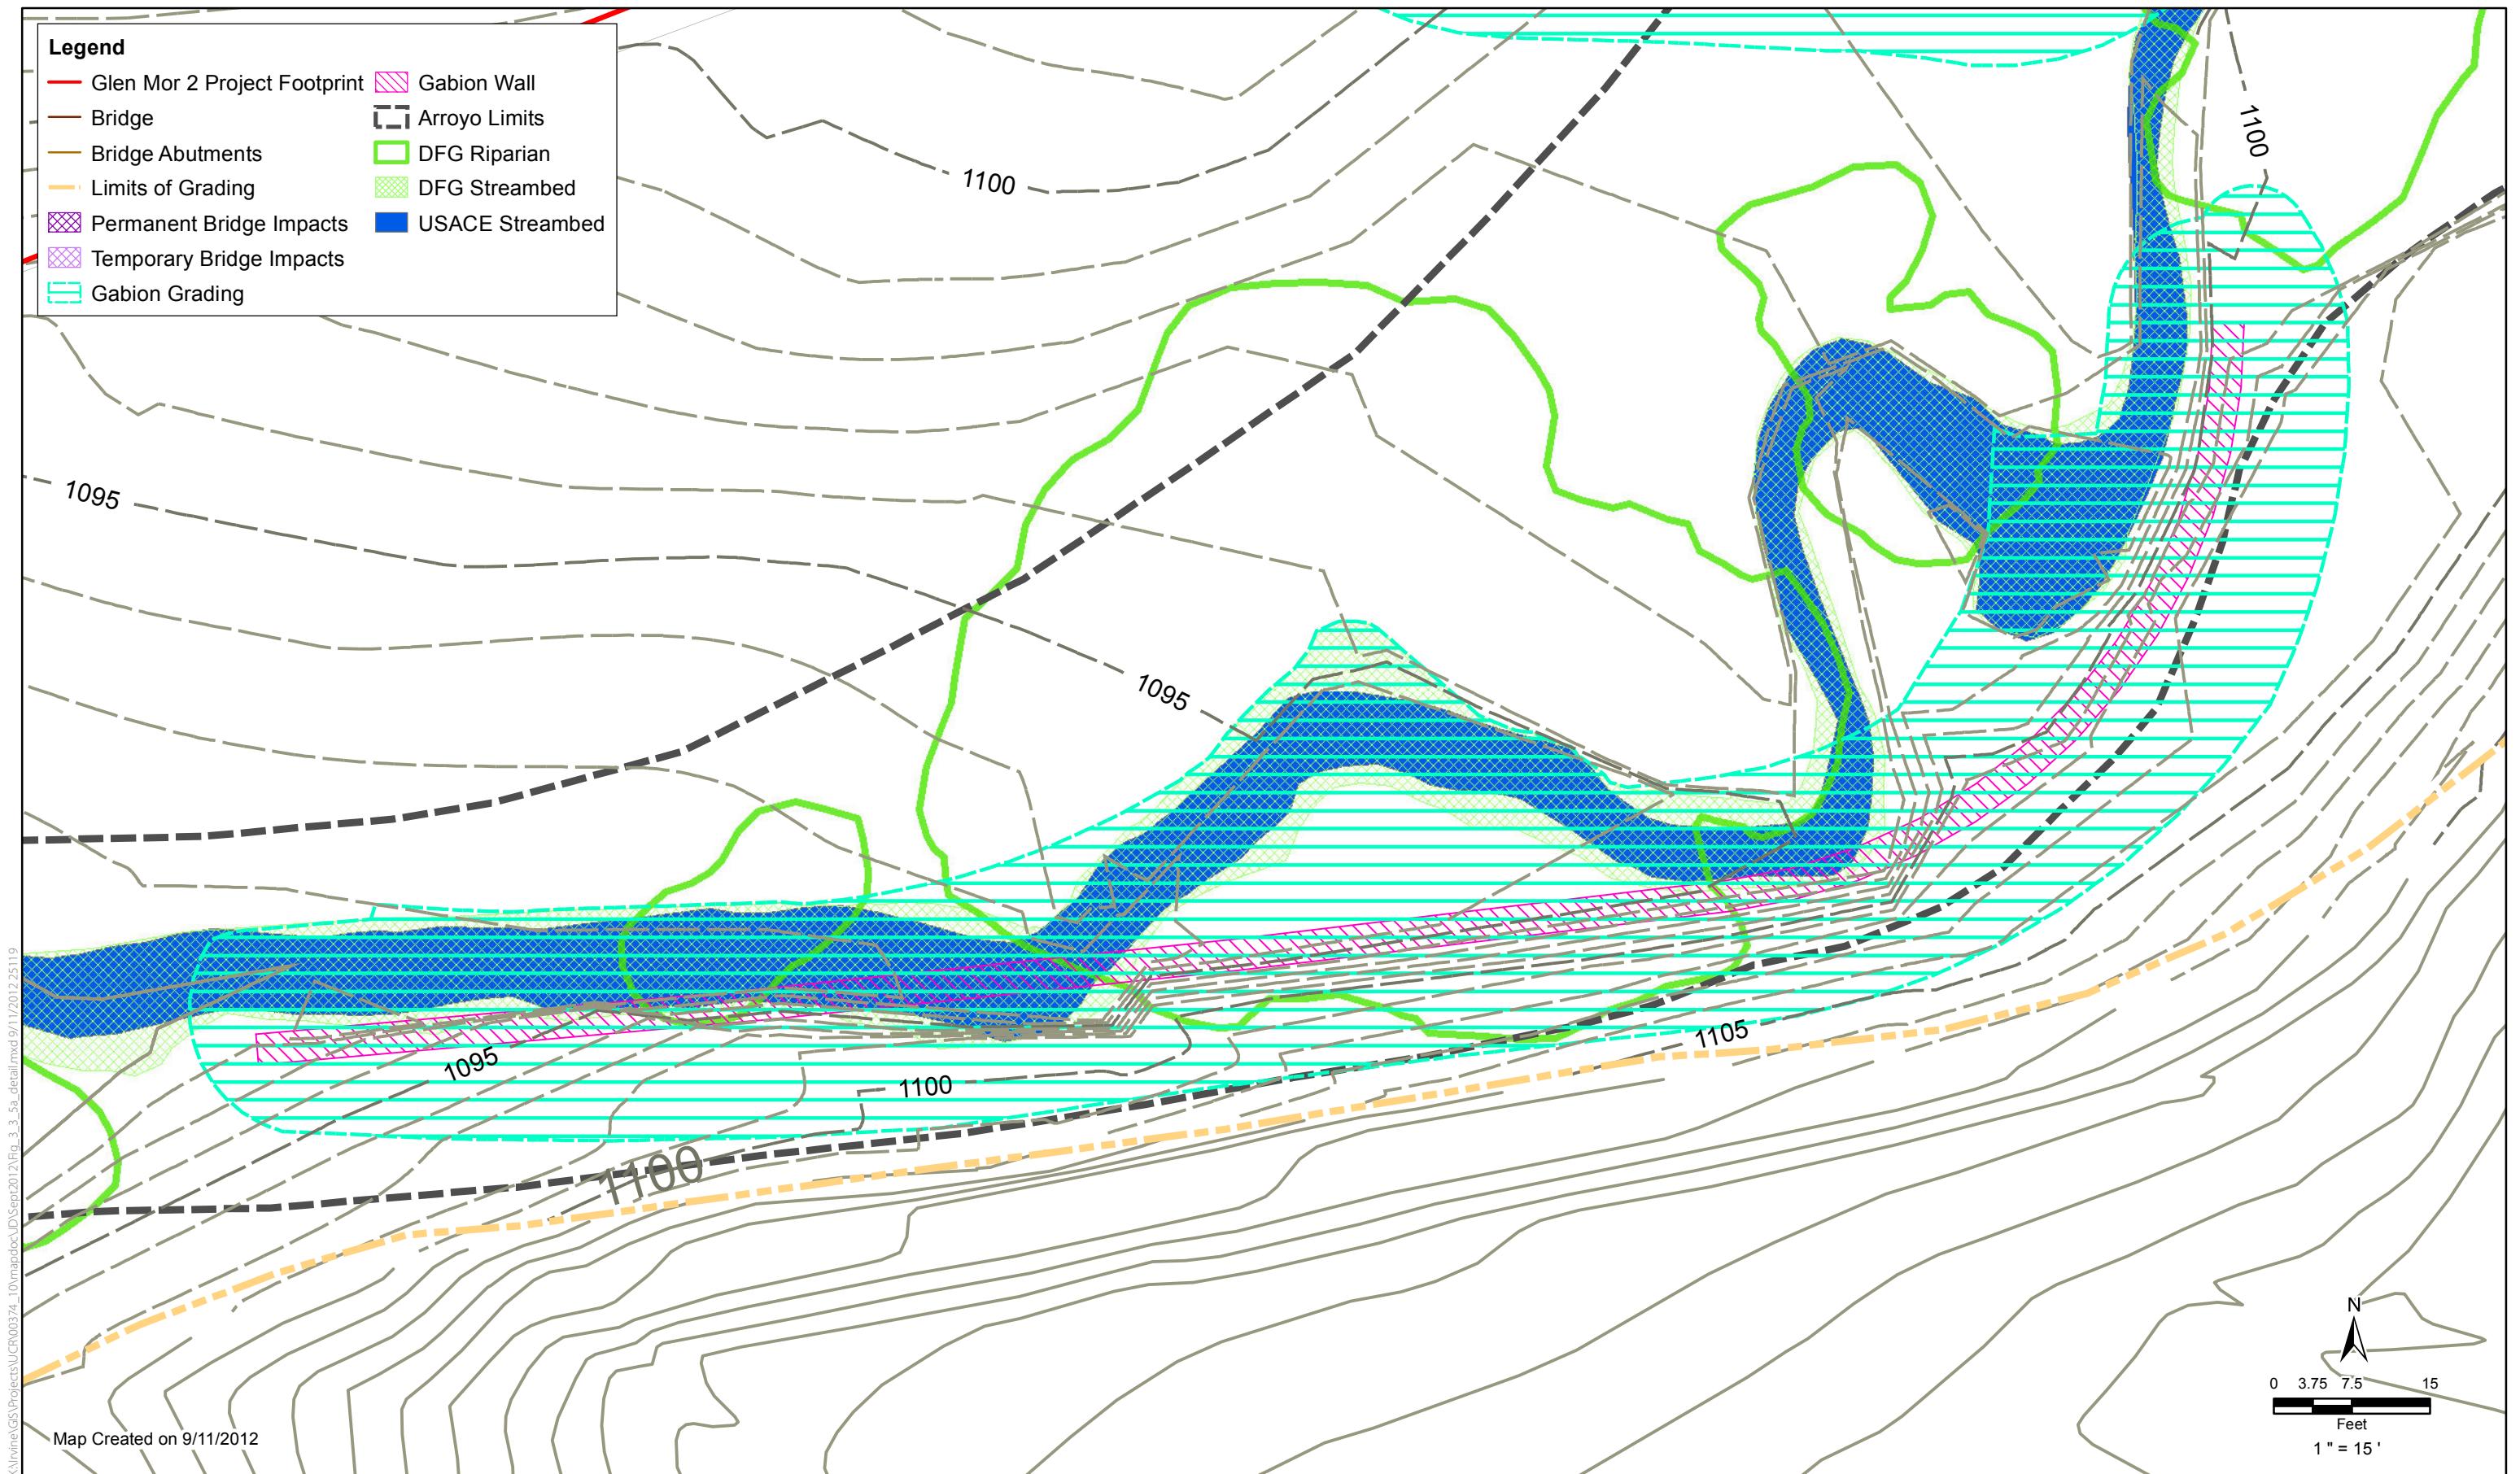
Figure 3.3-5a
Arroyo and Jurisdictional Water Impacts (Downstream Gabion Wall)
Glen Mor 2 Student Apartments
Revised September 2012 for Arroyo Improvements Addendum

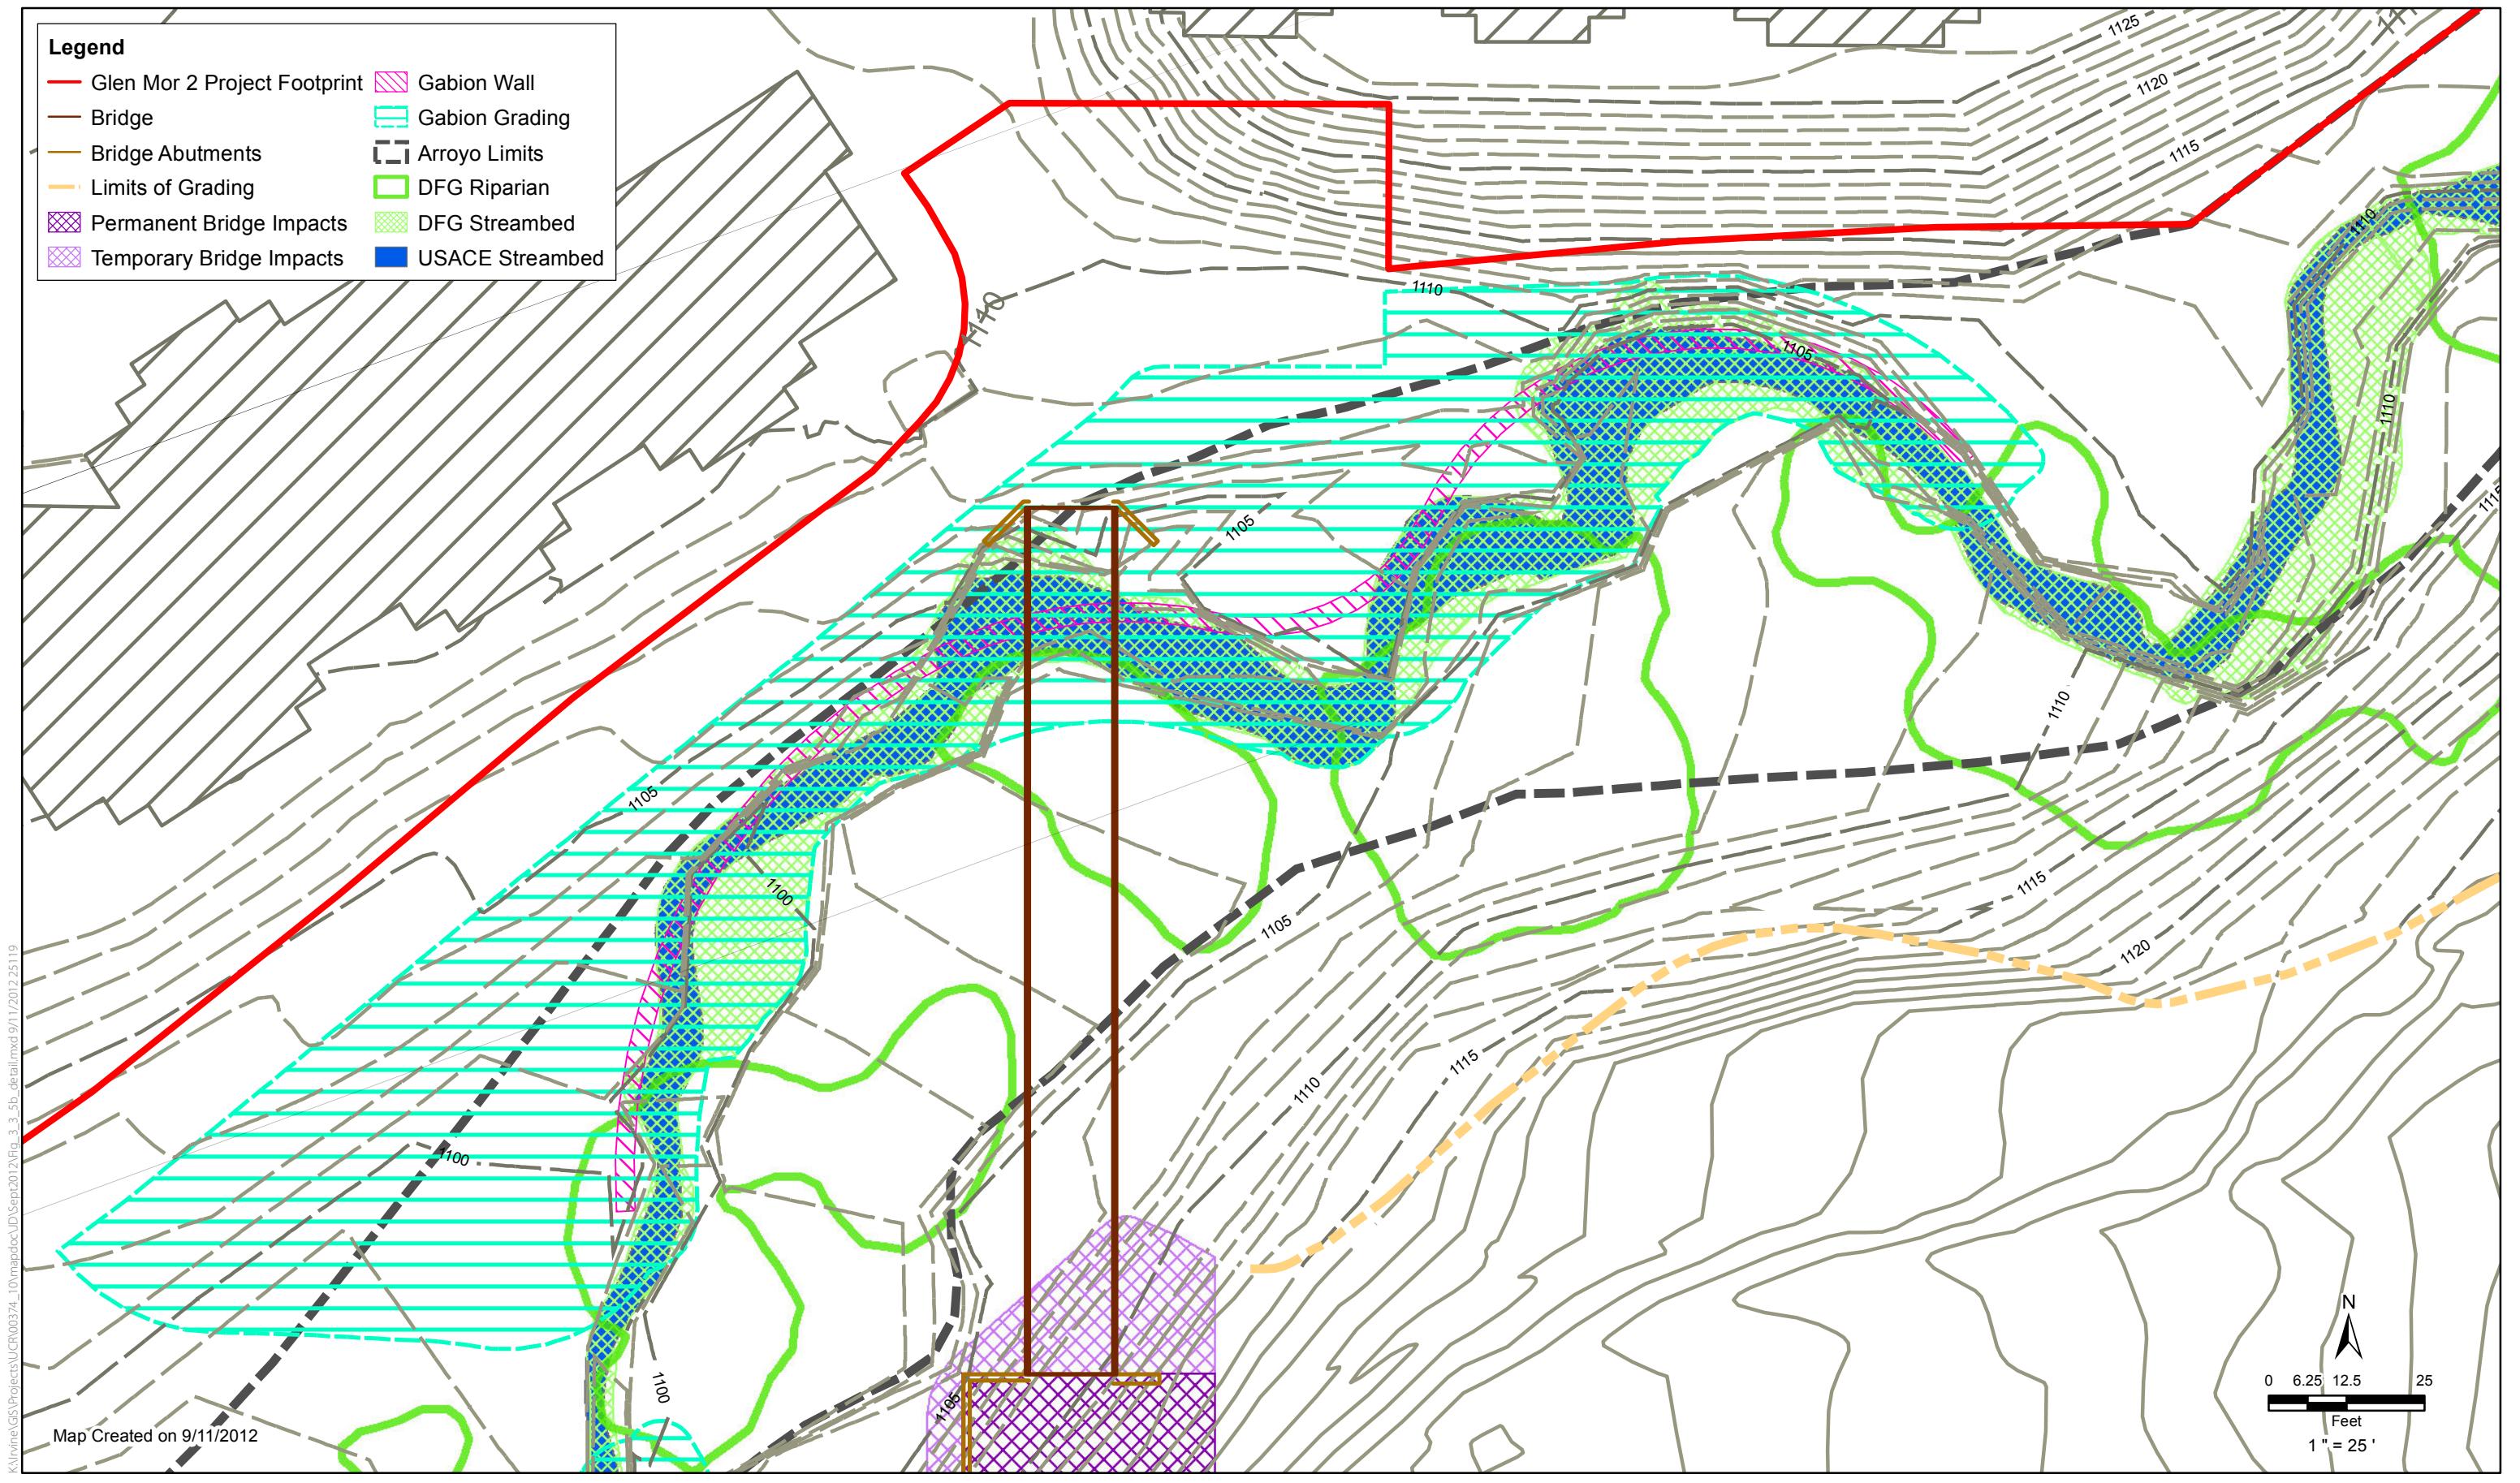
Figure 3.3-5b
Arroyo and Jurisdictional Water Impacts (Central Gabion Wall)
Glen Mor 2 Student Apartments
Revised September 2012 for Arroyo Improvements Addendum

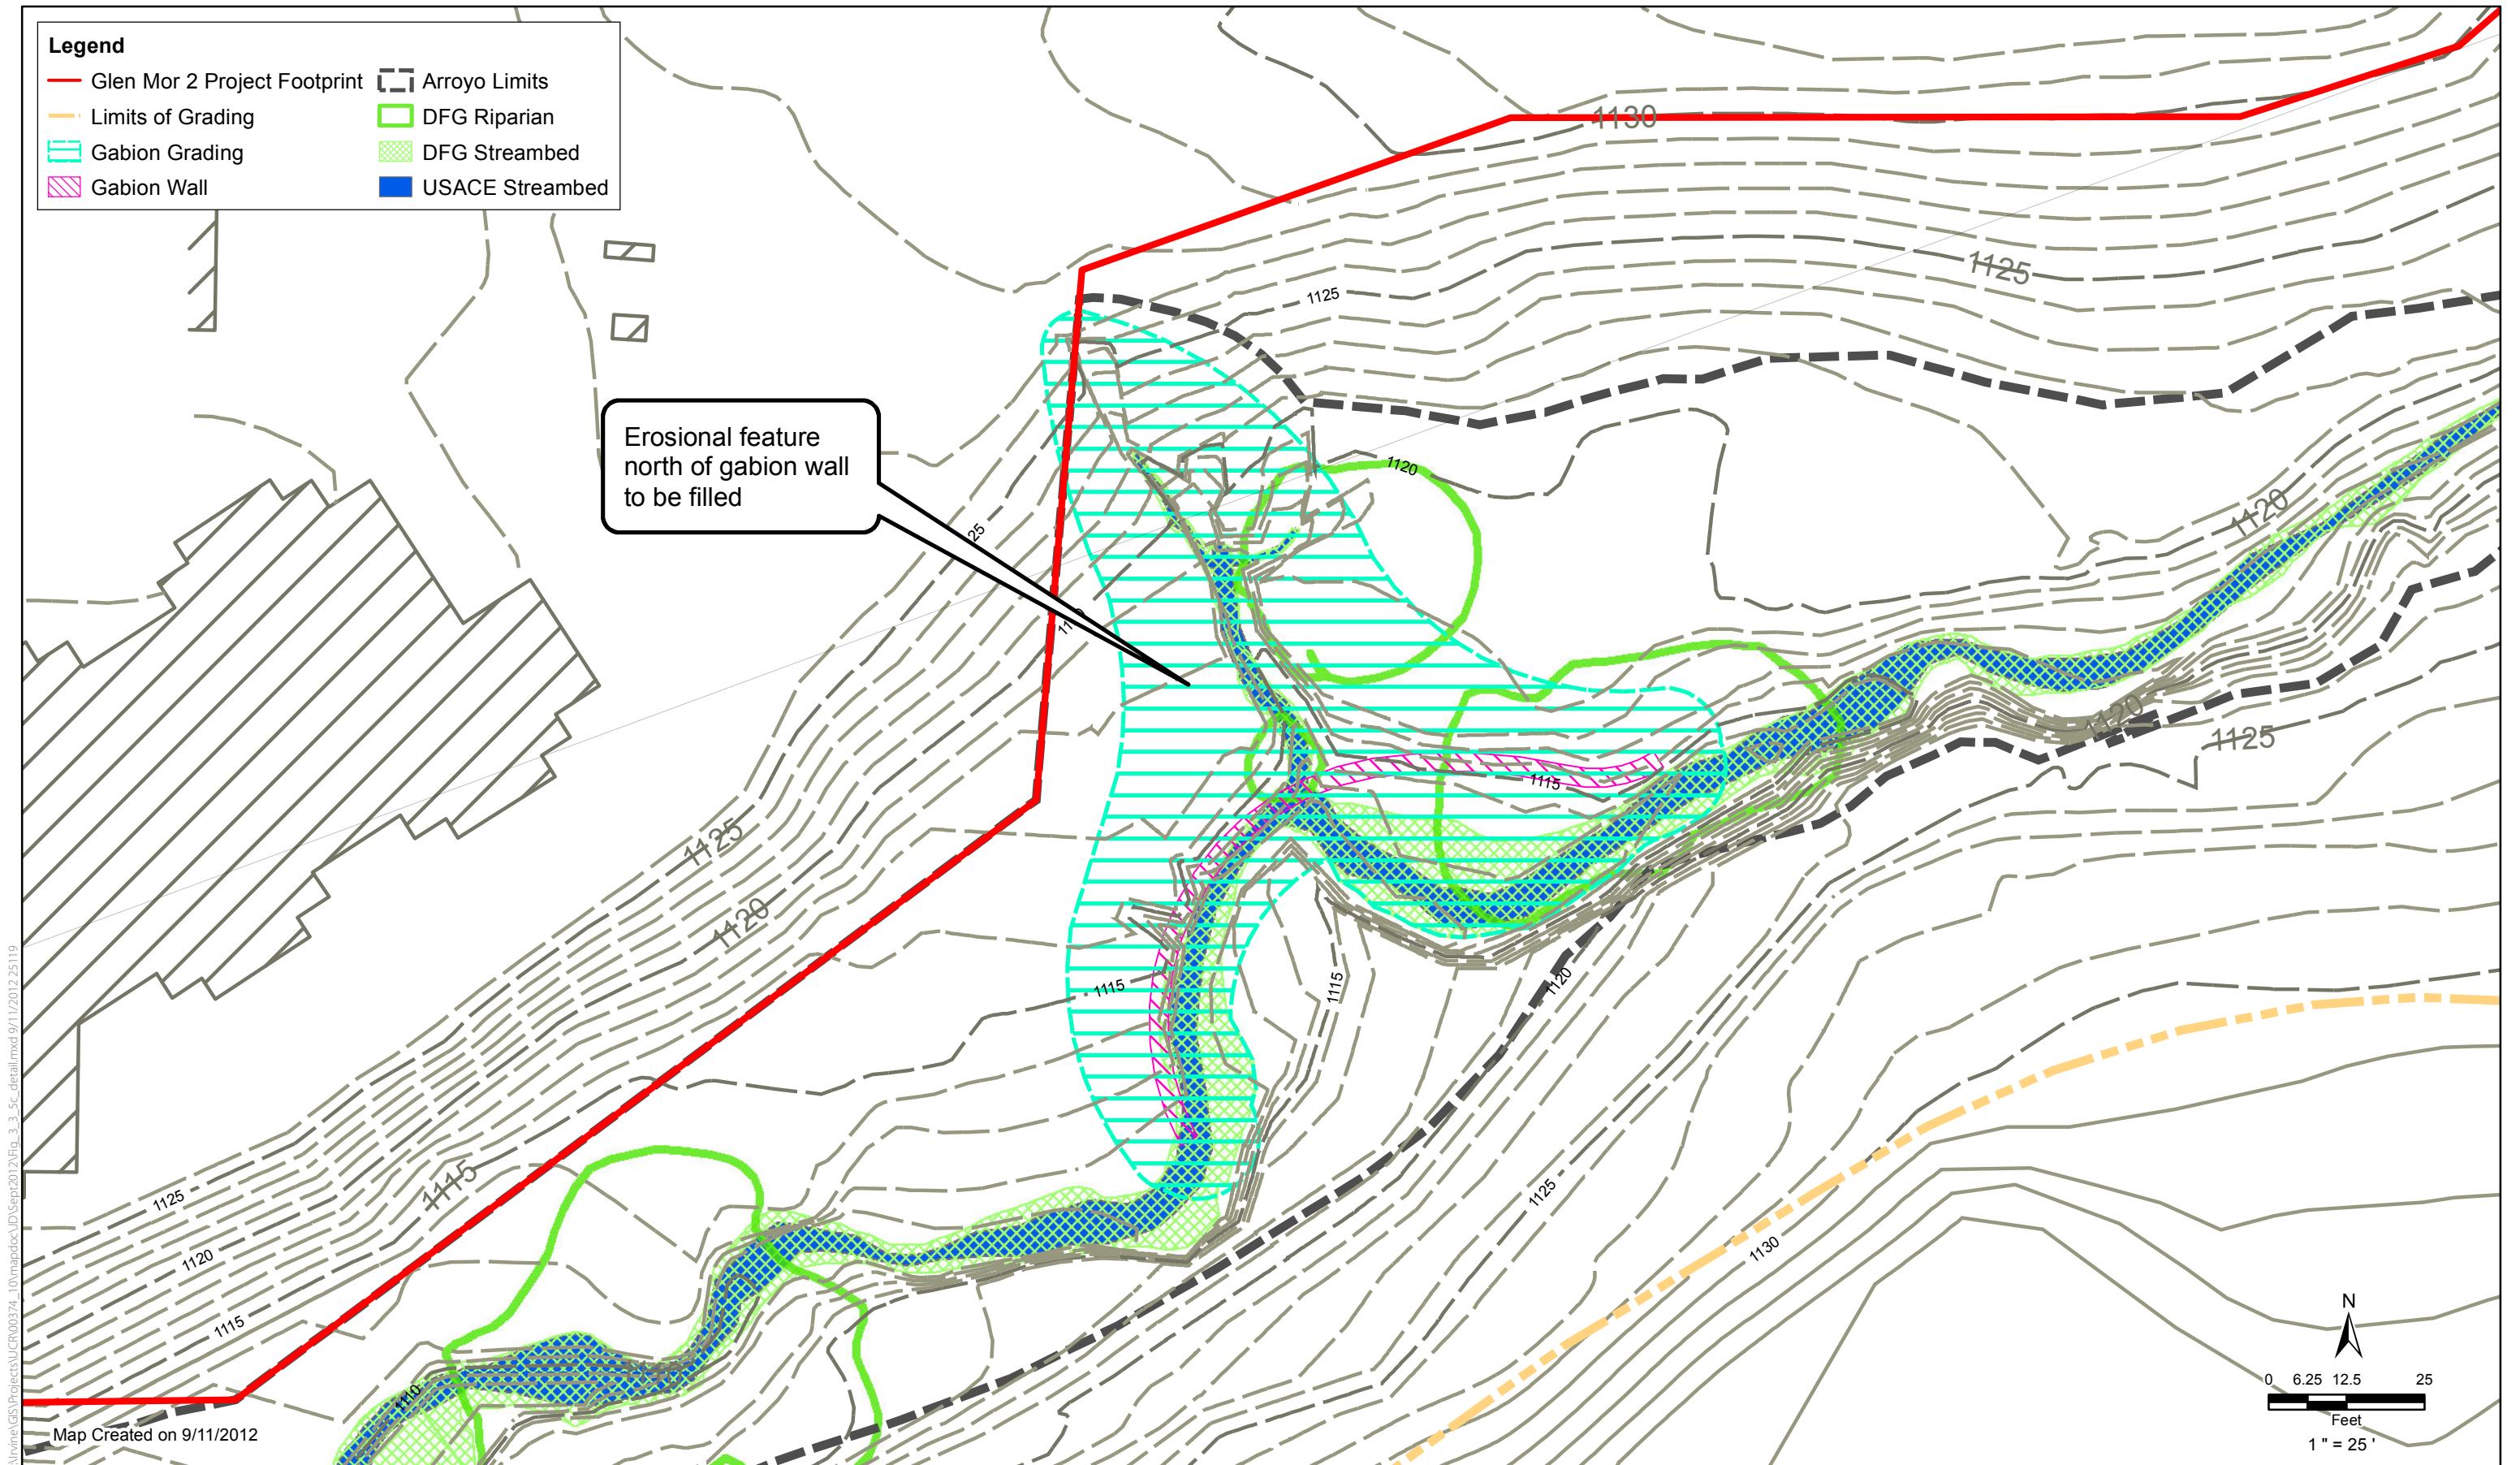
Figure 3.3-5c
Arroyo and Jurisdictional Water Impacts (Upstream Gabion Wall)
Glen Mor 2 Student Apartments
Revised September 2012 for Arroyo Improvements Addendum

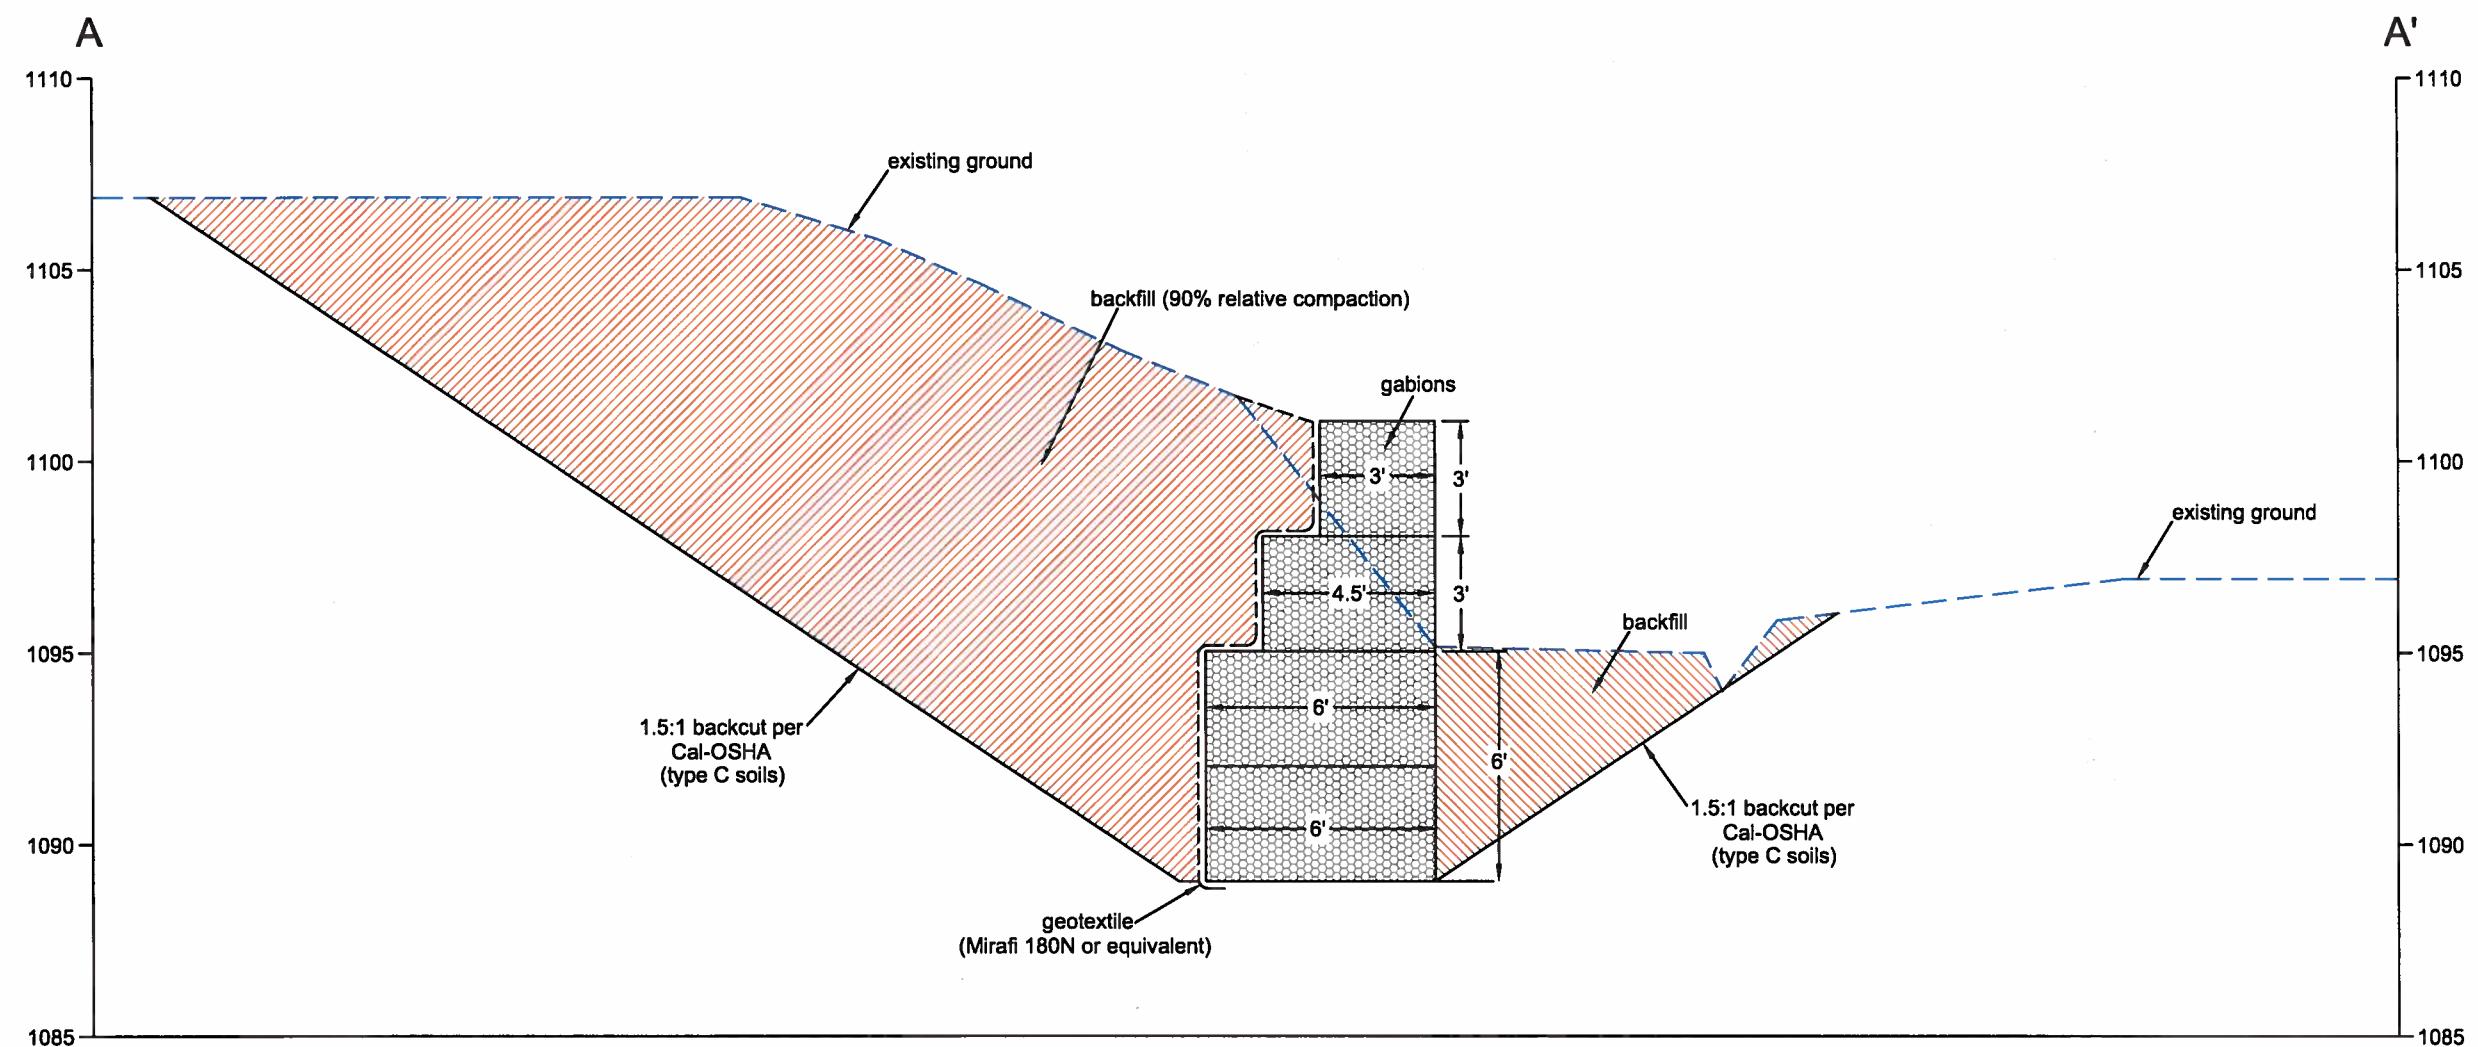
CROSS SECTION A-A'		
FOR:	UCR	ENCLOSURE "A-2"
DATE:	JUNE 2012	U.C. RIVERSIDE CAMPUS RIVERSIDE, CALIFORNIA

The stability of cross sections A and C (Enclosures "A-2" and "A-4", respectively) were analyzed for static and seismic conditions for circular failures utilizing the SLIDE computer program, version 6.0 (Rocscience, Inc., 2011). The seismic stability calculations were performed using a lateral pseudostatic coefficient "k" of 0.15. The factor of safety was calculated by Spencer's method which is considered the most conservative of the available methods.
