Addendum #1 to Final Environmental Impact Report for the
Glen Mor 2 Student Apartments Project
(SCH# 2010081020)

Project Title: Glen Mor 2 Student Apartments
Project Number: 956334
Project Location: The project is located on the University of California, Riverside (UCR) campus, generally northwest of Big Springs Road and Valencia Hill Drive. The site is south of the existing Glen Mor 1 and Pentland Hills residential complexes and east of Lothian residence hall.
City: Riverside
County: Riverside

Addendum #1 for Glen Mor 2 Student Apartments
Modified Arroyo Improvements
September 25, 2012

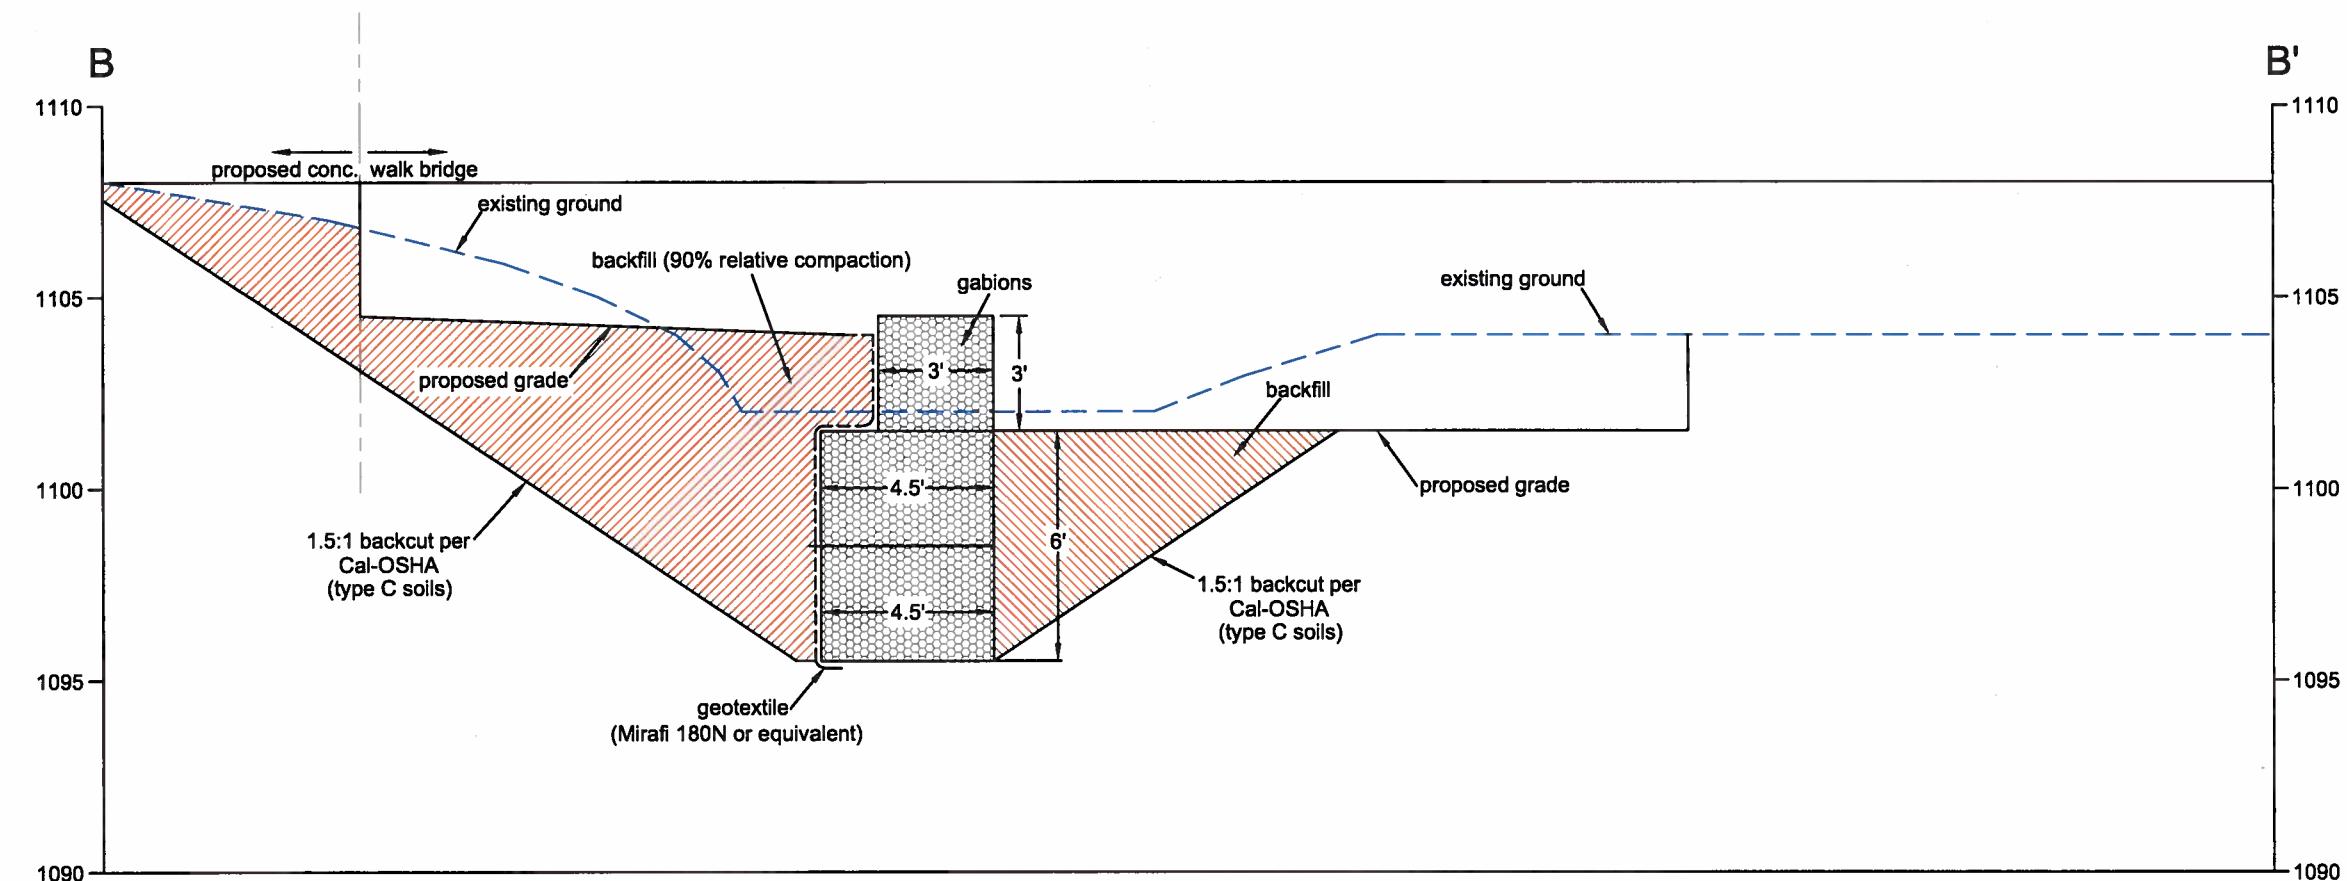
CROSS SECTION B-B'		
FOR:	UCR	ENCLOSURE "A-3"
DATE:	JUNE 2012	ARROYO MITIGATION PROJECT GLEN MOR 2 U.C. RIVERSIDE CAMPUS RIVERSIDE, CALIFORNIA

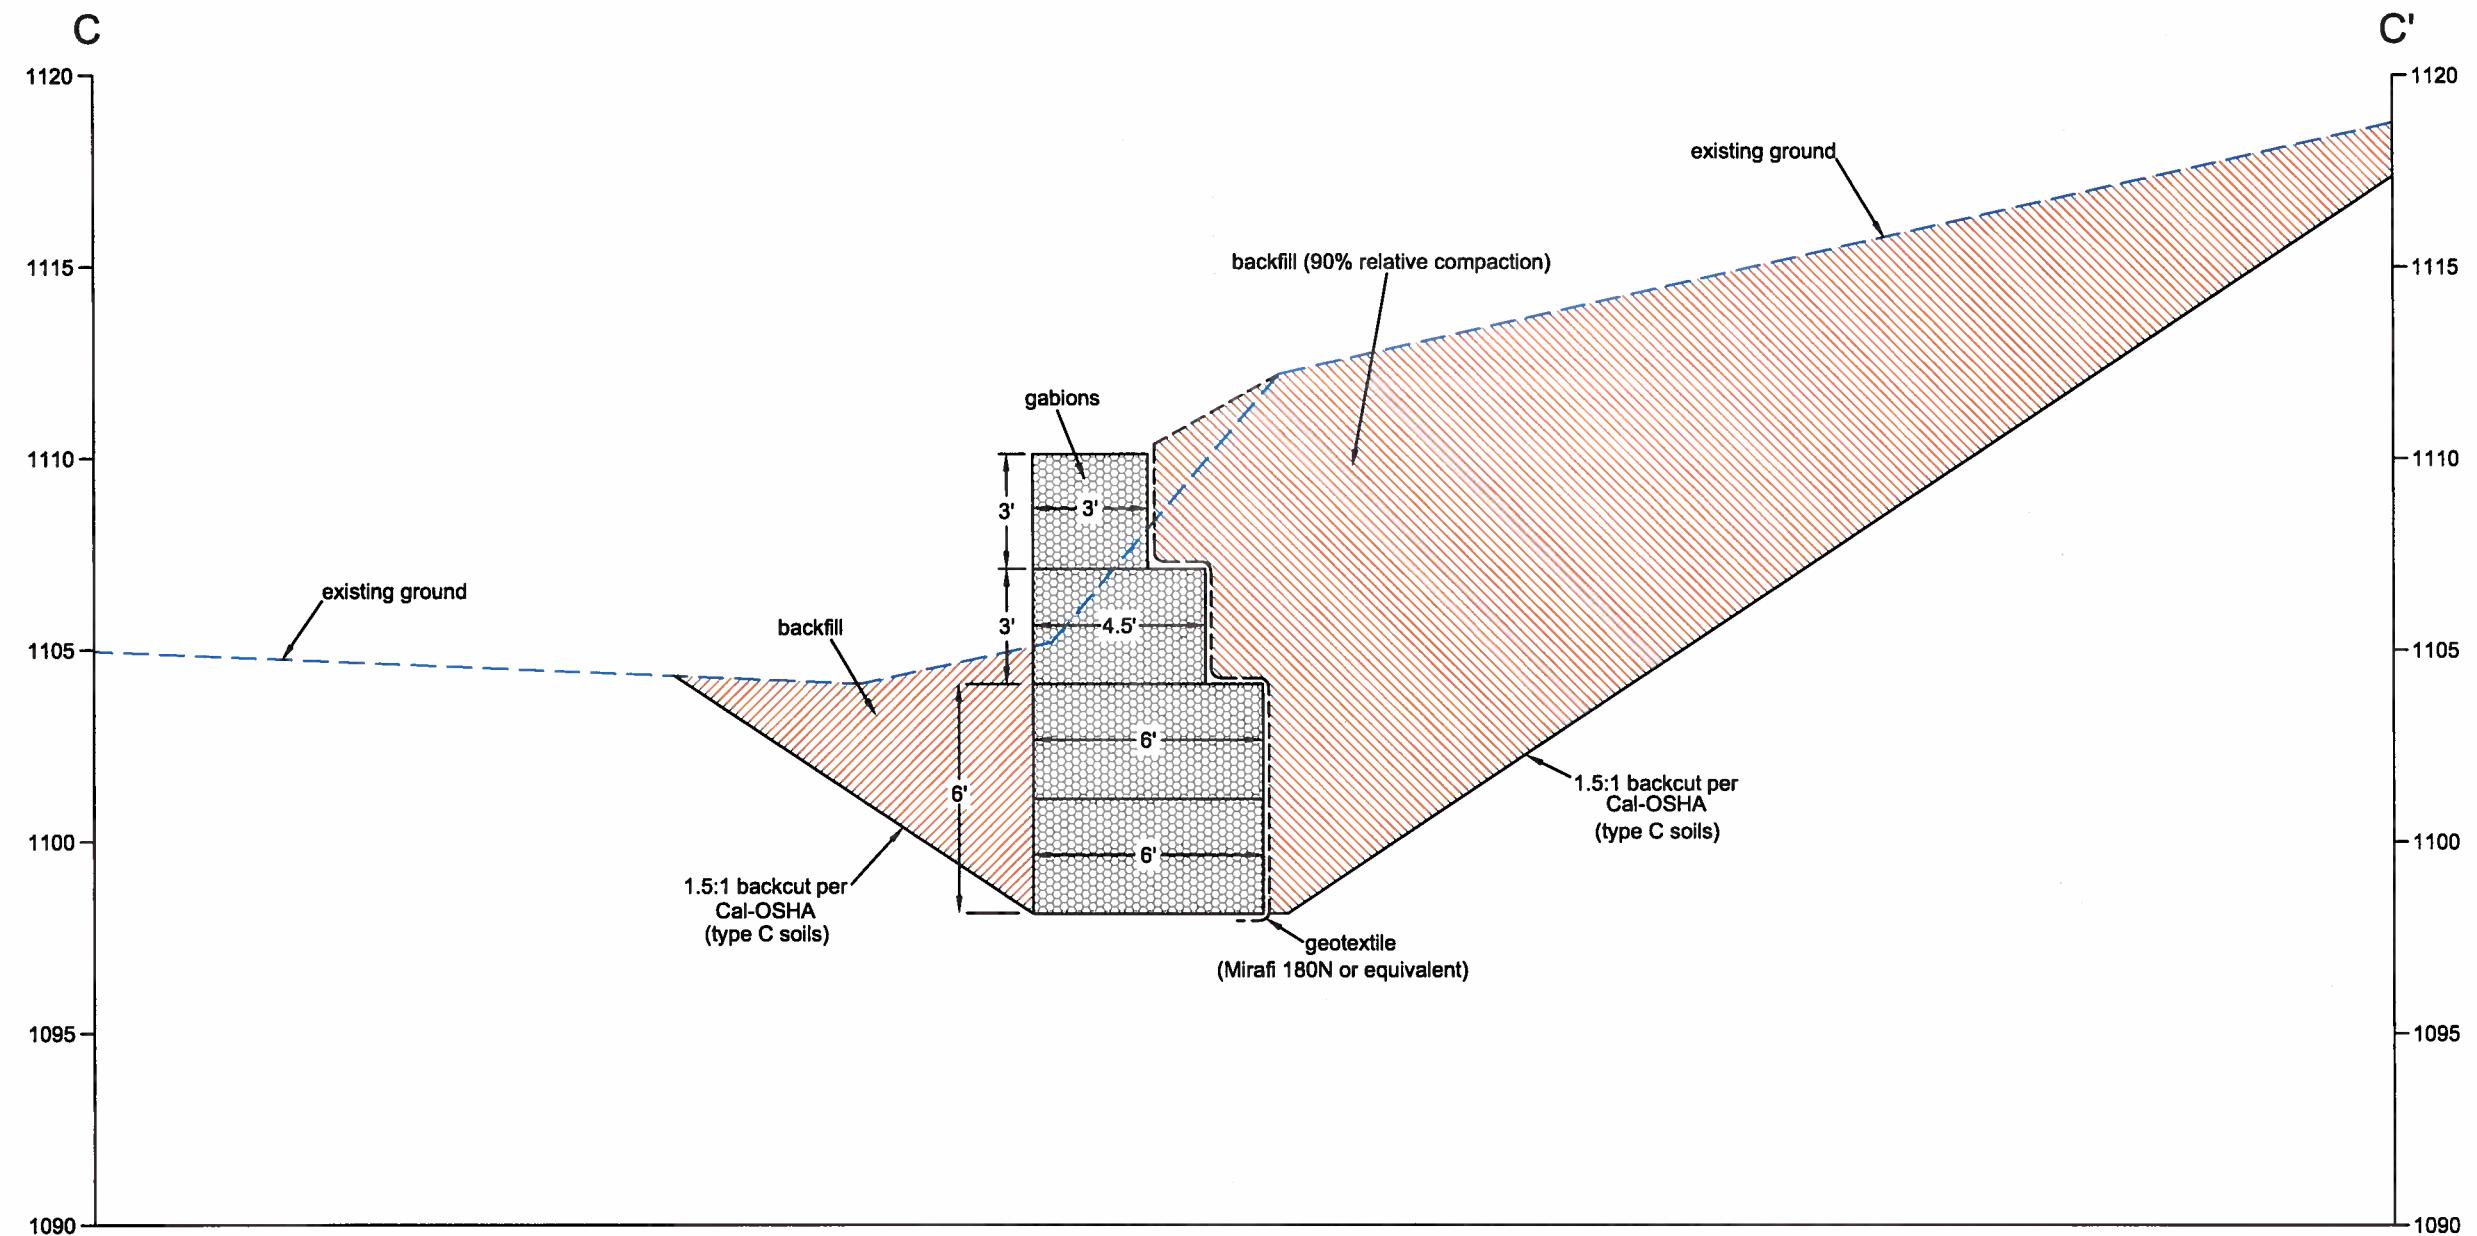
CROSS SECTION C-C'		
FOR:	ARROYO MITIGATION PROJECT GLEN MOR 2 U.C. RIVERSIDE CAMPUS RIVERSIDE, CALIFORNIA	ENCLOSURE "A-4"
DATE:	JUNE 2012	JOB NUMBER 12218-3

The stability of cross sections A and C (Enclosures "A-2" and "A-4", respectively) were analyzed for static and seismic conditions for circular failures utilizing the SLIDE computer program, version 6.0 (Rocscience, Inc., 2011). The seismic stability calculations were performed using a lateral pseudostatic coefficient "k" of 0.15. The factor of safety was calculated by Spencer's method which is considered the most conservative of the available methods.

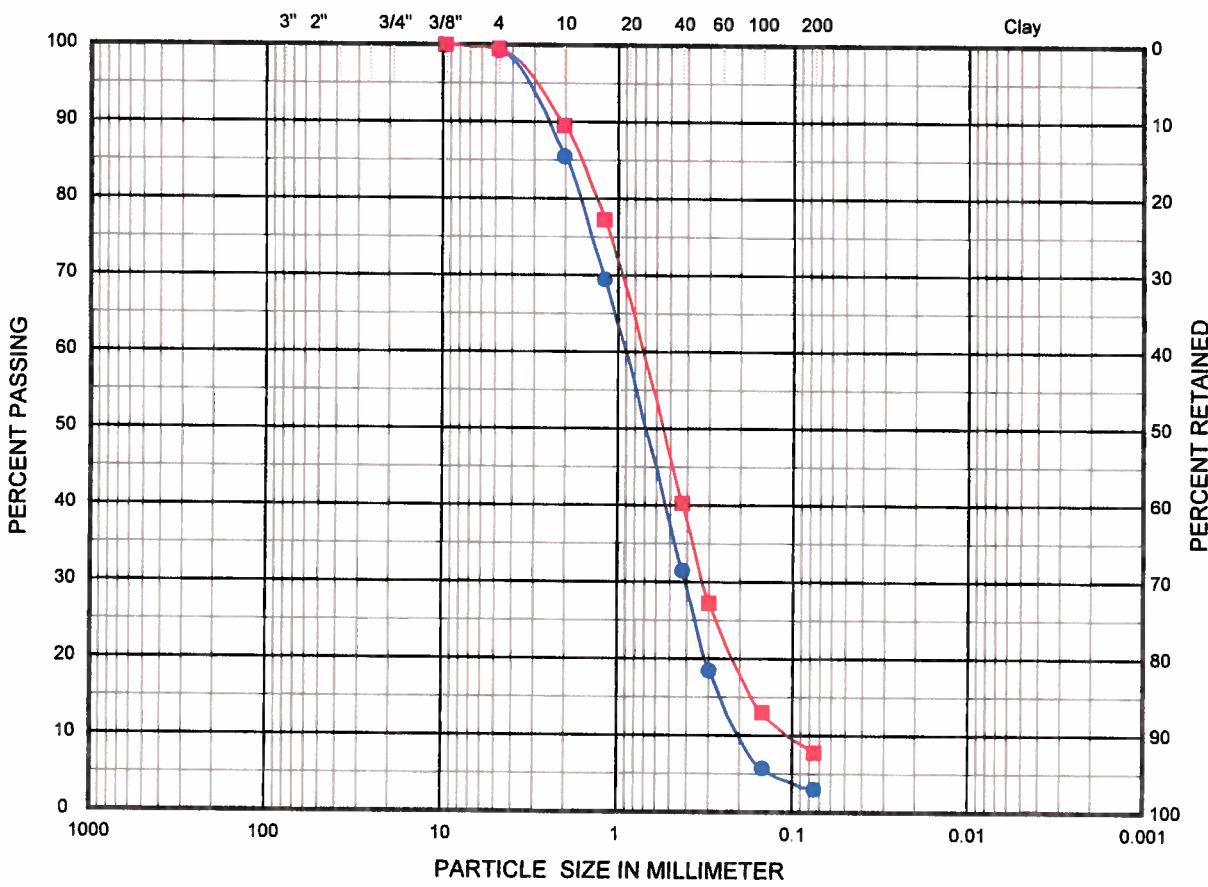
SCREEN (IN) / SIEVE NO. - U.S.A. Standard Series (ASTM D422)

Sample No.	Depth	Gravel	Sand	Fines	Clay	D ₁₀	D ₃₀	D ₅₀	D ₆₀	C _v	C _c
●	Down	stream	0.7	96.4	2.9		0.2060	0.409	0.68	0.90	0.9	4.4
(SP) Poorly-graded sand, fine to medium												
■	Up	stream	0.6	91.6	7.8		0.1055	0.327	0.55	0.71	1.4	6.7
(SP-SM) Poorly-graded sand with silt, fine to medium

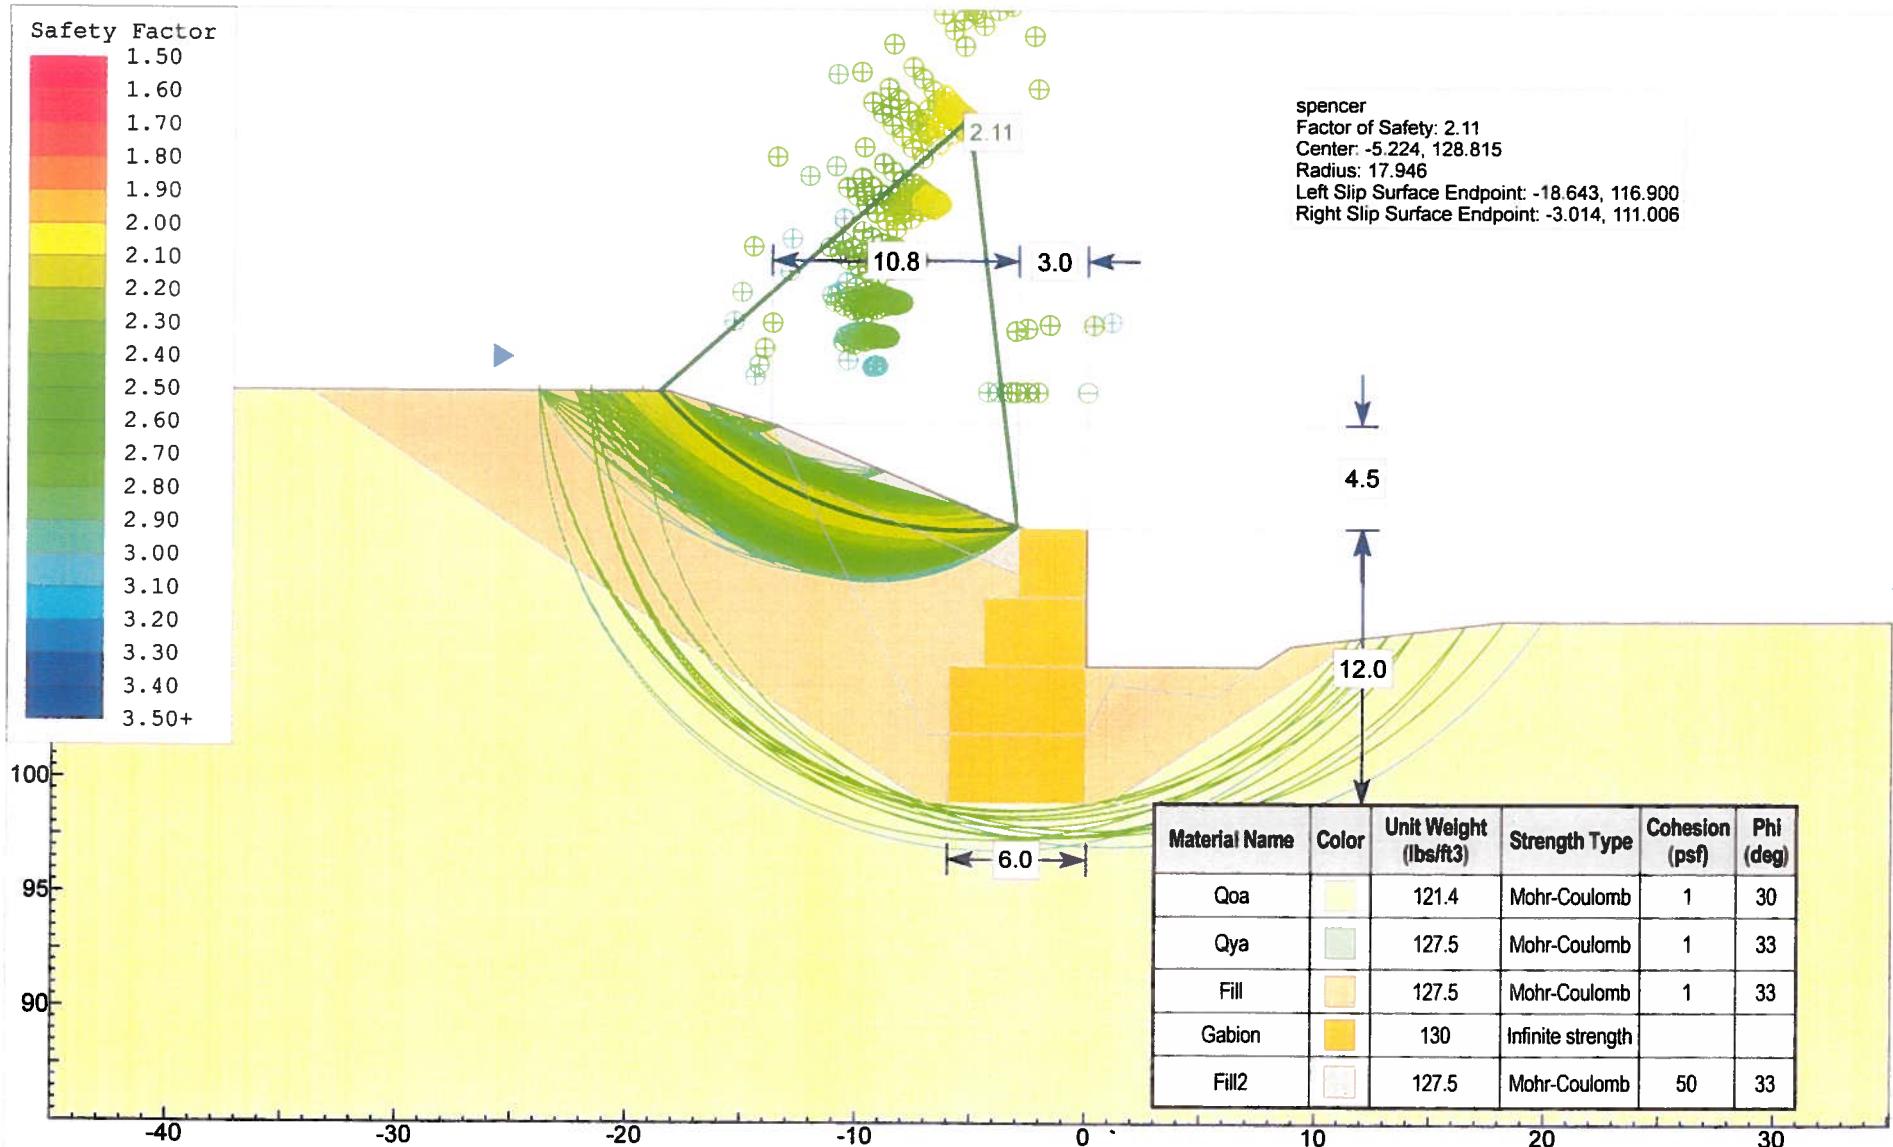
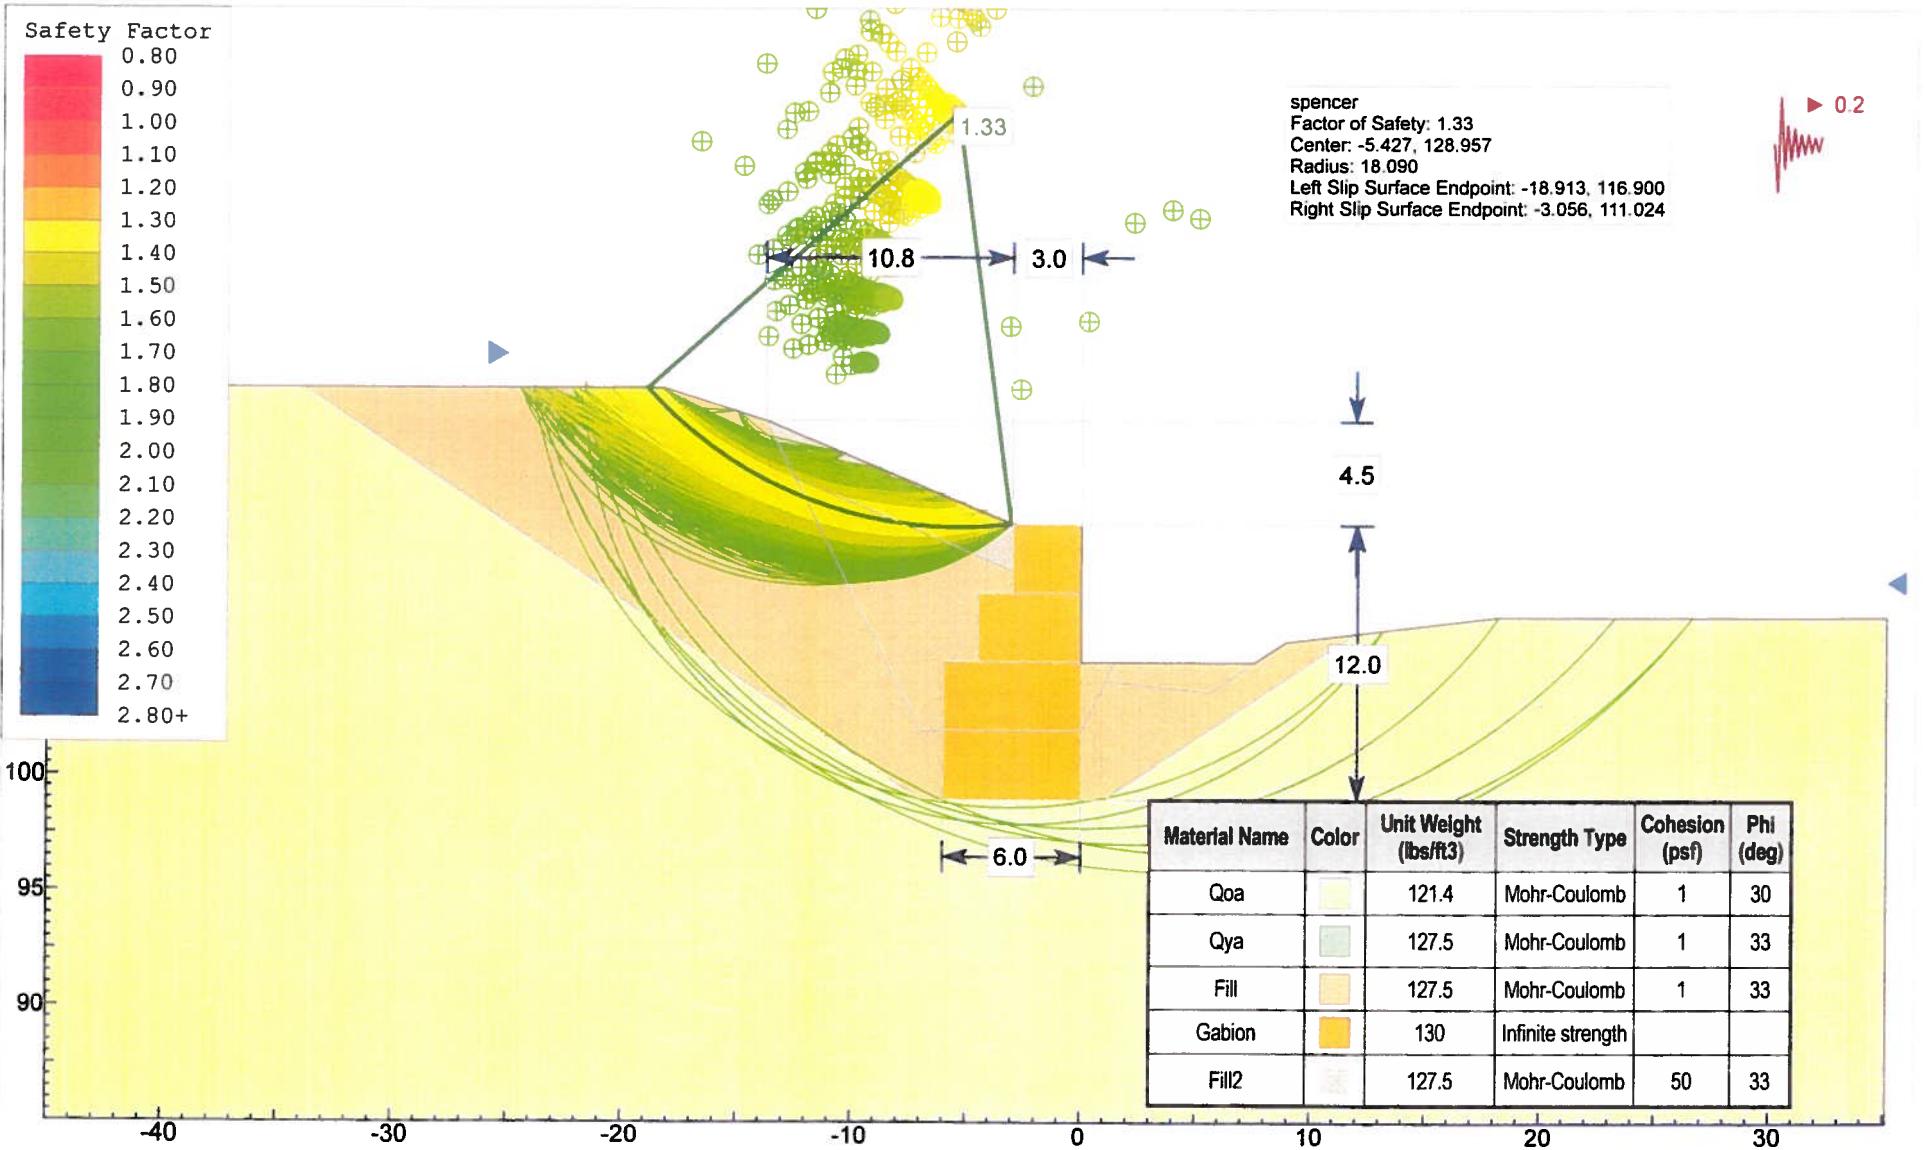
Project			
Arroyo Erosion Mitigation Project, Glen Mor 2			
Analysis Description			
Slope Stability Analysis of Gabion Wall			
Drawn By	C.H.J., Incorporated		
File Name	12218-3 Slope Stability_Section A_6-20-12.slim	Author	Fred Yi, GE
Scale	1:100		
Date	6/20/2012	Enclosure	"C-2"

spencer
 Factor of Safety: 2.42
 Center: 1.583, 1130.661
 Radius: 32.983
 Left Slip Surface Endpoint: -18.691, 1104.645
 Right Slip Surface Endpoint: 32.038, 1117.999

Material Name	Color	Unit Weight (lbs/ft³)	Strength Type	Cohesion (psf)	Phi (deg)
Qoa	Yellow	121.4	Mohr-Coulomb	1	30
Qya	Light Green	127.5	Mohr-Coulomb	1	33
Fill	Orange	127.5	Mohr-Coulomb	1	33
Gabion	Dark Orange	130	Infinite strength		
Fill2	Light Orange	127.5	Mohr-Coulomb	50	33

Both sections analyzed meet required factors of safety for static (minimum 1.50) and seismic (minimum 1.10) conditions. Plots of the results of the analyses are included as Enclosures "C-1" through "C-4".

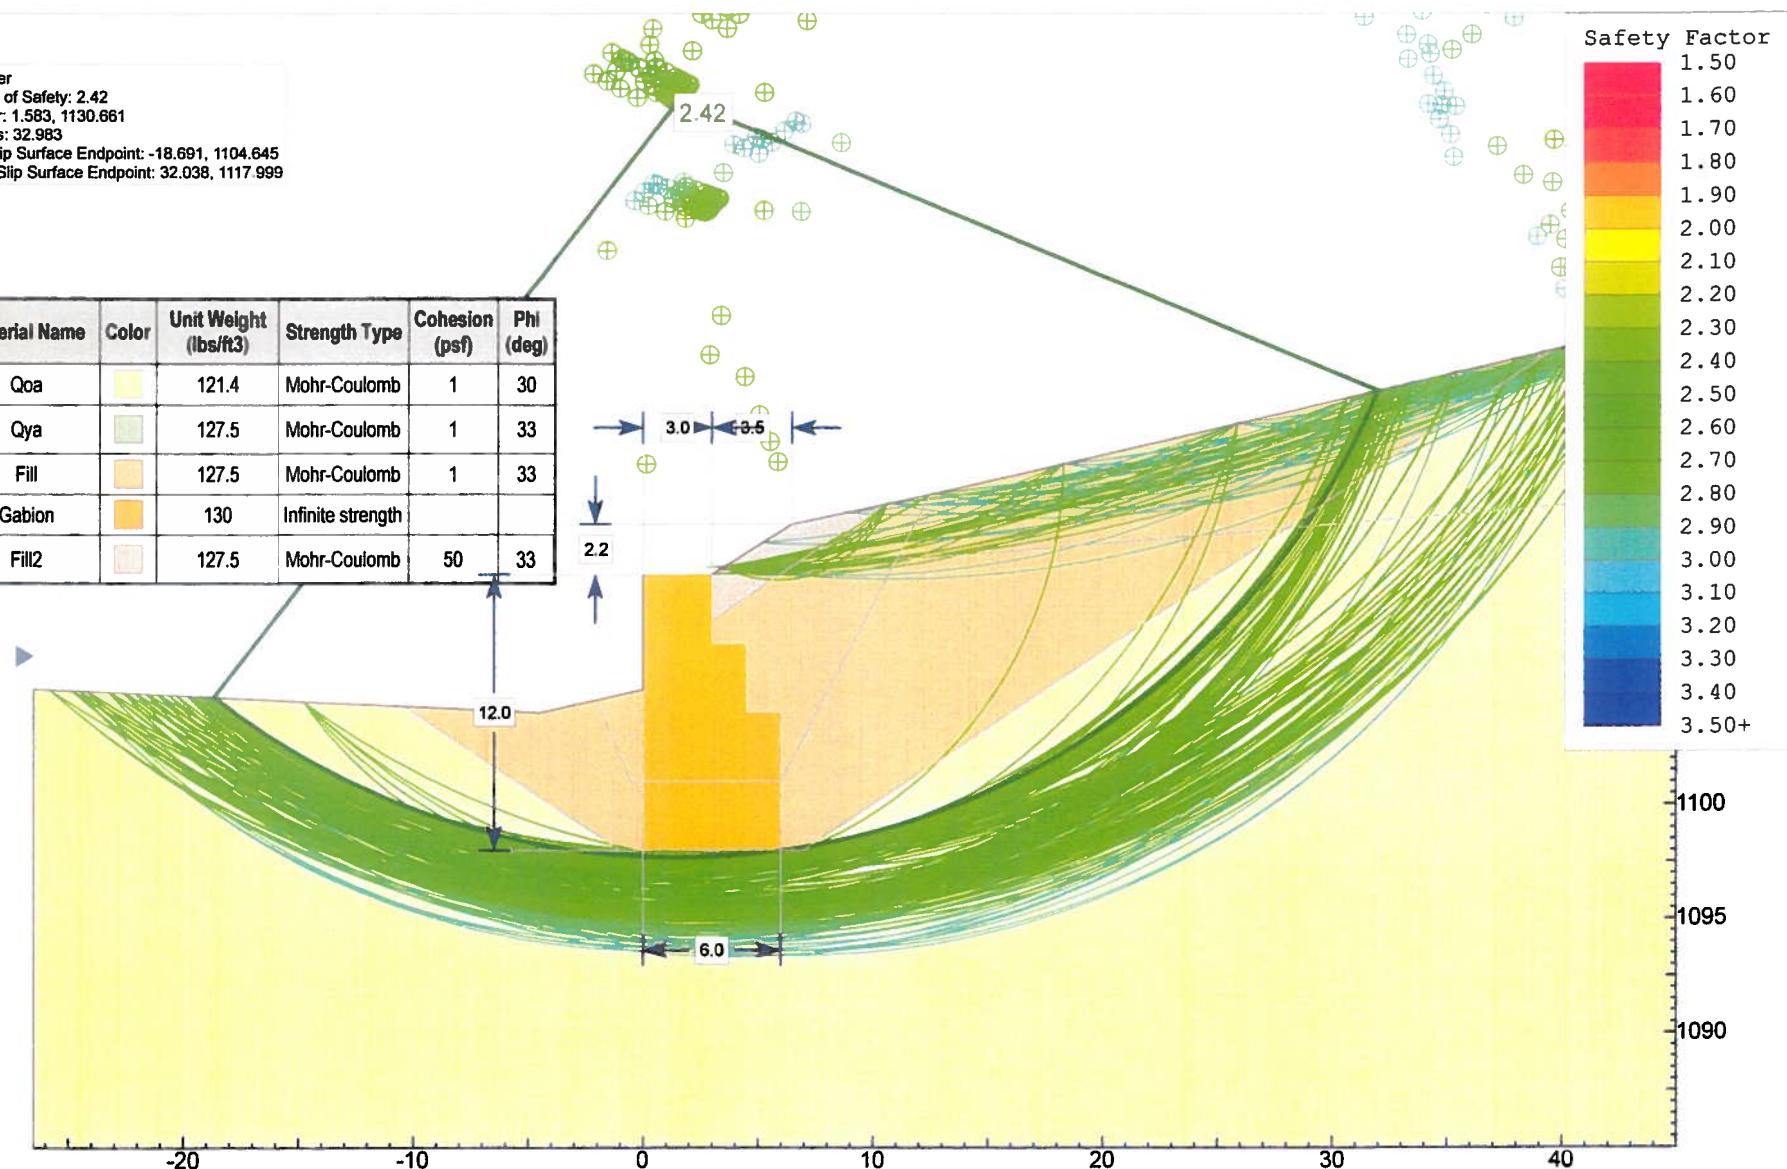
SLIDEINTERPRET 6.017	Project			
	Arroyo Erosion Mitigation Project			
	Analysis Description			
	Slope Stability Analysis of Gabion Wall			
	Drawn By	C.H.J., Incorporated	Author	Scale
		Fred Yi, GE	1:100	
	File Name	12218-3 Slope Stability_Section C_6-20-12.slim	Date	6/20/2012
			Enclosure	"C-3"

spencer
 Factor of Safety: 1.46
 Center: -15.679, 1254.030
 Radius: 145.223
 Left Slip Surface Endpoint: 3.026, 1110.017
 Right Slip Surface Endpoint: 39.607, 1119.742

Material Name	Color	Unit Weight (lbs/ft³)	Strength Type	Cohesion (psf)	Phi (deg)
Qoa	Light Yellow	121.4	Mohr-Coulomb	1	30
Qya	Light Green	127.5	Mohr-Coulomb	1	33
Fill	Orange	127.5	Mohr-Coulomb	1	33
Gabion	Dark Orange	130	Infinite strength		
Fill2	Light Brown	127.5	Mohr-Coulomb	50	33

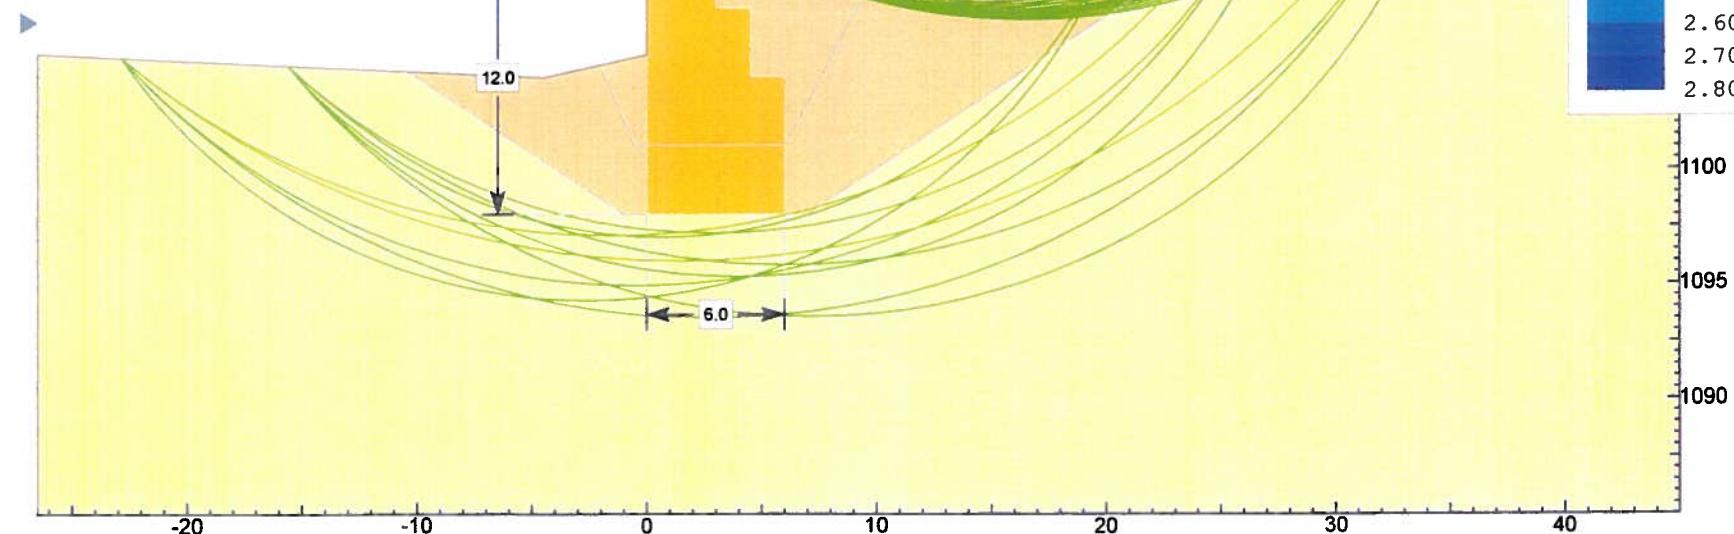
SLIDEINTERPRET 6.017	Project	Arroyo Erosion Mitigation Project		
	Analysis Description	Slope Stability Analysis of Gabion Wall		
	Drawn By	C.H.J., Incorporated	Author	Fred Yi, GE
	File Name	12218-3 Slope Stability_Section C_6-20-12.slim		Date 6/20/2012
		Scale 1:100		Enclosure "C-4"

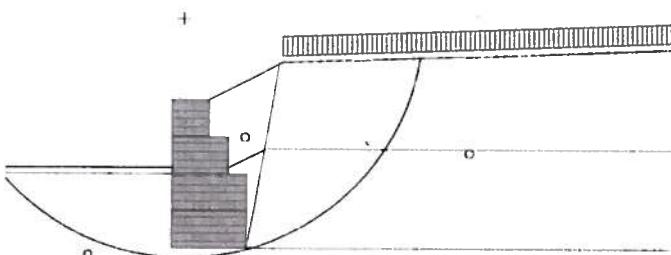
Layer	Length ft	Width ft	Offset ft
Wall batter	: 0.00 deg				
Rockfill unit weight	: 150.00 lb/ft ³				
Porosity of gabions	: 30.00 %				
Geotextile in the backfill	: Yes	1	6.00	3.00	-
Friction reduction	: 15.00 %	2	6.00	3.00	0.00
Geotextile on the base	: Yes	3	4.50	3.00	0.00
Friction reduction	: 15.00 %	4	3.00	3.00	0.00
Mesh and the wire diam.:	: 8x10, ø 2.70 mm

Inclination of Stretch 1	: 27.00 deg
Length of stretch 1	: 6.00 ft
Inclination of Stretch 2	: 2.00 deg
Soil unit weight	: 120.00 lb/ft ³
Soil friction angle	: 30.00 deg
Soil cohesion	: 0.00 lb/ft ²

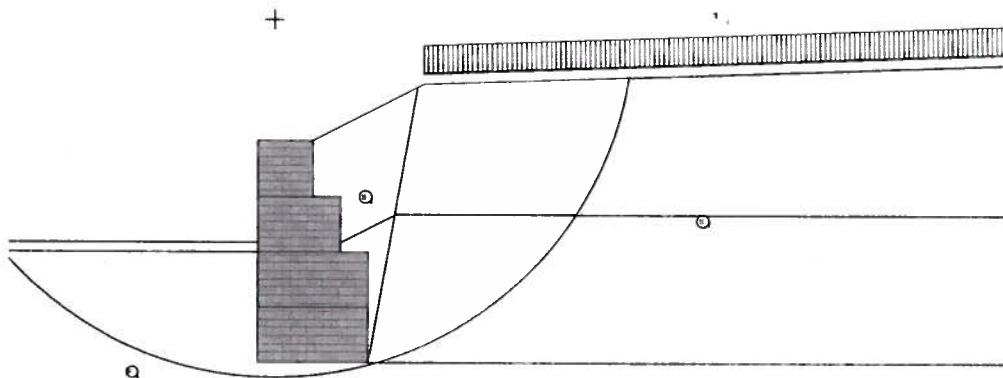
File: 6ftAGL Section A - Option 1

Soil	γ lb/ft ³	c lb/ft ²	ϕ deg	Soil	γ lb/ft ³	c lb/ft ²	ϕ deg
B _s	120.00	0.00	30.00	F _s	120.00	0.00	30.00
B ₁	120.00	0.00	30.00

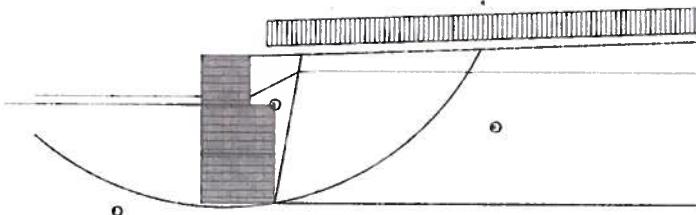
Layer	Length ft	Width ft	Offset ft
Wall batter	: 0.00 deg				
Rockfill unit weight	: 150.00 lb/ft ³				
Porosity of gabions	: 30.00 %	1	4.50	3.00	-
Geotextile in the backfill	: Yes	2	4.50	3.00	0.00
Friction reduction	: 15.00 %	3	3.00	3.00	0.00
Geotextile on the base	: Yes				
Friction reduction	: 15.00 %				
Mesh and the wire diam.:	: 8x10, ø 2.70 mm

Inclination of Stretch 1	: 0.00 deg
Length of stretch 1	: 1.00 ft
Inclination of Stretch 2	: 2.00 deg
Soil unit weight	: 120.00 lb/ft ³
Soil friction angle	: 30.00 deg
Soil cohesion	: 0.00 lb/ft ²

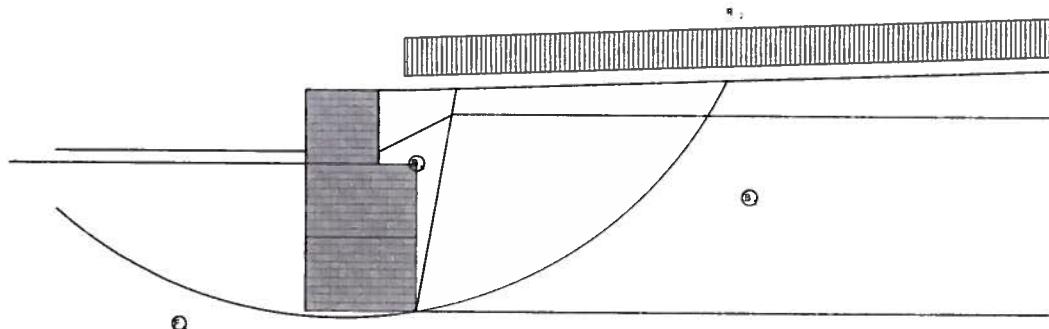
Project: UCR Arroyo Gabions
File: 3ftAGLSection B - Option 1

Soil	γ lb/ft ³	c lb/ft ²	ϕ deg	Soil	γ lb/ft ³	c lb/ft ²	ϕ deg
B _s	120.00	0.00	30.00				
B ₁	120.00	0.00	30.00	F _s	120.00	0.00	30.00

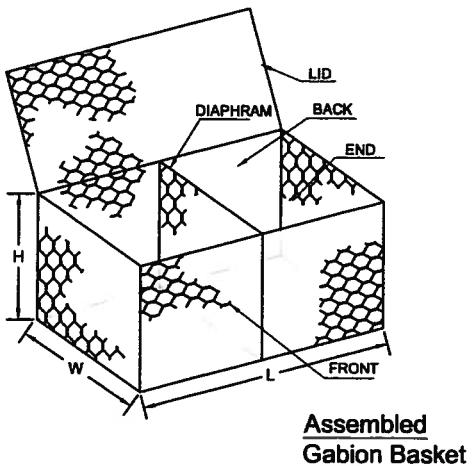
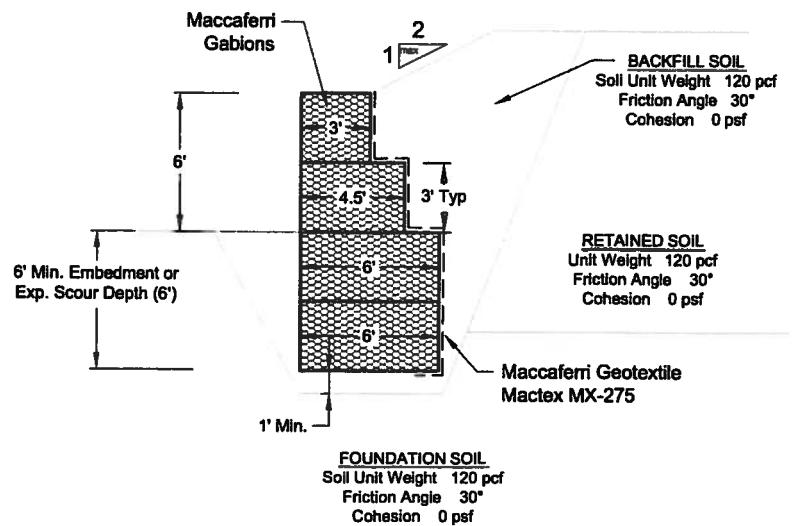
A 6' AGL TYPICAL CROSS SECTION - OPTION 1
Maccaferri Gabion Wall

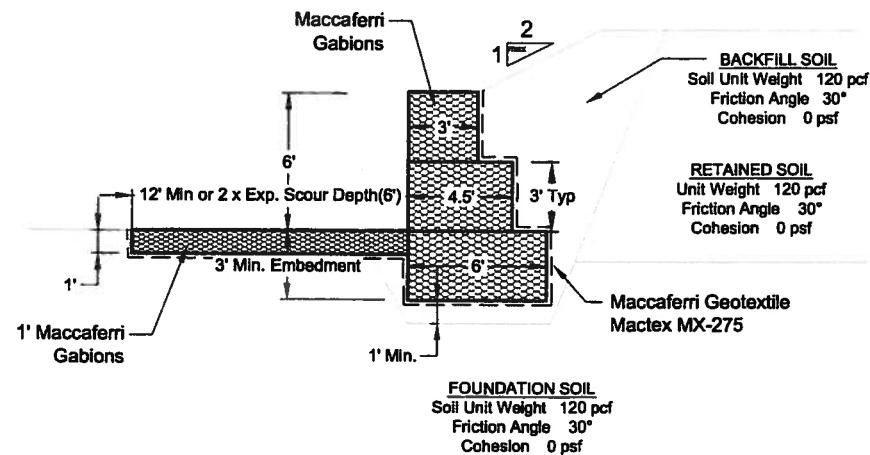
A 6' AGL TYPICAL CROSS SECTION - OPTION 2
Maccaferri Gabion Wall

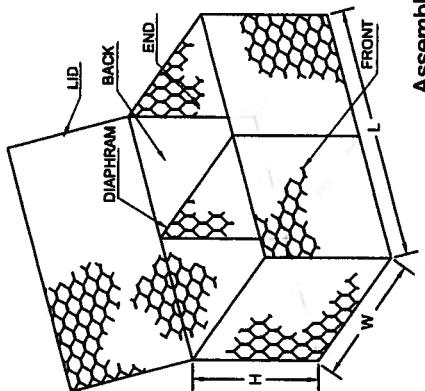
Assembled
Gabion Basket

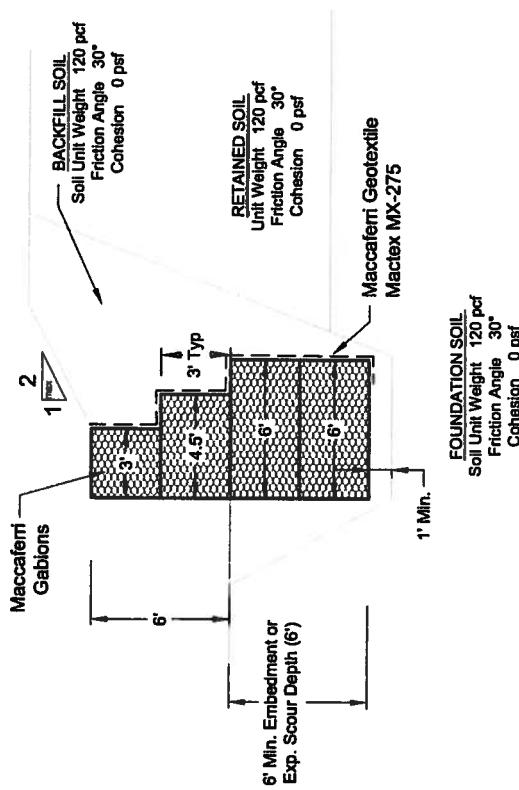
6' AGL TYPICAL CROSS SECTION - OPTION 1

(A)
Maccaferri Gabion Wall

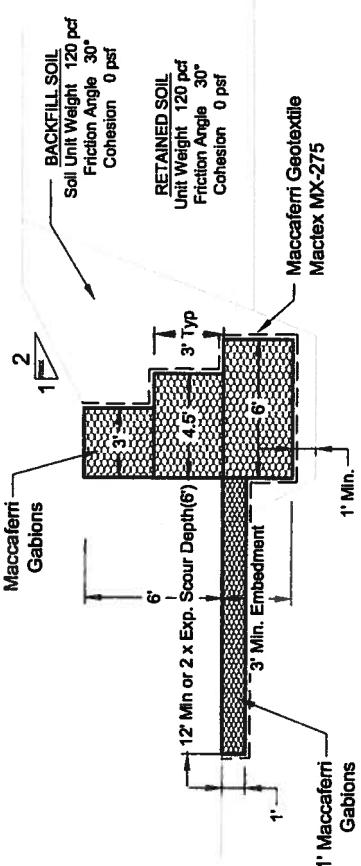
6' AGL TYPICAL CROSS SECTION - OPTION 2

(A)
Maccaferri Gabion Wall

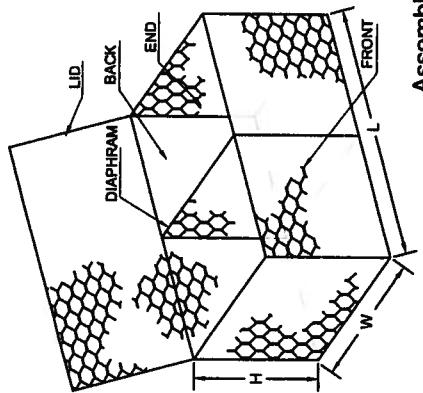
**Assembled
Gabion Basket**

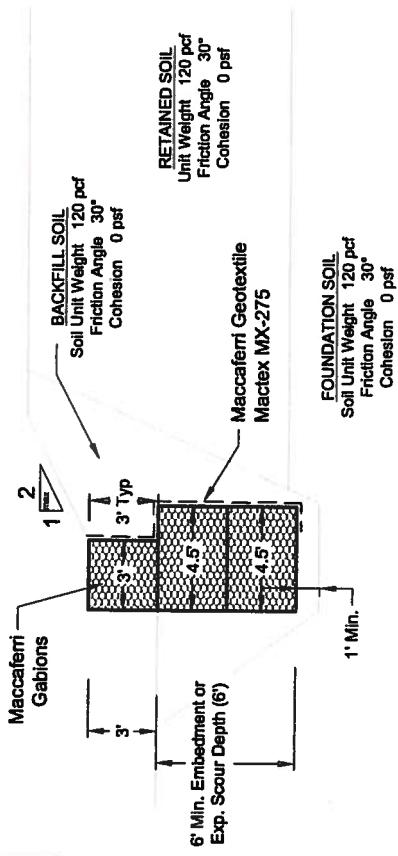
B Maccaferri Gabion Wall
3' AGL TYPICAL CROSS SECTION - OPTION 1

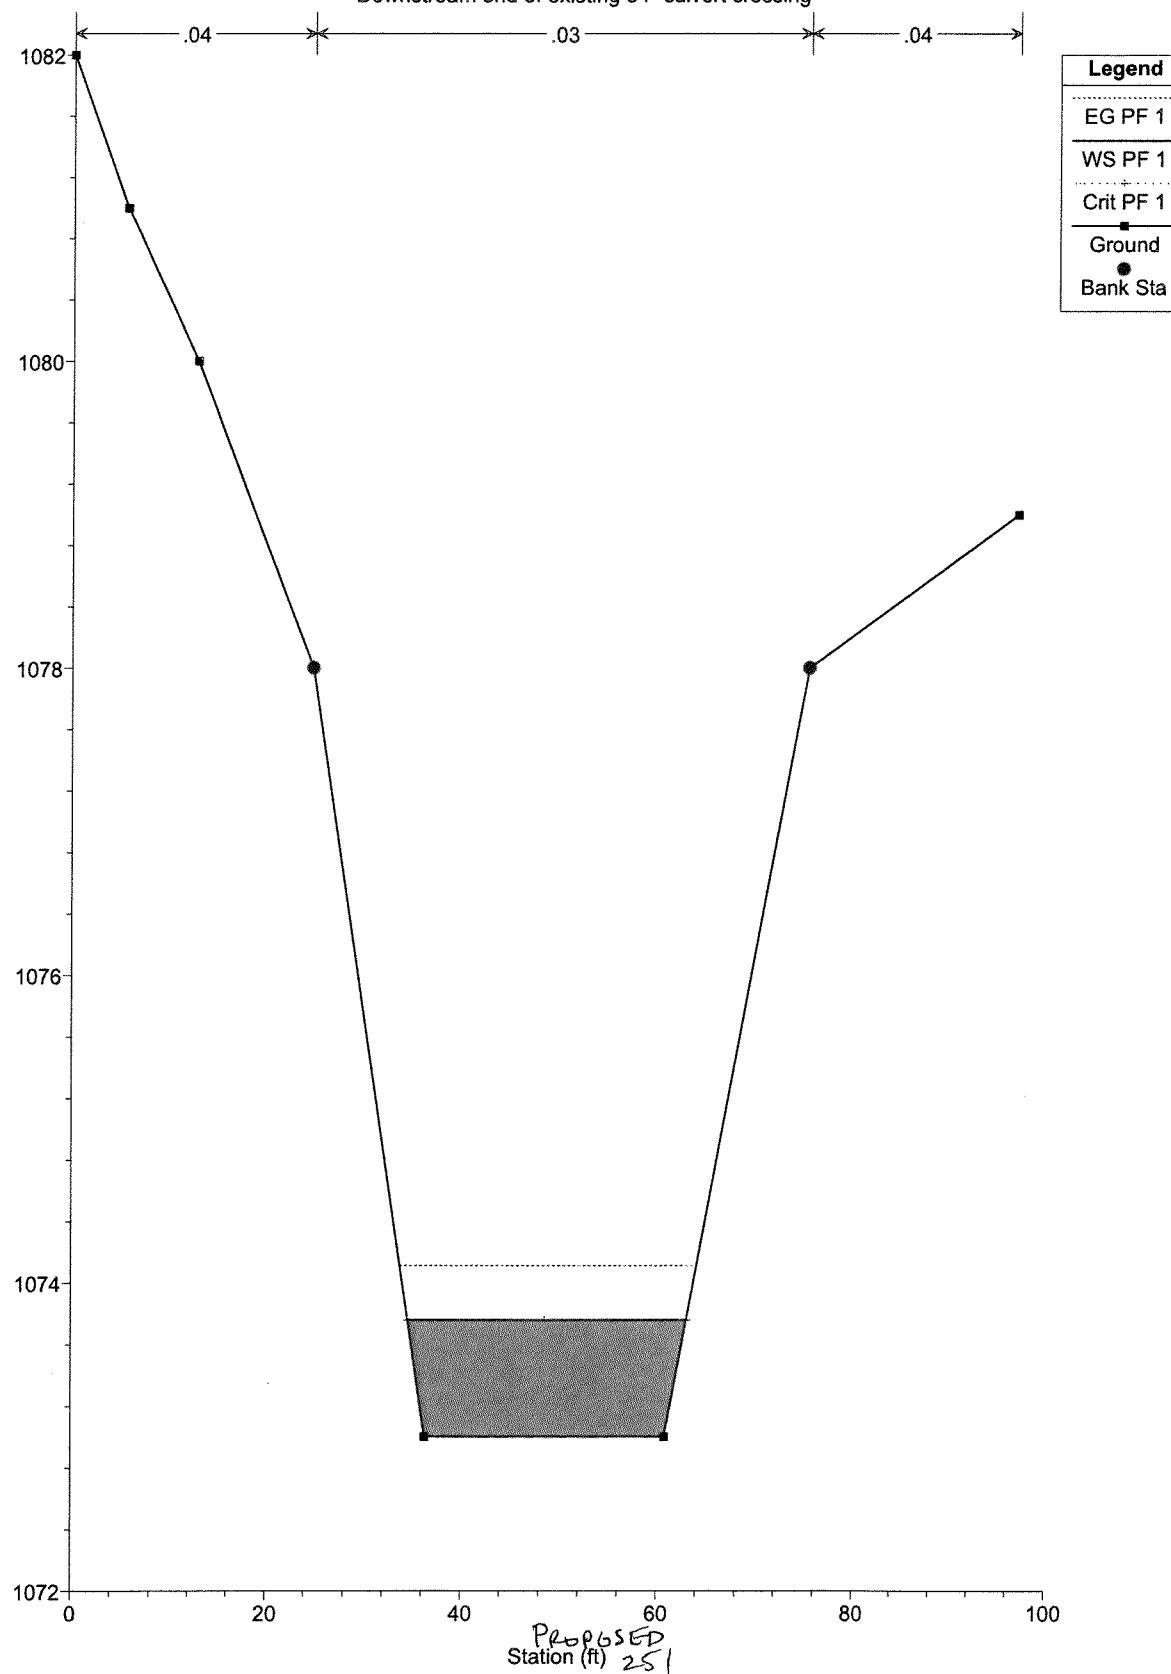
UCR Glen Mor 2 Arroyo Proposed Plan: plan 11 8/14/2012

Downstream end of existing 54" culvert crossing

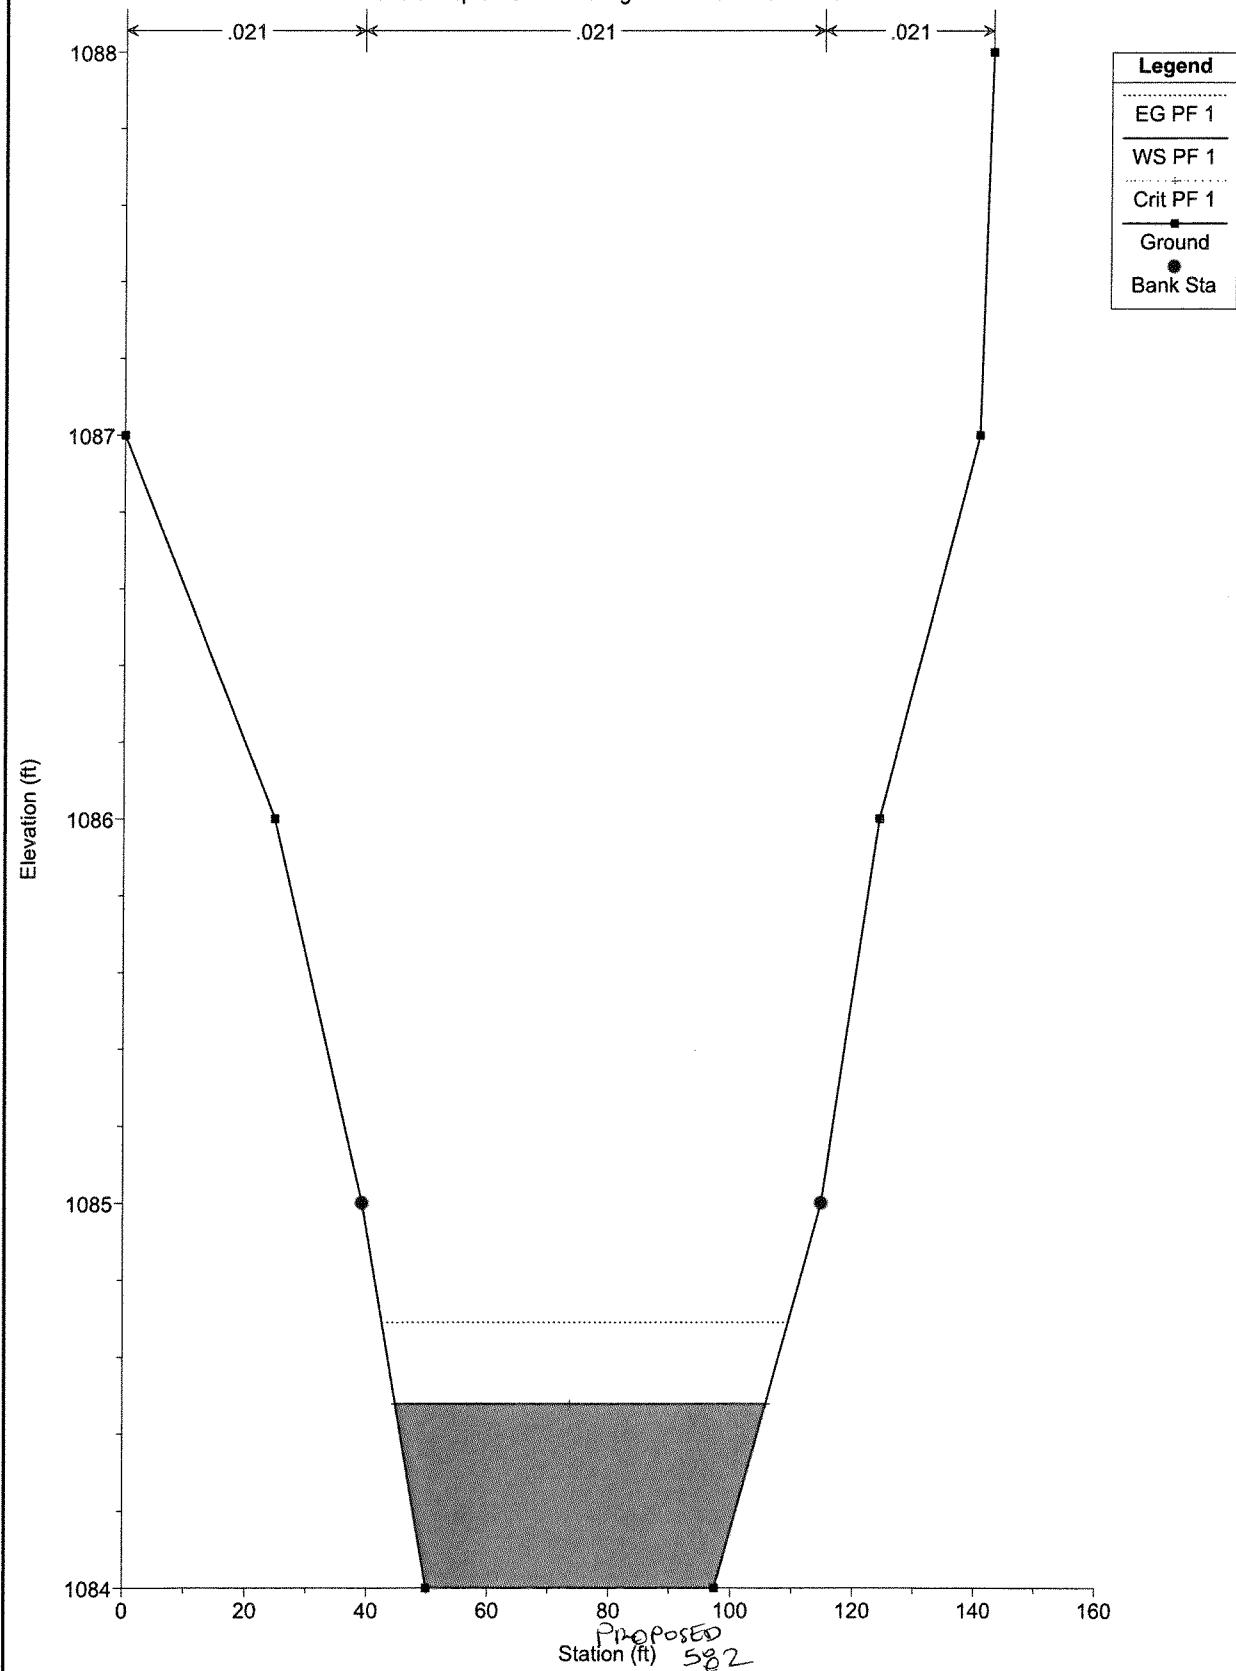
UCR Glen Mor 2 Arroyo Proposed Plan: plan 11 8/14/2012

Modeled top of road. Existing 12" culvert filled w/ sediment.
