Addendum #1 to Final Environmental Impact Report for the
Glen Mor 2 Student Apartments Project
(SCH# 2010081020)

Project Title: Glen Mor 2 Student Apartments
Project Number: 956334
Project Location: The project is located on the University of California, Riverside (UCR) campus, generally northwest of Big Springs Road and Valencia Hill Drive. The site is south of the existing Glen Mor 1 and Pentland Hills residential complexes and east of Lothian residence hall.
City: Riverside
County: Riverside

Addendum #1 for Glen Mor 2 Student Apartments
Modified Arroyo Improvements
September 25, 2012

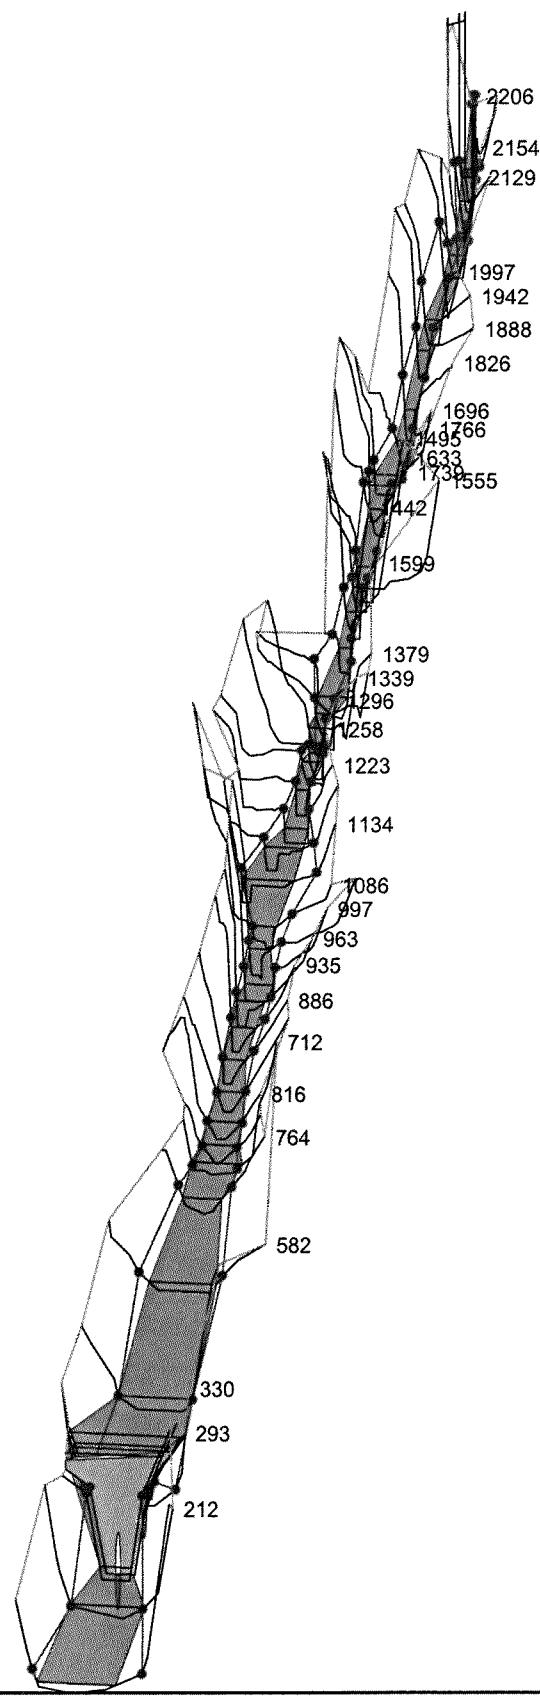
PROPOSED PERSPECTIVE

Legend
WS PF 1
Ground
Bank Sta

HEC-RAS Plan: plan 11 River: Arroyo Reach: Glen Mor 2 Profile: PF 1

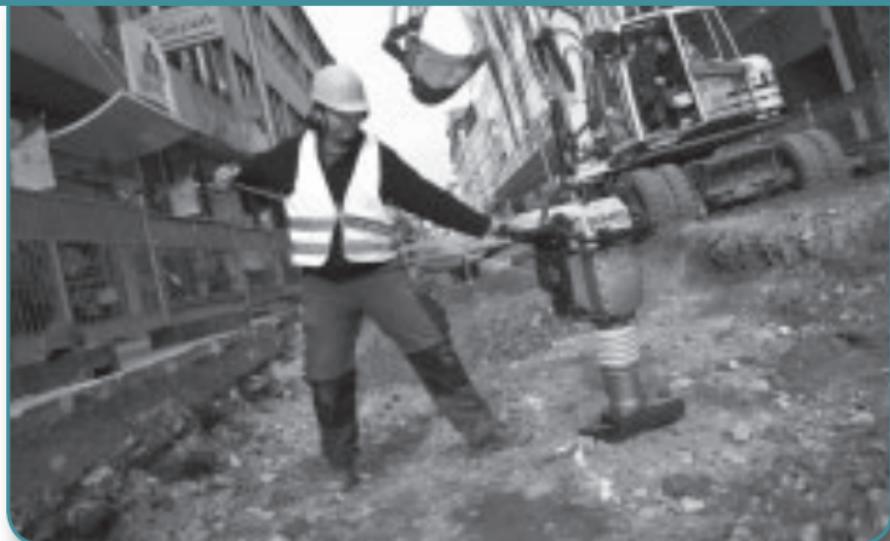
- Backfill around footings and foundations
- Subbase and base preparation
- Compaction of underground sewer, water, telephone and electrical lines
- Backfilling trenches

- Four-cycle engine offers convenience while maintaining high stroke and impact force.
- Low oil system helps to prevent premature engine damage.
- Dual fuel filter system for higher reliability.
- Engine design allows transportation in any position without concern for fuel contamination.
- Six interchangeable shoe sizes provide a variety of compaction widths.
- Dual air filters system protects engine in dusty conditions.
- Hour / Tachometer with integrated service indicator
- All around engine guard protection to reduce expensive repair costs.
- Acceleration pump for efficient power curve.

BT 60/4	BT 65/4
Operating weight	137 lbs 62 kg	150 lbs 68 kg
Length	28.9 in 73.5 cm	28.9 in 73.5 cm
Height	37.8 in 96 cm	39.4 in 100 cm
Width	13.8 in 35 cm	13.8 in 35 cm
Working width	11 in 28 cm	11 in 28 cm
Impact force	3035 lbs 13.5 kN	3642 lbs 16.2 kN
Frequency	600 - 708 bpm 10 - 11.8 Hz	600 - 708 bpm 10 - 11.8 Hz
Max. working speed*	66 ft/min 20 m/min	66 ft/min 20 m/min
Engine / Power Power rating ISO 9249	Honda 3.4 hp 2.5 kW	Honda 3.4 hp 2.5 kW
Max. compaction depth*	21.7 in 55 cm	25.6 in 65 cm

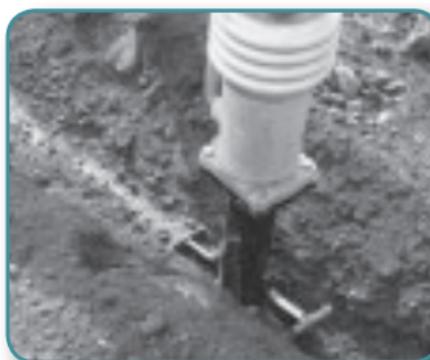
BT 65/4 with special extension

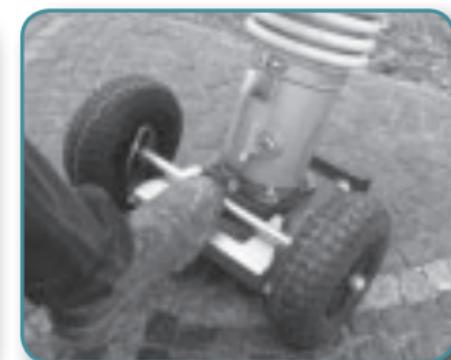
BT 65/4 with transport wheels

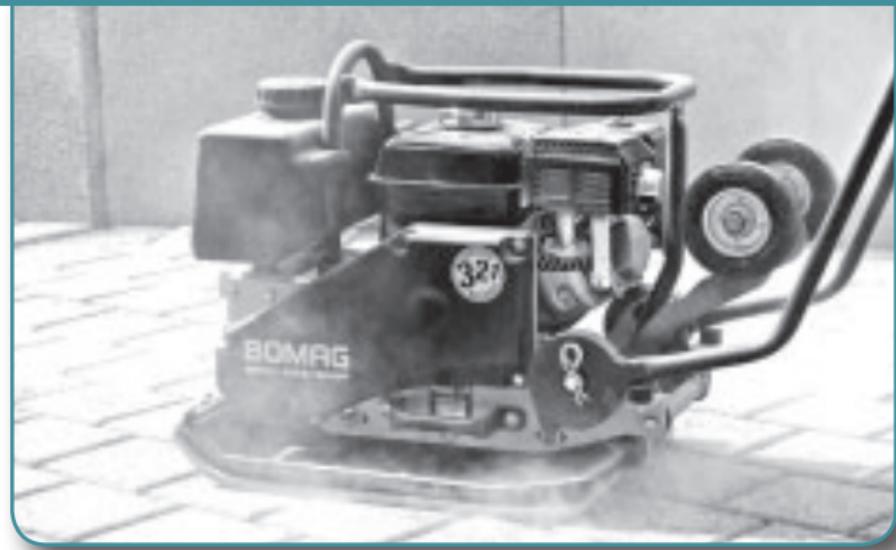
- Compaction of a wide variety of sand, gravel and granular base materials.
- Hot and cold asphalt patching.

- Powerful and reliable Honda engine guarded with protection frame.
- High-density polyfiber belt guard and closed drive prevents V-belt damage and extends belt life.
- Sealed exciter housing offers greater service life.
- Self-cleaning, wear-resistant base plate ensures reduced maintenance and long service life.
- Removable handle permits easy loading into pickup, car trunk or SUV.
- Shock absorbing handle reduces operator fatigue.
- Foldable steering handle enhances maneuverability.
- Compact design allows compaction work close to curbs and retaining walls.
- Optional water spray system and transport device offers flexibility on job sites.
- Optional Vulcolan mat protects against damage to paving blocks.

BVP 10/36	BVP 18/45
Operating weight	183 lbs 83 kg	201 lbs 91 kg
Length	43.9 in 111.5 cm	43.9 in 111.5 cm
Height	36 in 91.5 cm	36 in 91.5 cm
Working width	14.2 in 36 cm	17.7 in 45 cm
Centrifugal force	2250 lbs 10 kN	4050 lbs 18 kN
Frequency	5400 vpm 90 Hz	5400 vpm 90 Hz
Max. working speed*	82 ft/min 25 m/min	82 ft/min 25 m/min
Max. gradeability*	30%	30%
Engine / Power Power rating ISO 9249	Honda 3.5 hp 2.6 kW	Honda 4.8 hp 3.6 kW

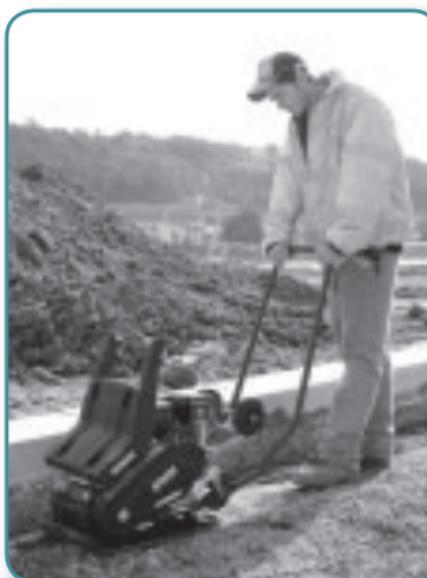
BP 10/35

Operating weight	143 lbs 65 kg	159 lbs 72 kg	165 lbs 75 kg
Length	42.7 in 108.4 cm	42.7 in 108.4 cm	42.7 in 108.4 cm
Height	37.9 in 96.2 cm	37.9 in 96.2 cm	37.9 in 96.2 cm
Working width	13.8 in 35 cm	15.7 in 40 cm	19.7 in 50 cm
Centrifugal force	2250 lbs 10 kN	2700 lbs 12 kN	2700 lbs 12 kN
Frequency	5400 vpm 90 Hz	5400 vpm 90 Hz	5400 vpm 90 Hz
Max. working speed*	82 ft/min 25 m/min	82 ft/min 25 m/min	72 ft/min 22 m/min
Max. gradeability*	30%	30%	30%
Engine / Power	Honda 3.5 hp 2.6 kW	Honda 3.5 hp 2.6 kW	Honda 3.5 hp 2.6 kW
Power rating ISO 9249

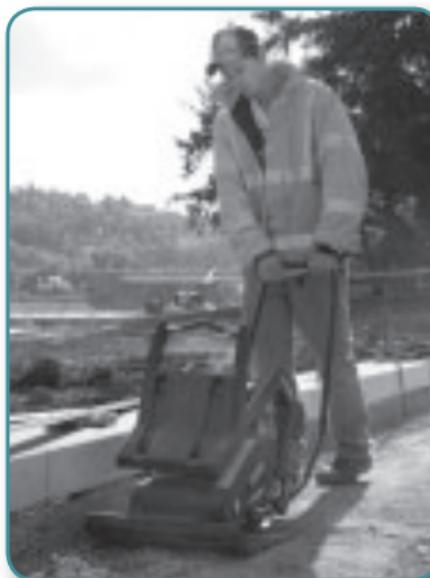
BP 20/50	BP 25/50
Operating weight	209 lbs 95 kg	238 lbs 108 kg
Length	42.7 in 108.4 cm	42.7 in 108.4 cm
Height	37.9 in 96.2 cm	37.9 in 96.2 cm
Working width	19.7 in 50 cm	19.7 in 50 cm
Centrifugal force	4500 lbs 20 kN	5620 lbs 25 kN
Frequency	5400 vpm 90 Hz	5520 vpm 92 Hz
Max. working speed*	98 ft/min 30 m/min	98 ft/min 30 m/min
Max. gradeability*	30%	30%
Engine / Power Power rating ISO 9249	Honda 4.8 hp 3.6 kW	Honda 4.8 hp 3.6 kW

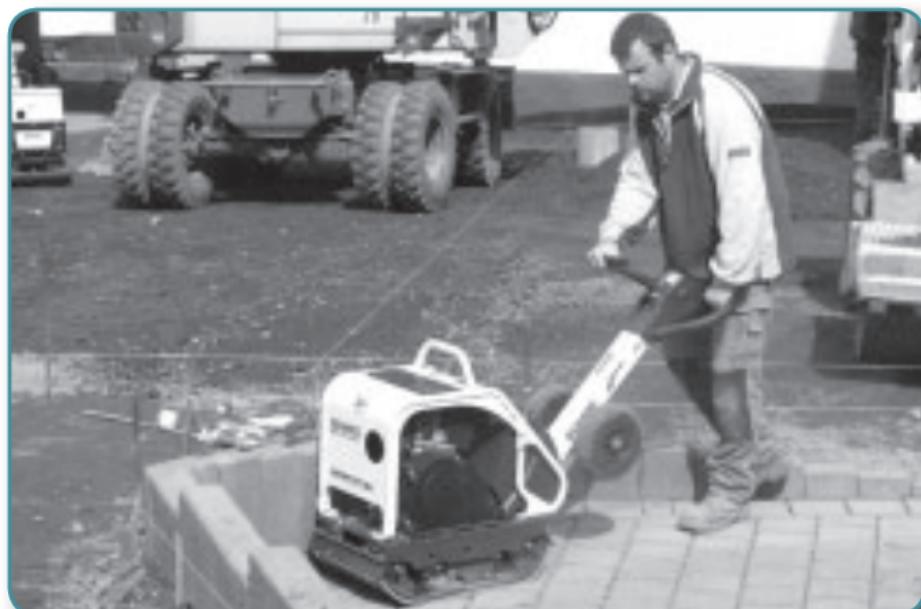
BPR 25/40	BPR 25/40 D
Operating weight	245 lbs 111 kg	284 lbs 129 kg
Length Adjustable handle	57.5 in 146 cm	57.5 in 146 cm
Height Adjustable handle	34.3 in 87 cm	34.3 in 87 cm
Working width	15.7 in 40 cm	15.7 in 40 cm
Centrifugal force	5620 lbs 25 kN	5620 lbs 25 kN
Frequency	5100 vpm 85 Hz	5100 vpm 85 Hz
Max. working speed*	82 ft/min 25 m/min	82 ft/min 25 m/min
Max. gradeability*	30%	30%
Engine / Power Power rating ISO 9249	Honda 4.8 hp 3.6 kW	Hatz 4.2 hp 3.1 kW

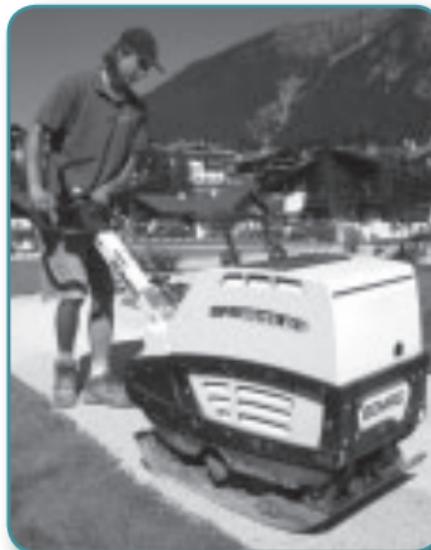
BPR 45/55 D/E

Operating weight	873 lbs 396 kg	1005 lbs 456 kg	
Length Adjustable handle	66.9 in 170 cm	66.9 in 170 cm	
Height Adjustable handle	31.5 in 80 cm	31.5 in 80 cm	
Working width	21.7 in 55 cm	25.6 in 65 cm	
Centrifugal force	10116 lbs 45 kN	12364 lbs 55 kN	
Frequency	4200 vpm 70 Hz	3960 vpm 66 Hz	
Max. working speed*	92 ft/min 28 m/min	92 ft/min 28 m/min	
Max. gradeability*	35%	35%	
Engine / Power Power rating ISO 9249	Lombardini	8.9 hp 6.6 kW	8.9 hp 6.6 kW

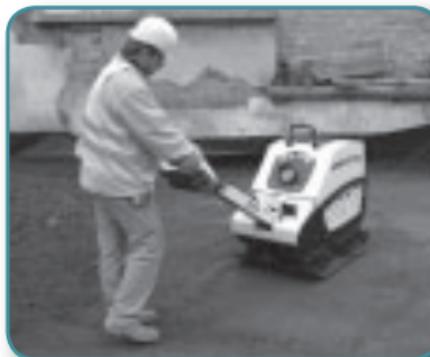
BPR 70/70 D/E

Centrifugal force	15736 lbs 70 kN	22481 lbs 100 kN
--------------------------	--------------------	---------------------

Engine / Power	Hatz 12.5 hp 9.3 kW	Hatz 13.8 hp 10.3 kW
-----------------------	------------------------	-------------------------

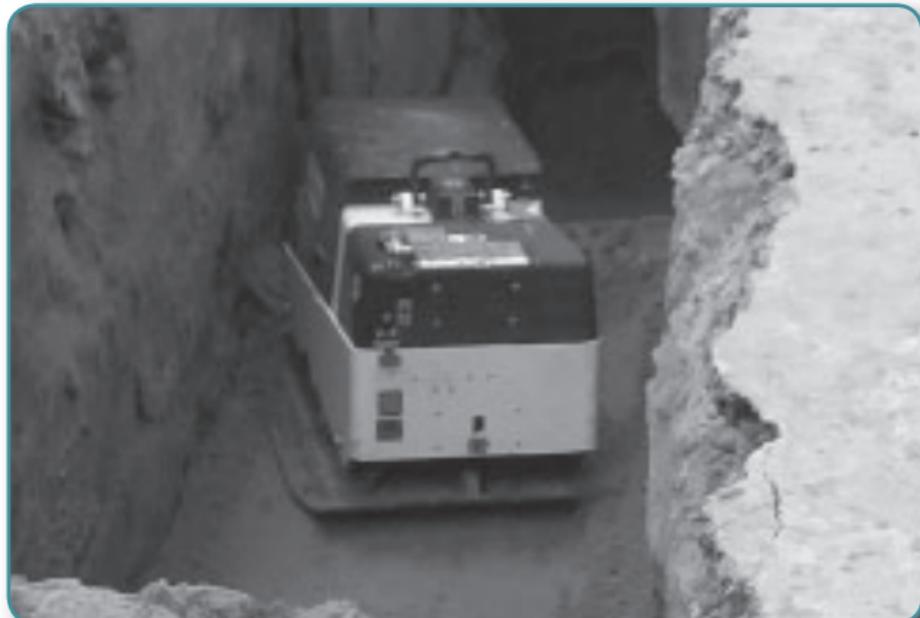
BPH 80/65 S D/E

Operating weight	1638 lbs 743 kg
Length	42.8 in 108 cm
Height	30.9 in 79 cm
Working width	31.5 in 80 cm
Centrifugal force	18000 lbs 80 kN
Frequency	3300 vpm 55 Hz
Max. working speed*	92 ft/min 28 m/min
Max. gradeability*	30%
Engine / Power Power rating ISO 9249	Hatz 15.2 hp 11.3 kW

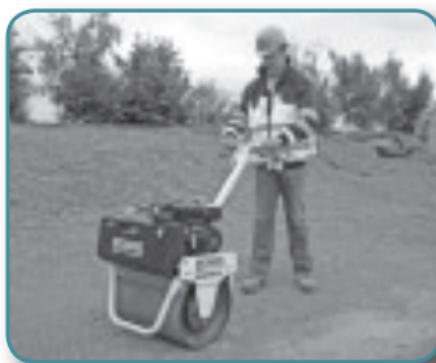
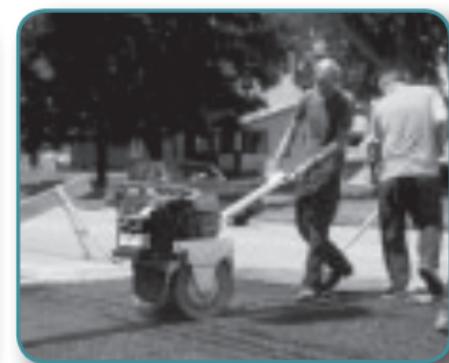
BW 55 E

Operating weight	355 lbs 161 kg
Length Adjustable handle	43.3 in 110 cm
Height Adjustable handle	35.4 in 90 cm
Width	26.7 in 68 cm
Working width	22 in 56 cm
Static linear load	16.2 pli 2.9 kg/cm
Centrifugal force	2250 lbs 10 kN
Frequency	4620 vpm 77 Hz
Amplitude	0.020 in 0.5 mm
Max. gradeability* without vibration with vibration	25% 20%
Engine / Power Power rating ISO 9249	Honda 3.5 hp 2.6 kW

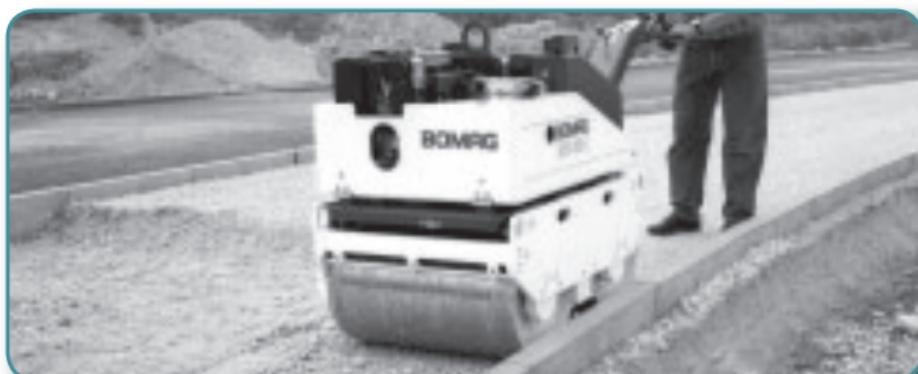
BW 65H D/E

Operating weight	1668 lbs 757 kg
Length Adjustable handle	91.3 in 232 cm
Height Adjustable handle	47.6 in 121 cm
Width	30 in 76 cm
Working width	25.6 in 65 cm
Static linear load	32.6 pli 5.8 kg/cm
Centrifugal force	4950 lbs 22 kN
Frequency	3300 vpm 55 Hz
Amplitude	0.018 in 0.45 mm
Max. gradeability* without vibration	40%
with vibration	35%
Engine / Power Power rating ISO 9249	Hatz 8.3 hp 6.2 kW

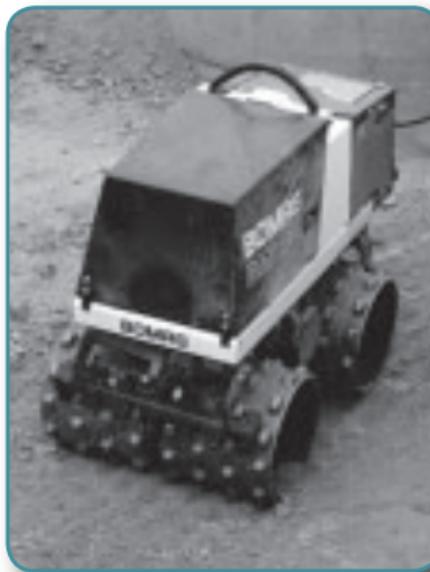
BMP 851

Operating weight	3413 lbs 1548 kg	3622 lbs 1643 kg
Length	69.3 in 176 cm	74.7 in 190 cm
Height	47.2 in 120 cm	50.2 in 128 cm
Working width	24 in / 33.5 in 61 cm / 85 cm	24 in / 33.5 in 61 cm / 85 cm
Centrifugal force	18000 lbs 80 kN	8000 lbs / 16000 lbs 36 kN / 72 kN
Frequency	1920 vpm 32 Hz	2520 vpm 42 Hz
Amplitude	0.083 in 2.1 mm	0.022 in / 0.044 in 0.56 mm / 1.12 mm
Max. gradeability*		
without vibration	55%	55%
with vibration	45%	45%
Engine / Power	Hatz 18.8 hp 14 kW	Kubota 19.4 hp 14.5 kW
Power rating ISO 9249

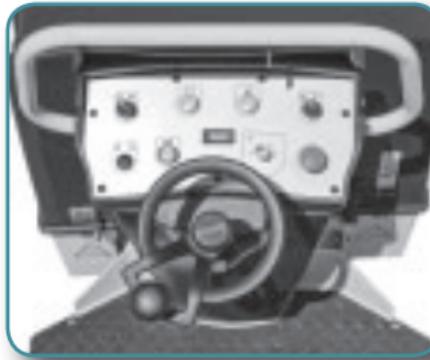
Operating weight	2639 lbs 1197 kg
Length	77.4 in 197 cm
Height	90.2 in 229 cm
Width	37.8 in 96 cm
Working width	35.4 in 90 cm
Static linear load	37.3 pli 6.7 kg/cm
Centrifugal force	3395 lbs 15.1 kN
Frequency	4200 vpm 70 Hz
Working speed with vibration	0 - 2.5 mph 0 - 5.4 kmph
Amplitude	0.02 in 0.5 mm
Max. gradeability*	
without vibration	40%
with vibration	30%
Engine / Power	Honda 16.6 hp
Power rating ISO 9249	12.4 kW

BW 900-50 with new comfort steering wheel.

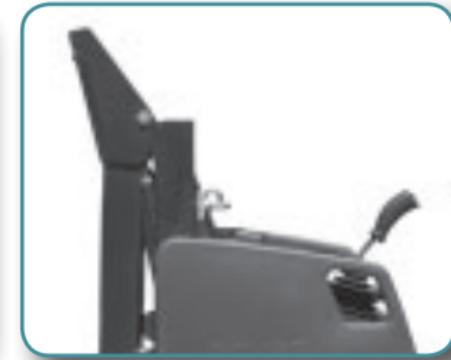
BW 900-50 with foldable ROPS Standard.

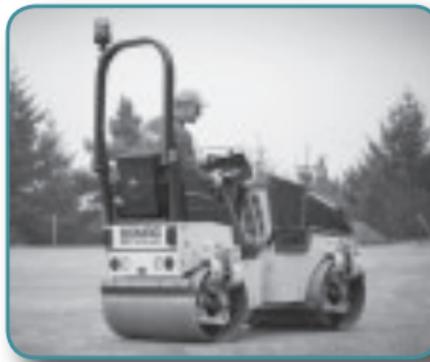
BW 90 ADM-5

Operating weight	3527 lbs 1600 kg	3638 lbs 1650 kg
Length	86.4 in 219.4 cm	86.4 in 219.4 cm
Height	90.7 in 230.4 cm	90.7 in 230.4 cm
Width	37.6 in 95.6 cm	41.6 in 105.6 cm
Working width	35.4 in 900 cm	39.4 in 100 cm
Static linear load	49.8 pli 8.9 kg/cm	46.2 pli 8.3 kg/cm
Centrifugal force (Each Drum)	3822 lbs 17 kN	3822 lbs 17 kN
Frequency	3780 vpm 63 Hz	3780 vpm 63 Hz
Working speed with vibration	0-2.8 mph 0-4.5 kmph	0-2.8 mph 0-4.5 kmph
Amplitude	0.020 in 0.50 mm	0.016 in 0.40 mm
Max. gradeability*		
without vibration	40%	40%
with vibration	30%	30%
Engine / Power	Kubota 20.2 hp 15.1 kW	Kubota 20.2 hp 15.1 kW
Power rating ISO 14396

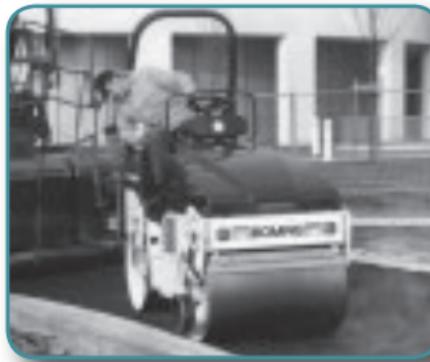
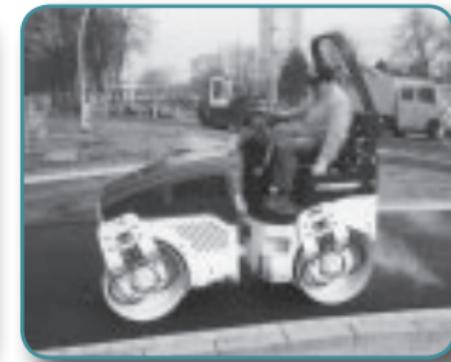
BW 100 AD-4

Operating weight	5291 lbs 2400 kg
Length	97.4 in 248 cm
Height	97.4 in 248 cm
Width	42.4 in 108 cm
Working width	39.4 in 100 cm
Static linear load	67.2 pli 12 kg/cm
Centrifugal force (per drum)	5175 lbs / 8550 lbs 23 kN / 38 kN
Frequency	3300 vpm / 4200 vpm 55 Hz / 70 Hz
Working speed with vibration	0 - 4.0 mph 0 - 6.5 kmph
Amplitude	0.02 in 0.5 mm
Max. gradeability*	
without vibration	40%
with vibration	30%
Engine / Power	Kubota 33.8 hp
Power rating ISO 9249	25.2 kW

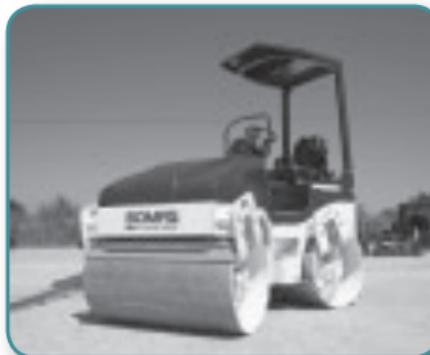
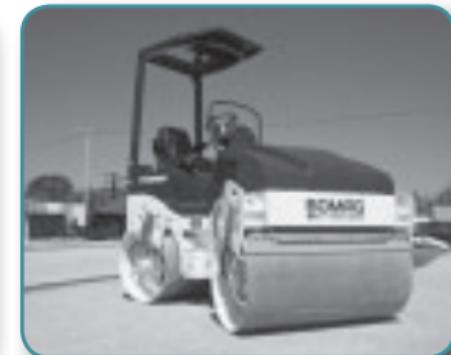
BW 120 AD-4

Operating weight	5732 lbs 2600 kg
Length	97.2 in 247 cm
Height	98.0 in 249 cm
Width	50.2 in 127.6 cm
Working width	47.2 in 120 cm
Static linear load	60.7 pli 11 kg/cm
Centrifugal force (per drum)	6300 lbs / 10125 lbs 28 kN / 45 kN
Frequency	3300 vpm / 4200 vpm 55 Hz / 70 Hz
Working speed with vibration	0 - 4.0 mph 0 - 6.5 kmph
Amplitude	0.02 in 0.5 mm
Max. gradeability*	
without vibration	40%
with vibration	30%
Engine / Power	Kubota 33.8 hp
Power rating ISO 9249	25.2 kW

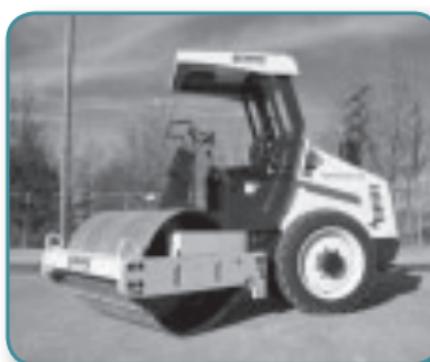
BW 124 DH-40	BW 124 PDH-40
Operating weight	7010 lbs 3180 kg	7120 lbs 3230 kg
Operating weight w/blade	N/A N/A	8050 lbs 3650 kg
Length	136.0 in 345 cm	136.0 in 345 cm
Length w/blade	N/A N/A	157.5 in 400 cm
Height	97.3 in 247.1 cm	97.3 in 247 cm
Width	51.6 in 131 cm	51.6 in 131 cm
Width w/blade	N/A N/A	59.6 in 151 cm
Working width	47.2 in 120 cm	47.2 in 120 cm
Centrifugal force (per drum)	18540 lbs 82.5 kN	18540 lbs 82.5 kN
Frequency	2460 vpm 41 Hz	2460 vpm 41 Hz
Working speed	0 - 5.6 mph 0 - 9 kmph	0 - 5.6 mph 0 - 9 kmph
Amplitude	0.067 in 1.7 mm	0.063 in 1.6 mm
Max. gradeability*	55%	55%
Engine / Power Power rating SAE J1995	Deutz 45 hp 33 kW	Deutz 45 hp 33 kW
Number of Pad Feet	N/A	70

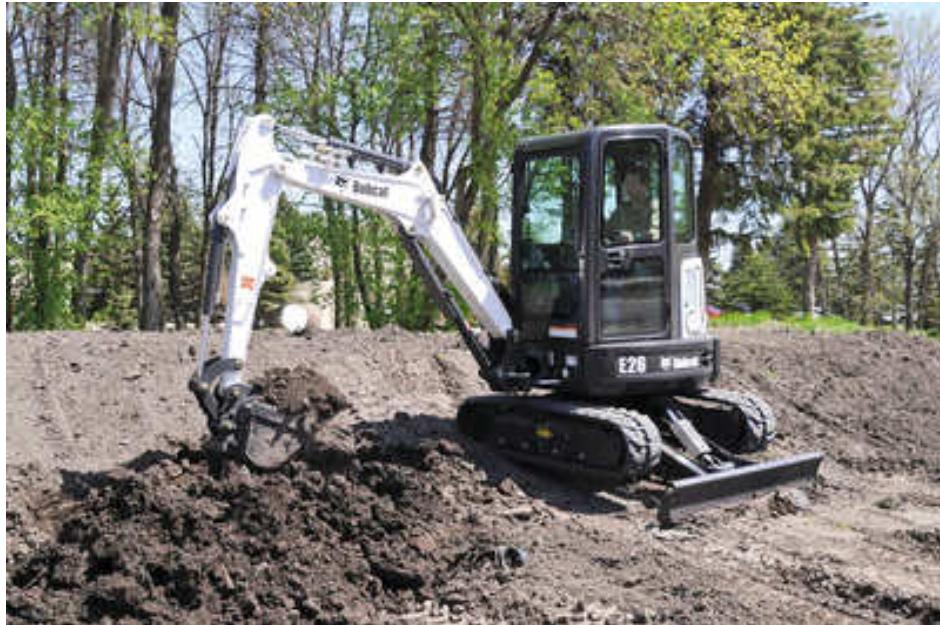
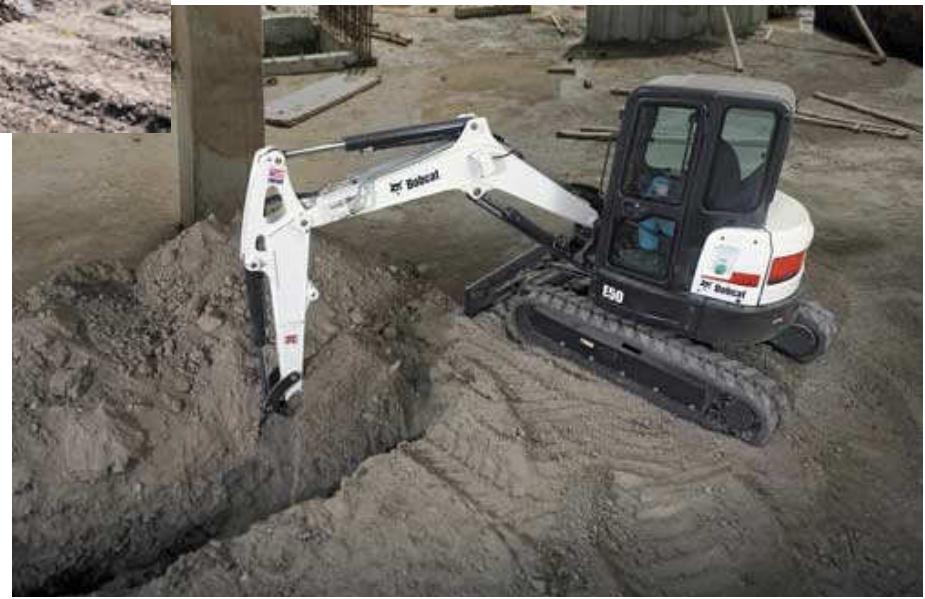
Photo – Bobcat Company – Compact Excavator

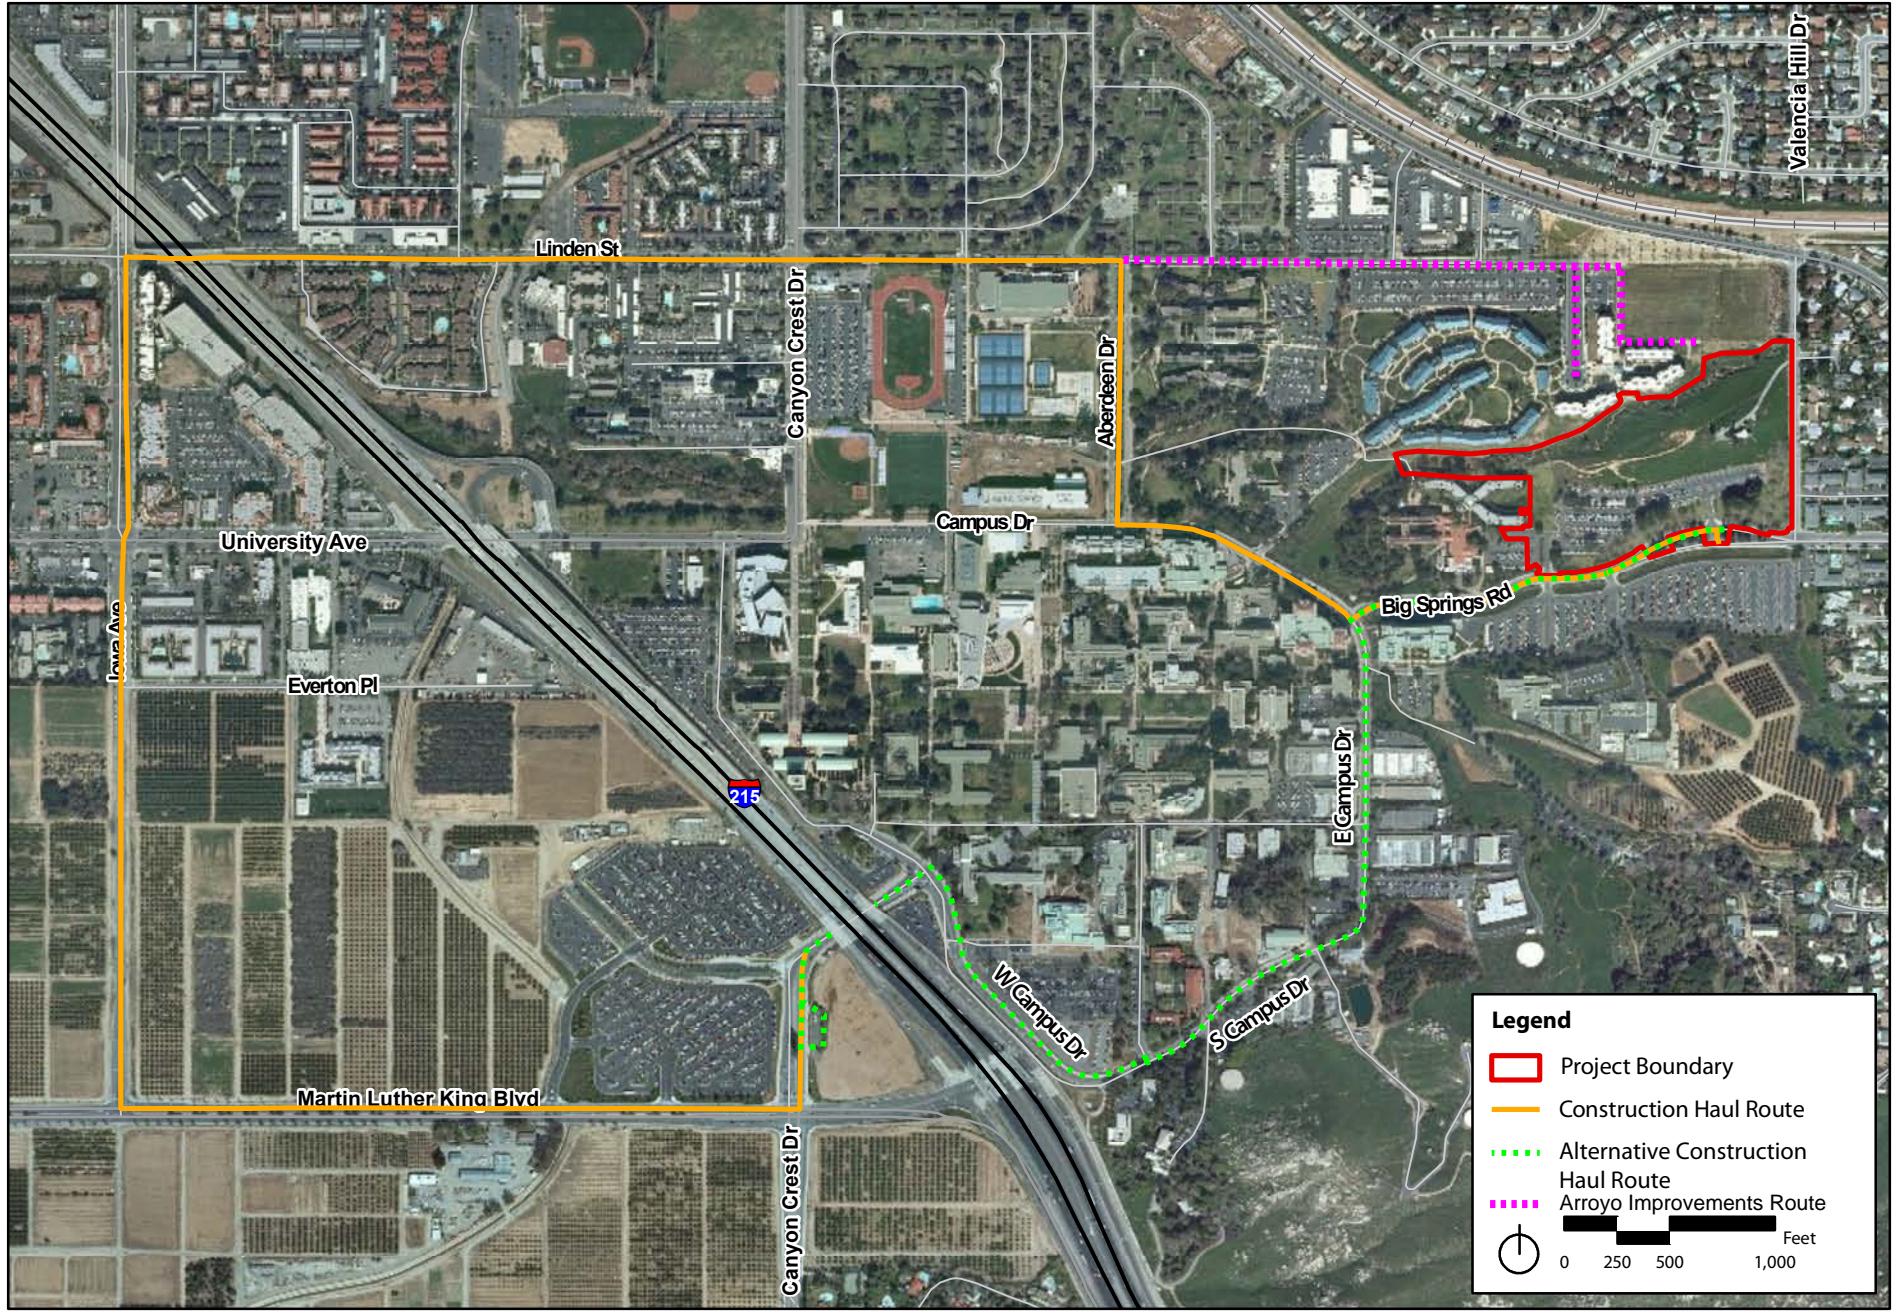
Attachment t
Revised Figure 3.13-2

Figure 3.13-2
Construction Haul Routes
Glen Mor 2 Student Apartments
Revised September 2012 for Arroyo Improvements Addendum

fields (see revised Figure 3.13-2 attached hereto). The receptors located along this route are similar to those considered in the EIR analysis and the level of activity will be more limited (240 total truck trips for duration of construction versus the 178 trucks per day assumed in the EIR). On this basis, the proposed project modification does not present the potential for new significant impacts or substantial increase in the severity of previously identified impacts.

- t. Revised Figure 3.13-2
